Walla Walla Public Schools
October, 2016

# Building Conditions

## OSPI Rating System

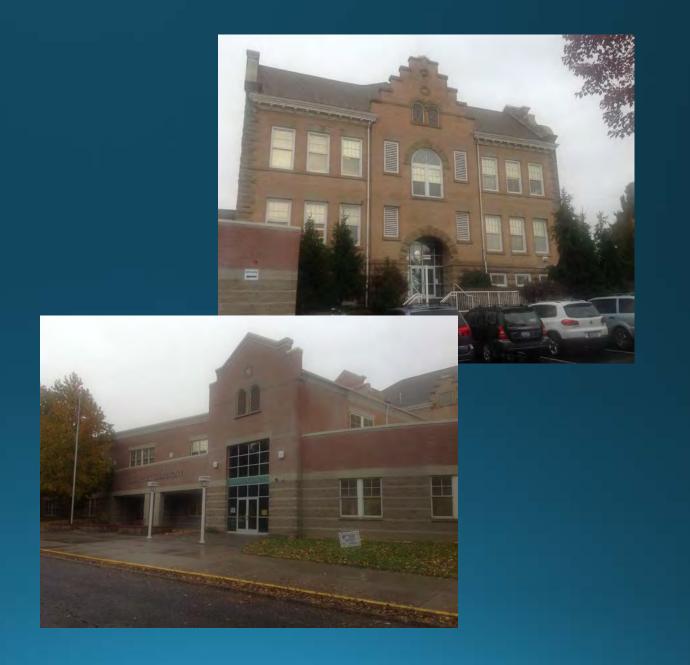
Green Park Elementary

- Roofing at end of life (losing shingles), frequent leaks
- Carpet needs replacing (especially stairs)
- Need to seal interior brick to stabilize crumbling
- Roof drainage issues at planters causing leaks into building
- Windows inoperable due to defects
- Water intrusion and settlement at SW corner of gym
- Exterior brick needs cleaning and sealing
- Original boilers (20+ years)
- Asphalt in parking lot failing, needs replacement

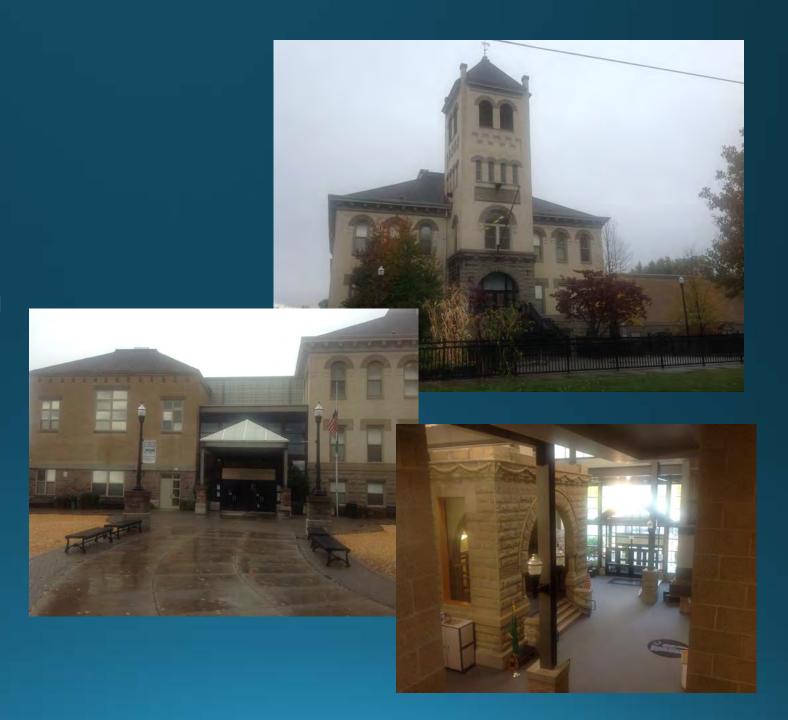
Sharpstein Elementary

- Minor amount of efflorescence on masonry
- Commons VCT floor tile due for replacement
- Carpets beginning to wear
- Exterior caulking and paint needed
- Some roof leaks
- Lighting original to 2000
- Some single pane windows

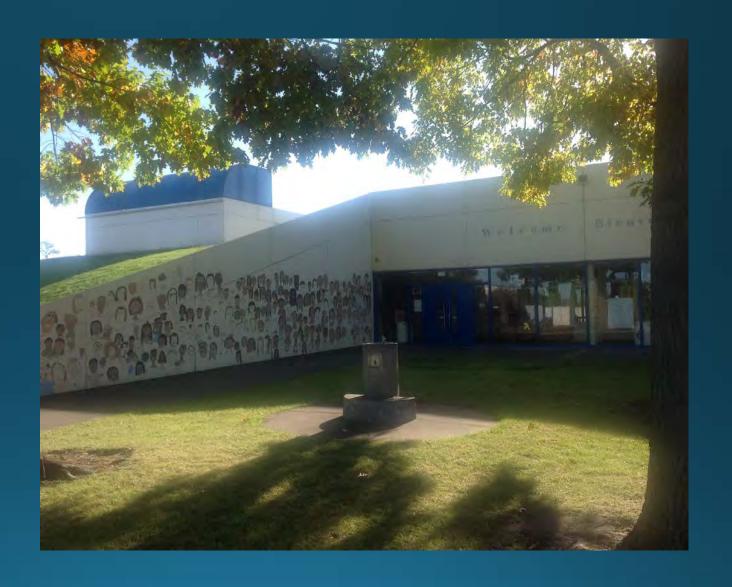
Blue Ridge Elementary

- Foundation cracking
- Roofing is original (end of life span?)
- Leaks and water intrusion (constant battle)
- Restrooms due for restoration
- Single pane windows
- Exterior painting and caulking needed
- Library carpet needs replaced (other carpets recently done)
- Significant cracking of concrete parking lot

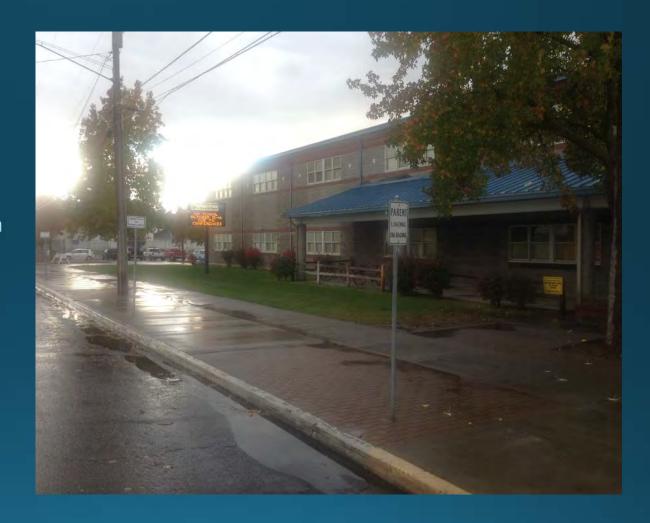
Garrison Middle School

- Exterior Masonry needs sealing water intrusion
- Minor cracking of brick veneer
- Restrooms need upgrading (in progress with 2 complete)
- Water intrusion at Kalwall skylights
- Pella windows leaking and peeling in some areas
- Exterior soffits/gutters need paint (showing rust)
- Most finishes in Fair condition (needs paint and VCT)
- Exterior steel structures showing rust
- Lighting original to 1994

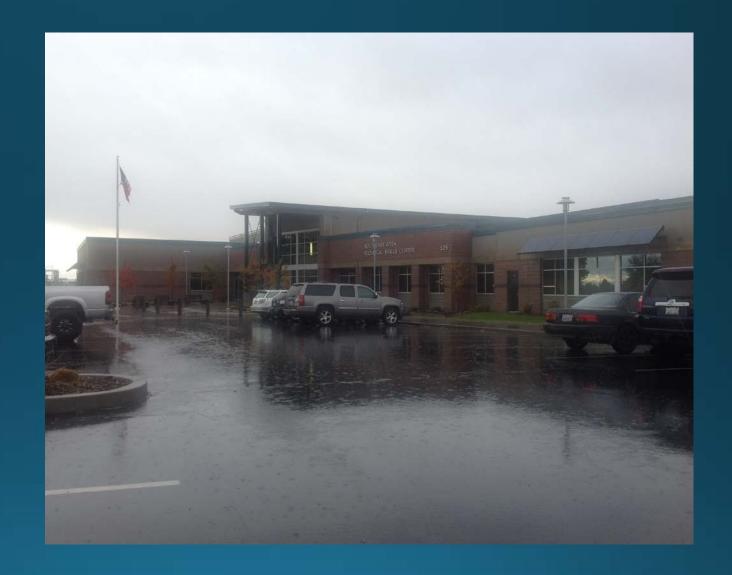
Sea Tech Skills Center

- New facility in new condition
- HVAC system makes "whale sounds" at startup (this has been corrected)
- Extreme negative pressure in mfg/welding shop (this has been corrected)
- Extron systems problematic

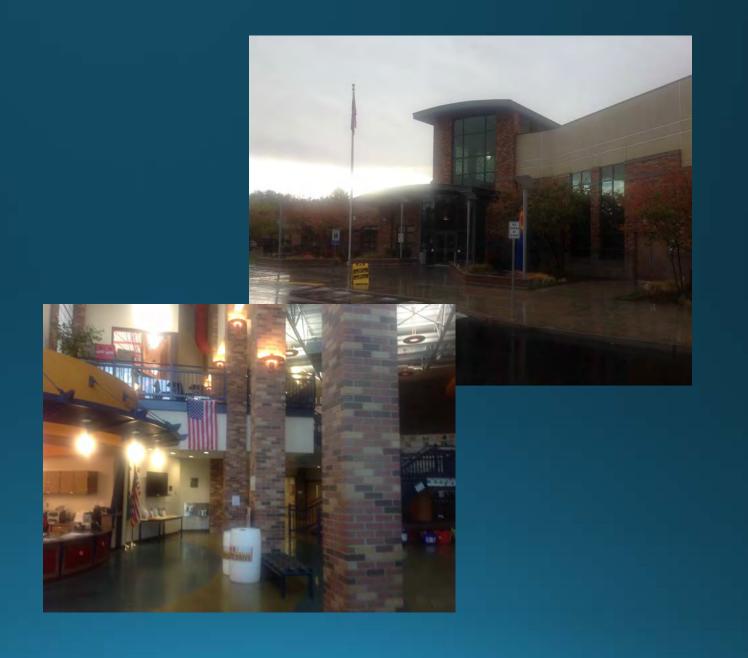
**Edison Elementary**

- Gym floor failing (widespread adhesion problems and bubbles)
- HVAC and controls work well

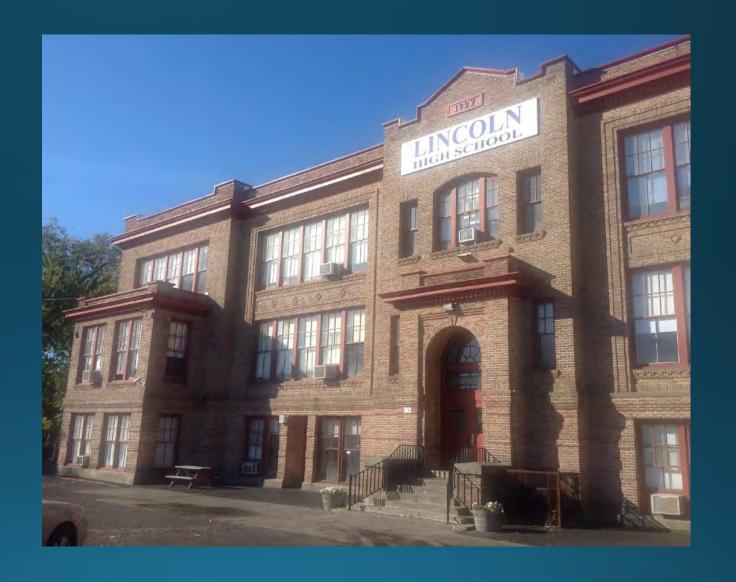
Lincoln Alternative High School

- Windows need replacement
- Old steam boiler has surpassed its useful life expectancy
- Asphalt slopes to building causing drainage problems
- Inadequate electrical capacity (always blowing breakers)
- Exposed wiring throughout
- HVAC systems beyond service life
- Plumbing systems beyond service life
- Aging restroom finishes and fixtures
- Detection and alarm inadequate

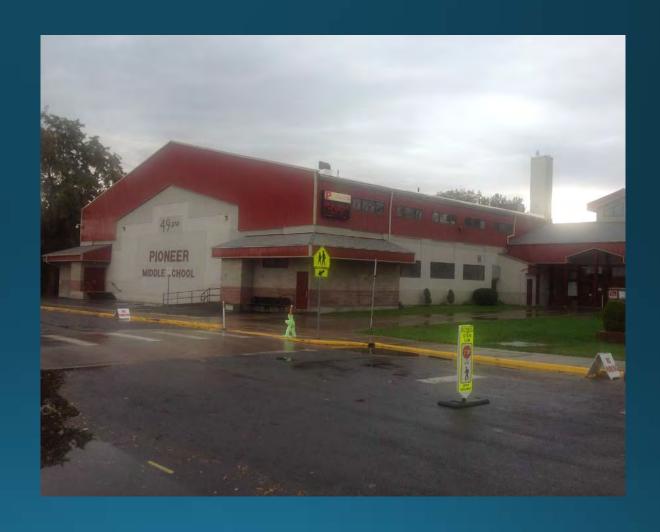
- Locker rooms antiquated (access, supervision issues)
- Subfloor and floor tile failure in areas (needs more investigation)
- Many interior finishes worn or damaged
- · Restrooms antiquated, need updating
- Mechanical systems upgraded 1990 (exception new boiler last year)
- Plumbing systems well beyond service life
- Plumbing failures such as carriers rusting out of walls
- Electric patched together (breakers, timeclocks, etc. in strange locations)
- Two very noisy transformers
- New roof in last few years
- Exterior masonry needs sealing
- Cracks in masonry
- Single pane windows
- Exterior sidewalks and stairs need replacement and repair

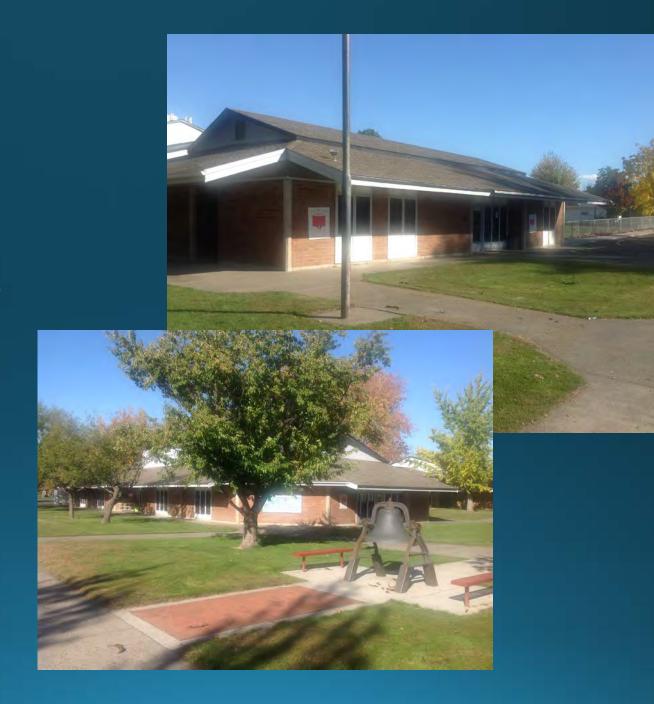
Prospect Point Elementary

- Exterior walls not insulated
- Restrooms can get cold and freeze pipes
- Moss on roofs, frequent roof leaks
- Single pane windows
- Need more roof gutters and improved drainage
- Zoning and air-flow issues due to added walls
- Flooring due for replacement
- Interior walls need repair and paint
- Parking lot needs crack sealing and seal coat

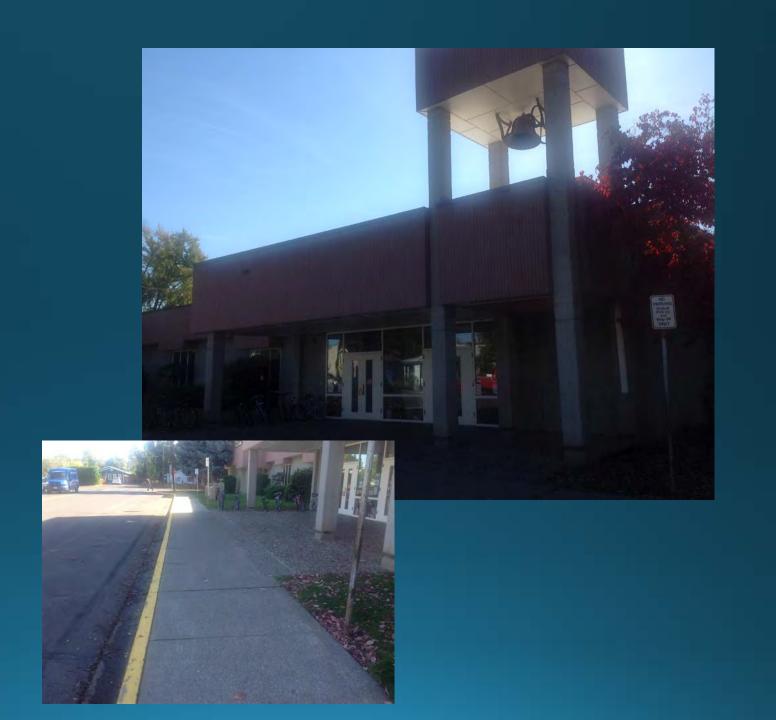
#### Berney Elementary

- Wood siding is aged and deteriorated
- Roof due for replacement (periodic leaks, fasteners wearing through)
- Due for lighting upgrade
- Restrooms need renovation (2 done already, 4 to go)
- Carpets need replacement (original)
- VCT in commons over crawl space failing
- Ceilings stained and dull
- HVAC system aged and needs upgrading
- Cooling tower due for replacement (leaks often)
- New boilers in 2014
- Some sidewalks settling and damaged/weathered
- Music room ventilation inadequate
- Parking lots need overlay/replacement

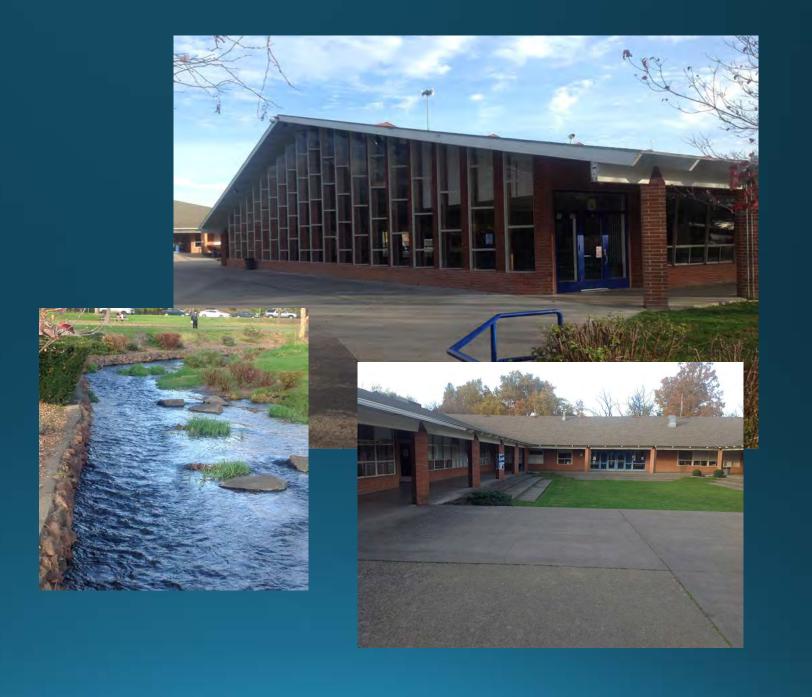
#### Walla Walla High School

- HVAC systems are aged and need major upgrade or replacement
- Plumbing systems are largely original and beyond service life, failing
- Lighting is inconsistent and discolored where not upgraded, mostly original to 1990
- No air-conditioning (few exceptions. Temporary window units to be installed this year. A short term fix.)
- Lockers are worn out and do not work
- Principal reports not enough cameras and many are inoperable
- Weight room mechanical not to code
- Door hardware failing in places
- Ceilings dirty and stained
- Communications exhibits inadequate coverage
- Surveillance and detection inadequate coverage
- Roofing mostly good but some nearing life expectancy
- Crawl spaces under science building always wet and "terrarium like" (results in rusty pipes and structures)
- Stormwater runoff causes problems throughout campus
- Restrooms not ADA and needing update
