Sprigeo, Summary Report

School Safety Onsite Evaluation Summary Report

Walla Walla School District

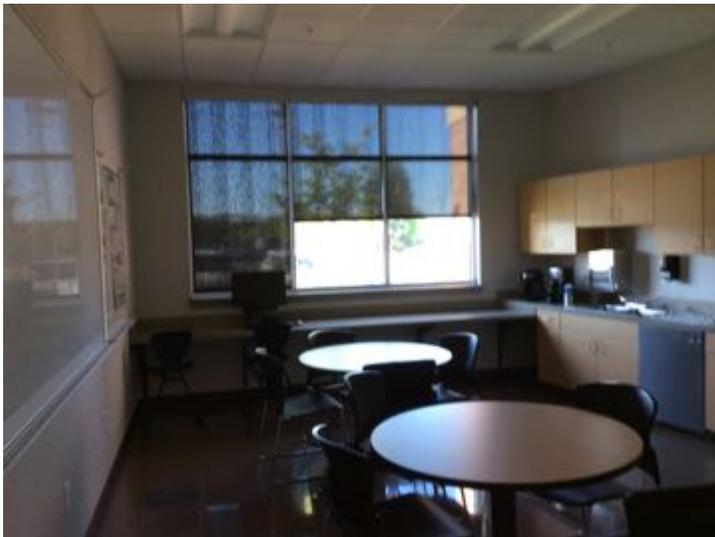
ST10 - Window shading is a positive example of minimizing visual access to the inside of the room. We recommend keeping these shades down during school hours.

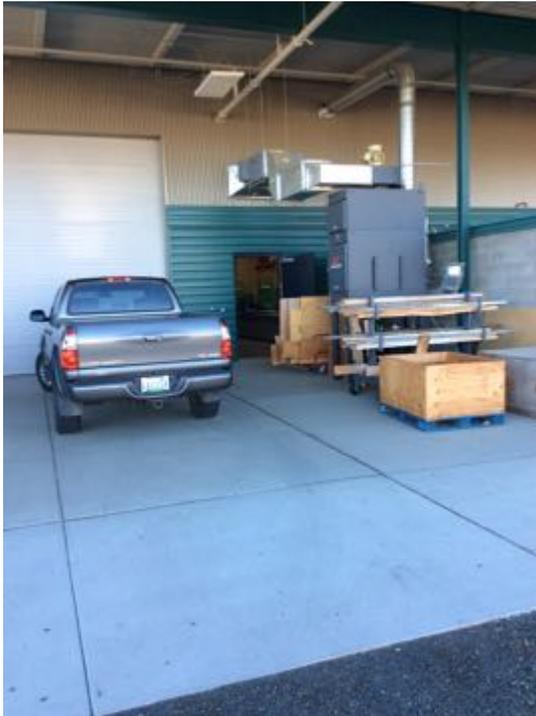
ST15 - Inside open chain link fence area. Open door found that should be locked during school hours.

7. Open fence access to #4 side. Area is surrounded by 12' high chain link fence. This area should be closed with a locked gate during school hours. (ST14)
8. Inside open chain link fence area. Open door found that should be locked during school hours. (ST15)

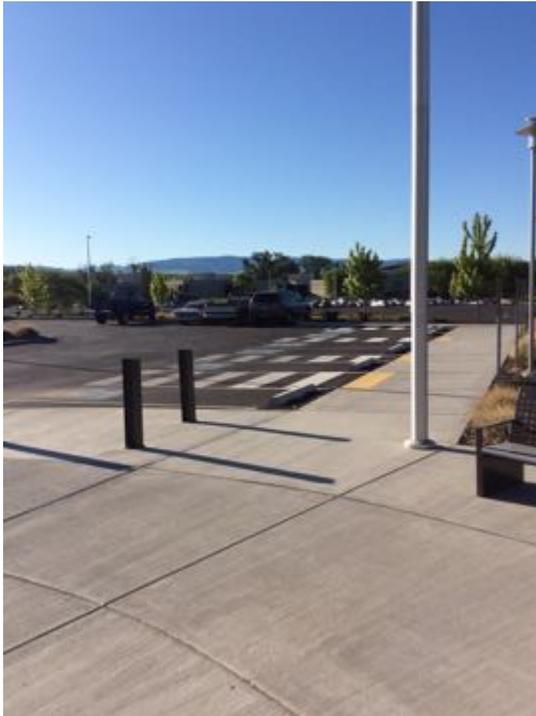
ST17 - #1 side looking out at parking lot. Good visibility looking out. Multiple security cameras are needed in parking lot. School is on high ground, which cameras should accommodate for. Camera on #1 and #3 sides recommended for top of building looking into parking lot and beyond.

6. #1 side looking out at parking lot. Good visibility looking out. Multiple security cameras are needed in parking lot. The school is on high ground, which cameras should accommodate for. Camera on #1 and #3 sides recommended for top of building looking into parking lot and beyond. (ST17)

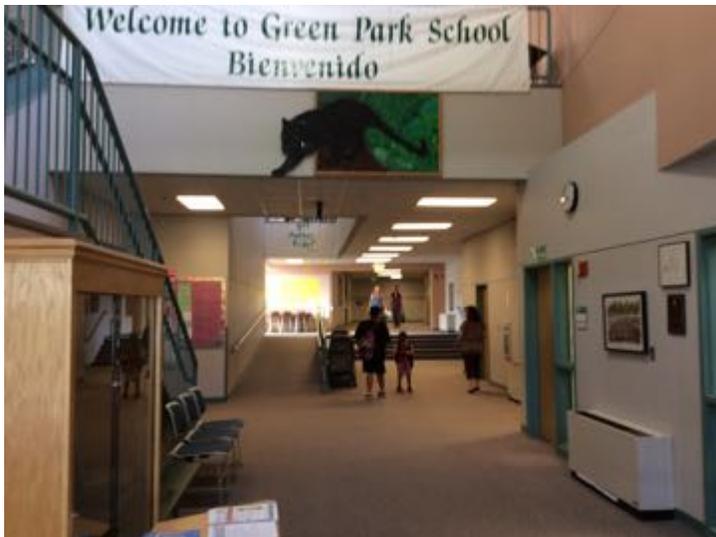
GP1 - Inside lobby area unsecured. We recommend creating a secure vestibule area here.

1. Inside lobby area unsecured. We recommend creating a secure vestibule area here. (GP1)
2. A security camera is needed in the Library/Media center. (GP2)

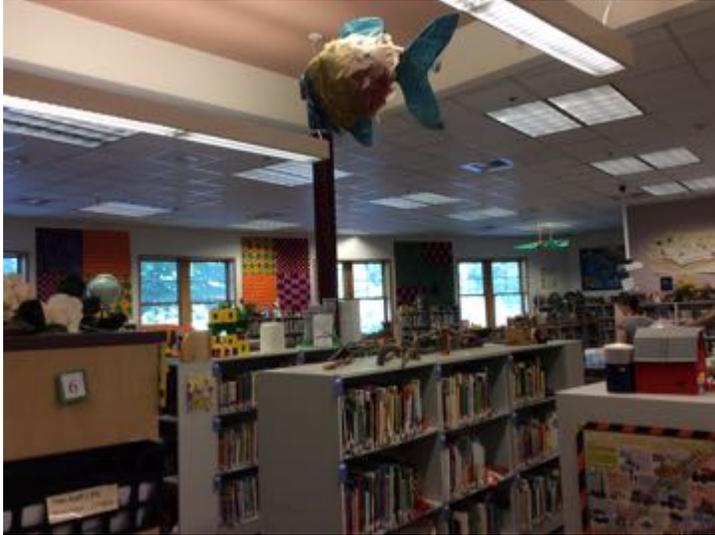
GP2 - A security camera is needed in the Library/Media Center.

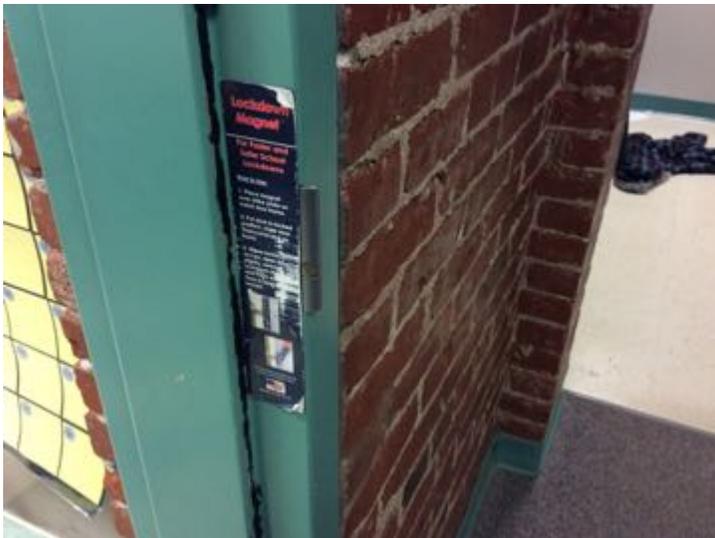
GP5 - Lockdown magnets were in place, covering the strike plate of most classroom doors. The magnets show signs of wear and may be in need of replacement.

3. A security camera is needed to see this blind spot of the corner view. (GP3)
4. A security camera is needed to see this view of the stairwell. (GP4)
5. Lockdown magnets are currently placed on the strike plate of classroom doors. The magnets appear to be worn. We recommend removing the lockdown magnets in favor of keeping all classroom doors closed and locked during the school day. Lockdown magnets, although simple in function, create one additional task for a teacher or student to manipulate in a lockdown situation. (GP5)

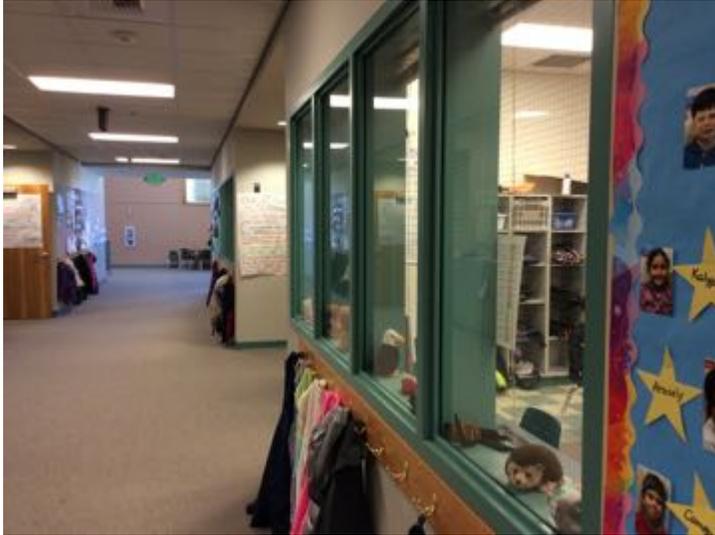
GP6 - Wire mesh windows were found in many of the classrooms. We prefer this type of window for classrooms as it creates a secondary layer of protection that must be penetrated in order to gain entry into the classroom.

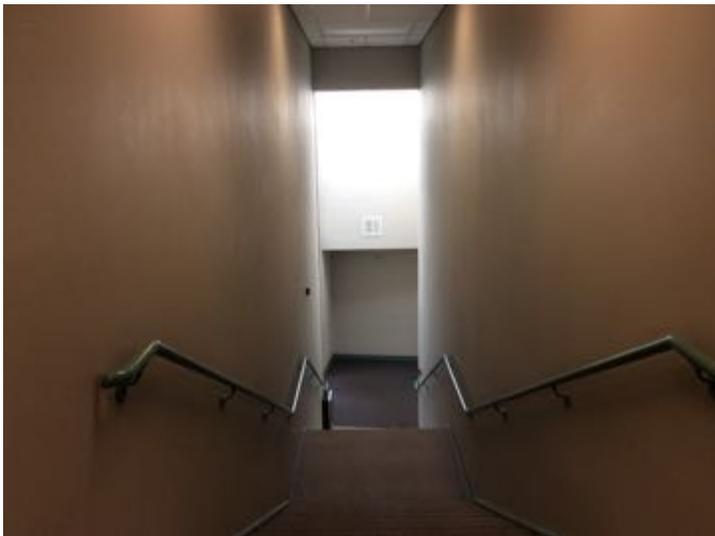
GP7 - A security camera is needed to see this view of the stairwell.

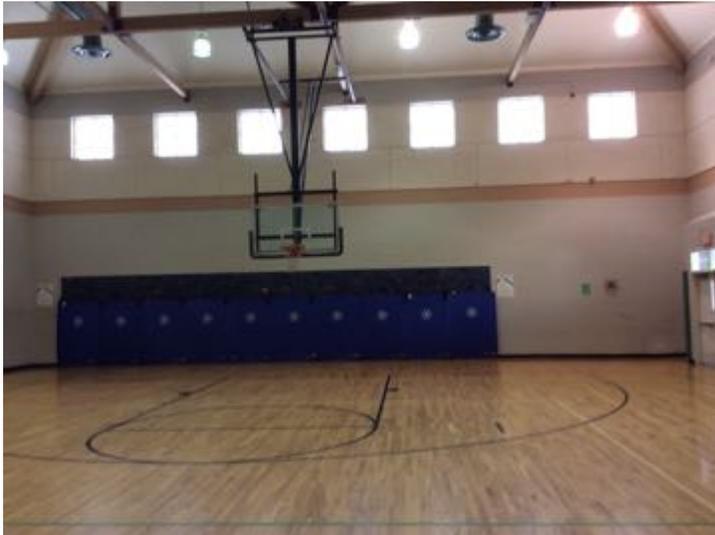
GP10 - Two security cameras needed in the gym. We recommend one camera on each end.

8. Two security cameras are needed to see to view the gym area. (GP10)
9. The school perimeter surrounding #2,3,4 side of fields and playground have 3' high chain link fence. School surrounded by dense neighborhood. We recommend installing a 6' high fence that would create a more effective deterrent to entering the school grounds.

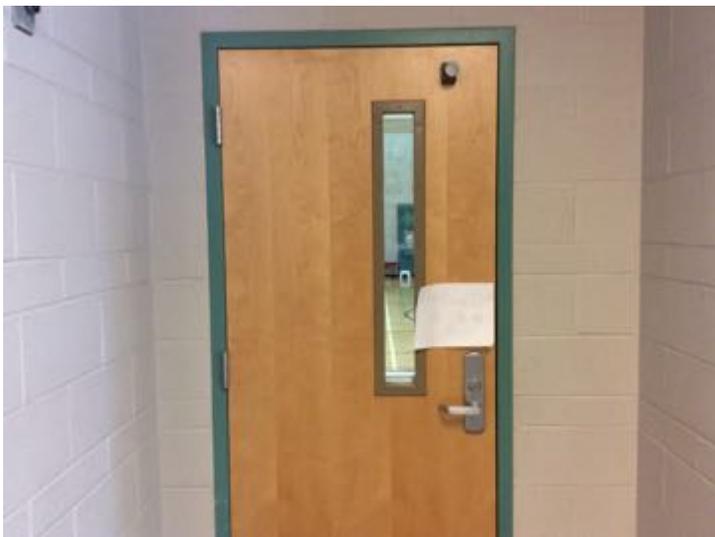
GP11 - Good example of a door with a minimal view of the room's interior. This size window also prohibits access to the room if broken.

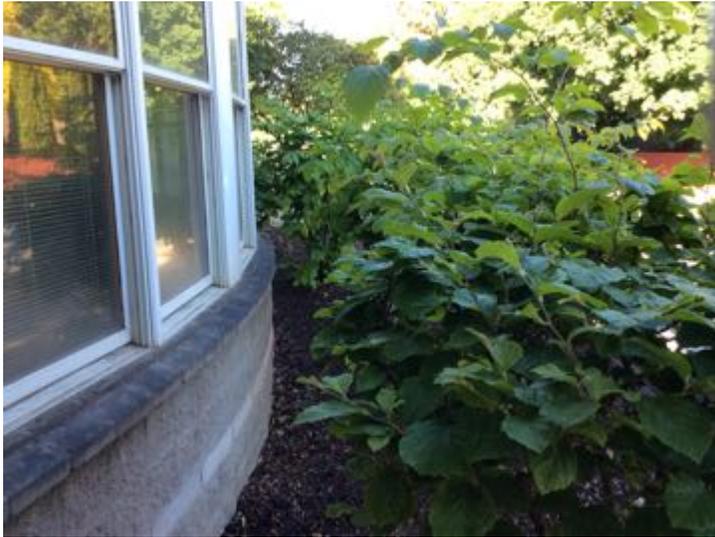
GP12 - Far left near #4 corner. Hedges should be trimmed for better natural surveillance.

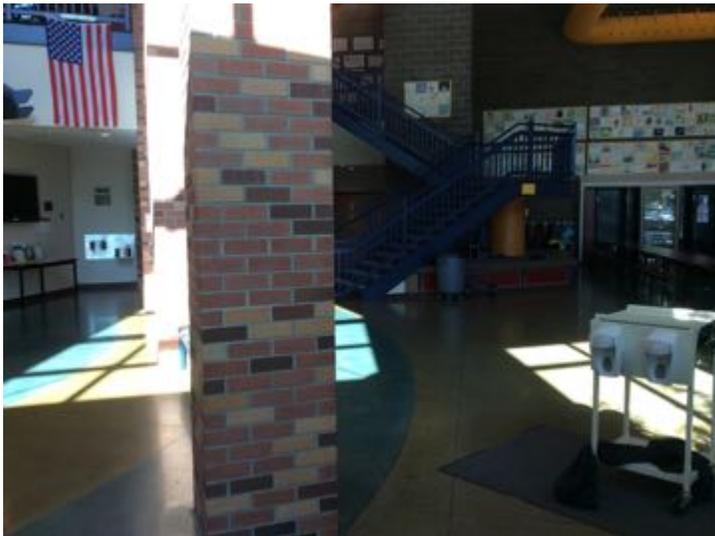
EE1 - We recommend creating a secure vestibule area here that would cut off access to the cafeteria and classrooms.

1. The current entrance to the school opens to the cafeteria, providing immediate access to students and staff. We recommend creating a secure vestibule area here. (EE1)

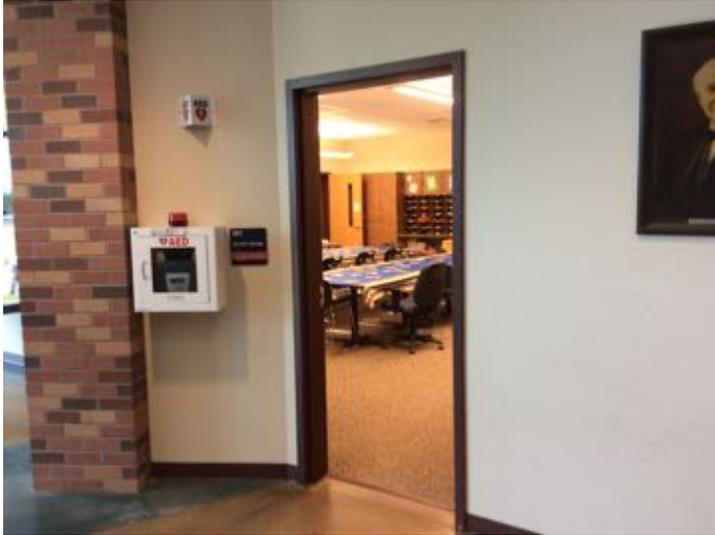
EE2 - Access doors to staff and work areas should be locked during school hours.

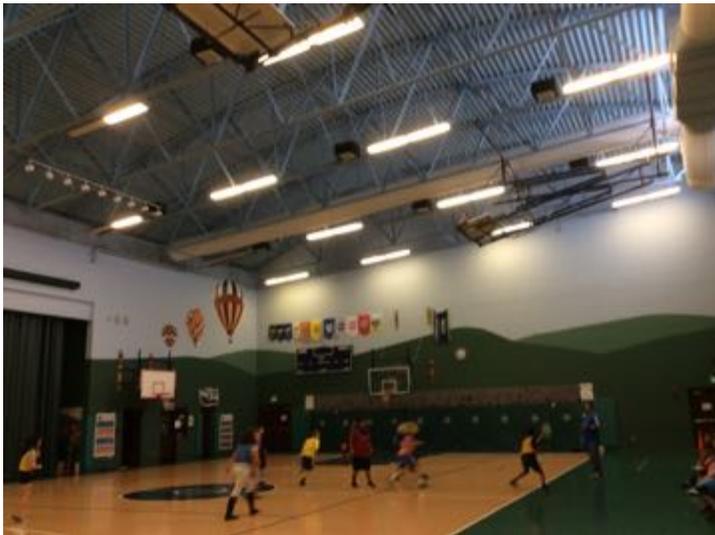
EE3 - Two security cameras needed in the gym. We recommend one camera on each end of the gym.

2. A security camera is needed to see the gym area. (EE3)
3. A security camera is needed to see the area in this open space. (EE5)
4. A ceiling panel is out of place and either needs to be repositioned or replaced. (EE6)

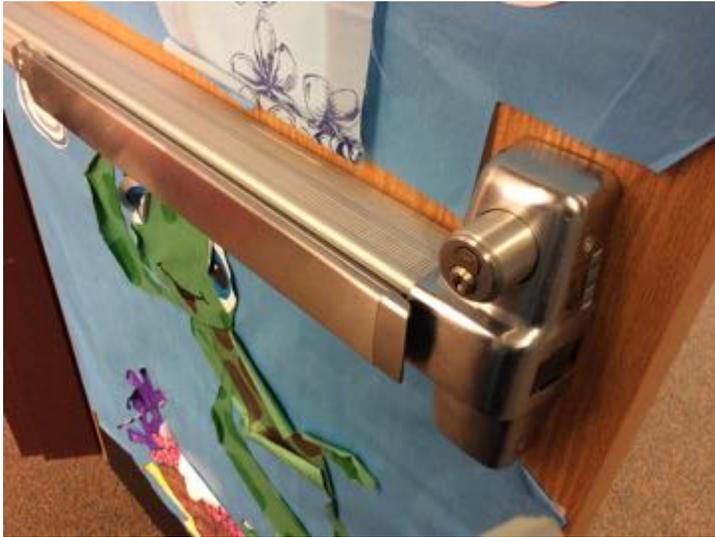
EE4 - Door handle unlocked and doors open. We recommended that classroom doors remain closed and locked during school hours prohibiting access except when someone on the interior of the classroom has opened the door.

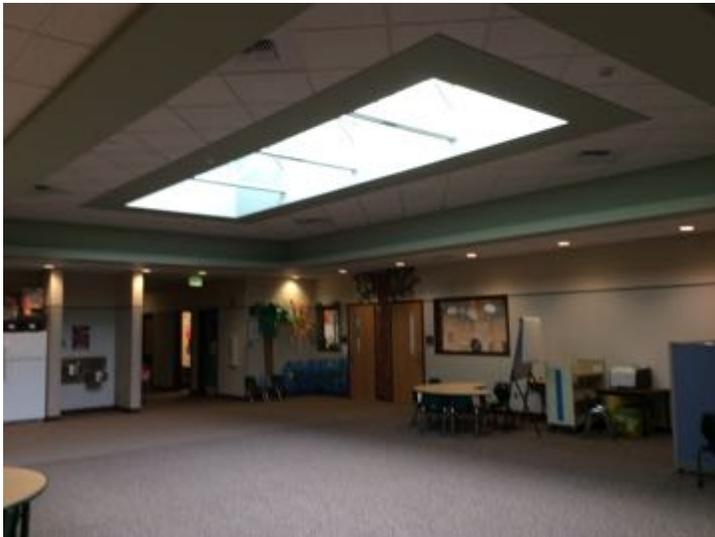
EE5 - A security camera is needed to see this open space area.

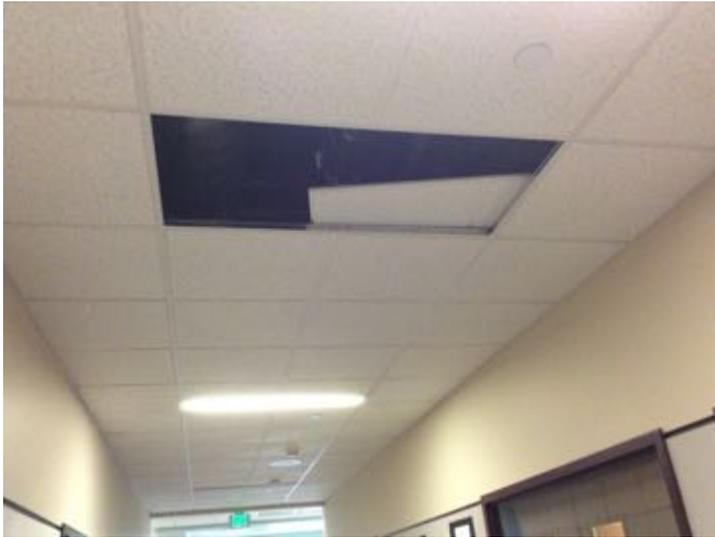
EE 6 - Ceiling panel needs to be replaced or repositioned.

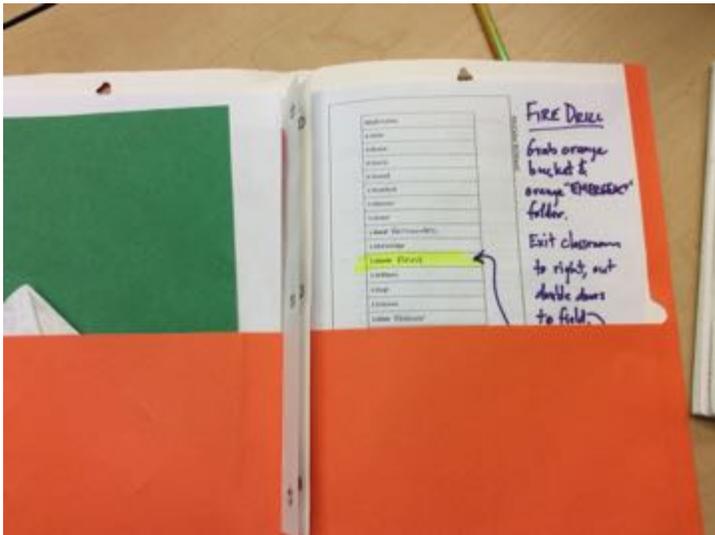
EE7 - Fire drill folder: Although the directions are complete we recommend a series of typed cards, one for each type of drill that will take place at the school.

5. Fire drill folder: Although the directions are complete we recommend a series of typed cards, one for each type of drill that will take place at the school. (EE7)

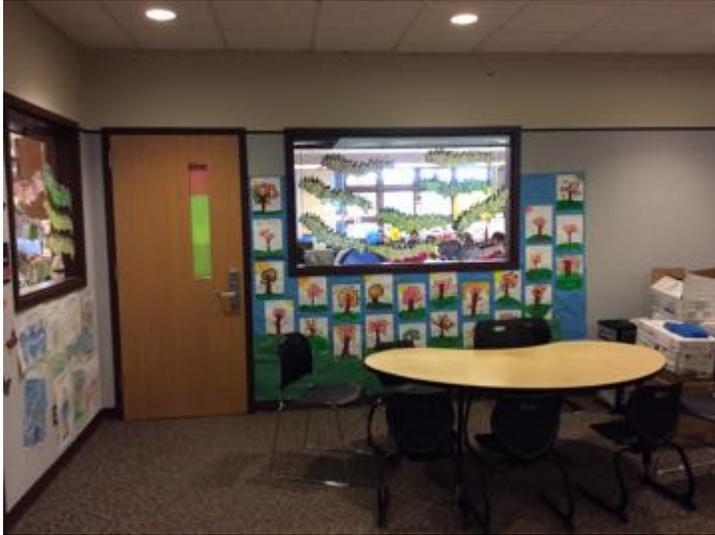
EE8 - Large glass classroom windows should have screens or blinds on the inside to limit viewing from the exterior.

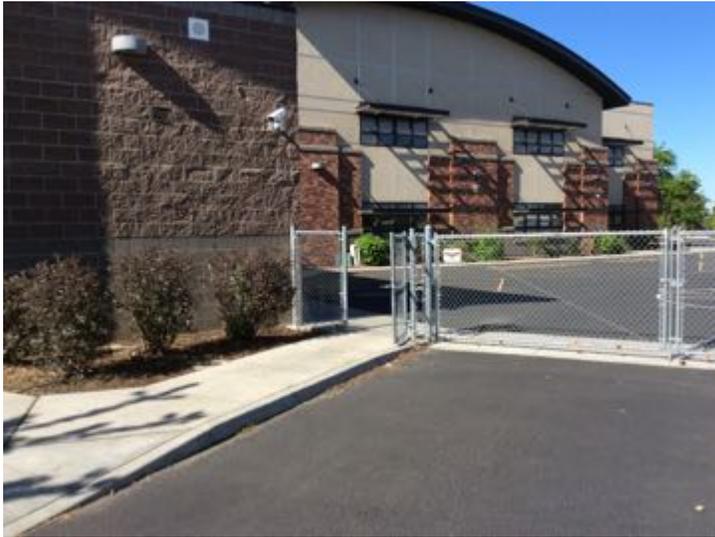
EE12 - 3' high fence surrounding playground area. Gate found open, security camera directly above camera. All gates should be closed and locked during school hours.

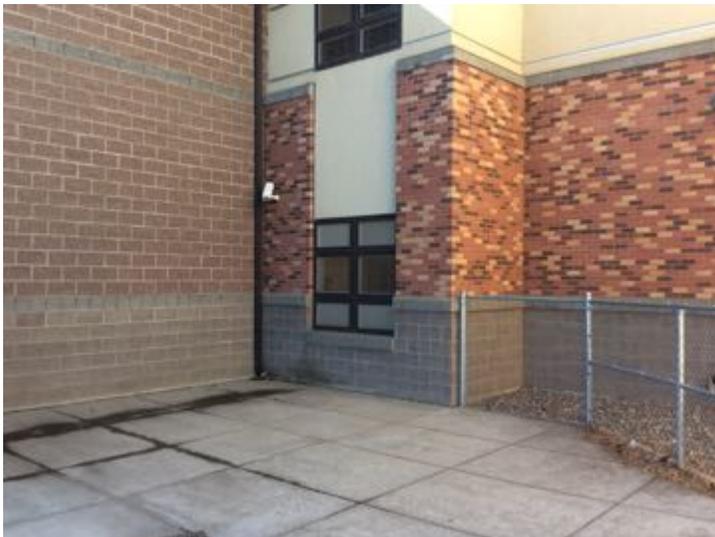
EE13- Mono camera in dead space. We recommend replacing the mono camera with a multi-lens camera to capture to multiple vantage points in this area.

9. Mono camera in dead space. We recommend replacing the mono camera with a multi-lens camera to capture to multiple vantage points in this area. (EE13)

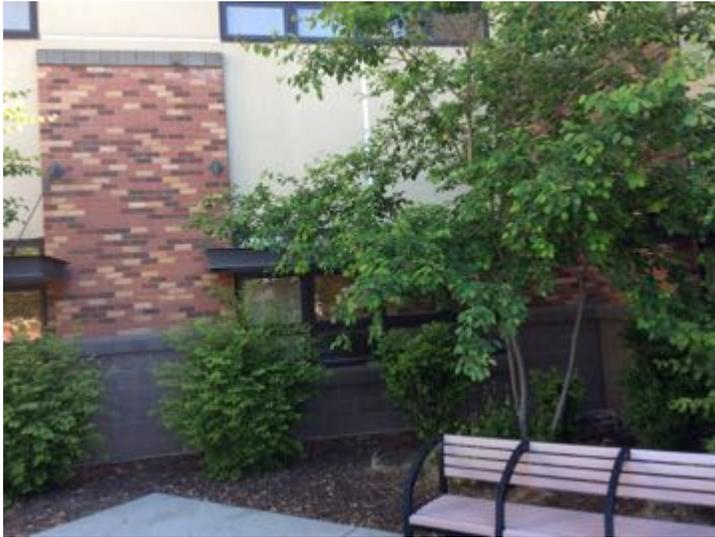
EE14 - Shrubbery cut down and away from building. Windows should also be coated with shatterproof tinting.

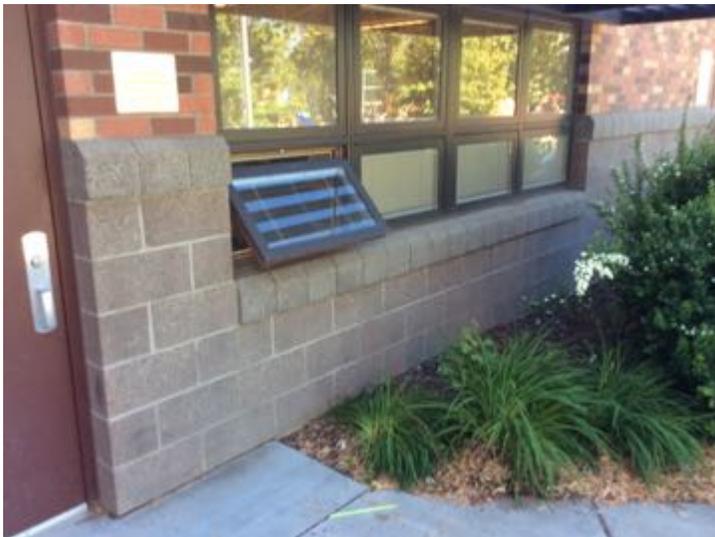
EE15 - Found open window. Close and lock all exterior windows during school hours.

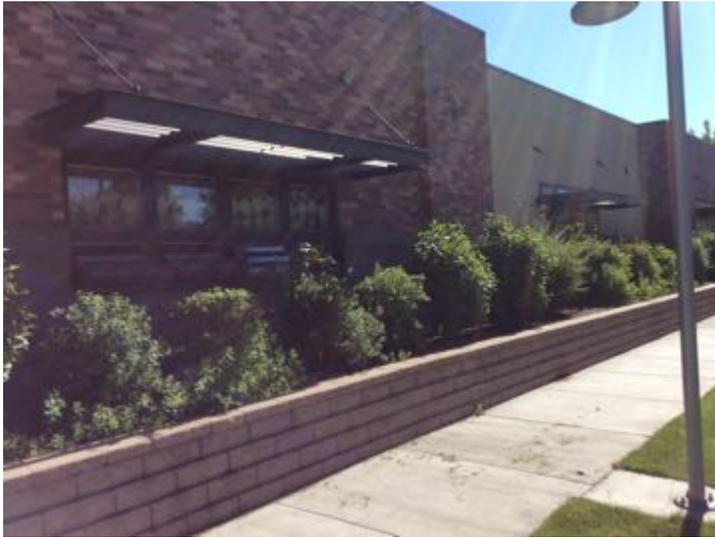
EE16 - Additional exterior windows found open that needed to be closed and locked during school hours.

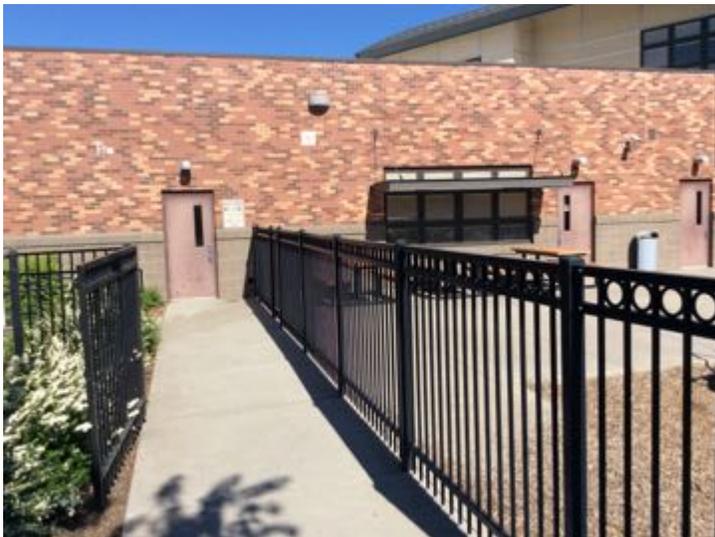
EE17 - Open fence access to playground near #1 side. Fences should be closed and locked during school hours.

1. Unsecured door leading directly into cafeteria. All exterior doors should be locked during school hours. (EE10)
2. 1,2 corner. A security camera is present here but the view is being blocked by the shrubbery. Cut back shrubbery to a minimum height of 6ft and trimmed to allow for a minimum, unobstructed passage way of 3ft between the shrubbery and the exterior school walls. (EE11)
3. 3' high fence surrounding playground area. Gate found open, security camera directly above camera. All gates should be closed and locked during school hours. (EE12)
4. Shrubby cut down and away from building. Windows should also be coated with shatterproof tinting. (EE14)
5. Found open window. Close and lock all exterior windows during school hours (EE15, EE16)
6. Open fence access to playground near #1 side. Fences should be closed and locked during school hours. (EE17)

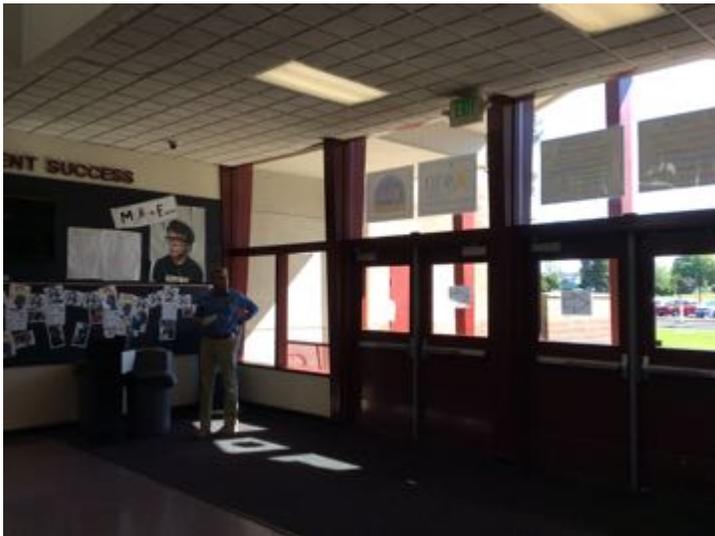
PM1 - We recommend creating a secure vestibule area at the front entrance of the school that would prohibit access to the main hallways and classrooms.

1. We recommend creating a secure vestibule area at the front entrance of the school that would prohibit access to the main hallways and classrooms. (PM1)
2. Door handles were found to be broken on most boy's and girl's restrooms. We recommend replacing the broken handles and keeping all restroom doors open during school hours. (PM7)
3. Shatterproof window tinting needed on all exterior windows. (PM10)
4. A security camera is needed to see this view of the alcove area. (PM12)
5. Portables with open doors and pane glass windows. Windows should be replaced with either wire mesh or double pane windows. (PM15)

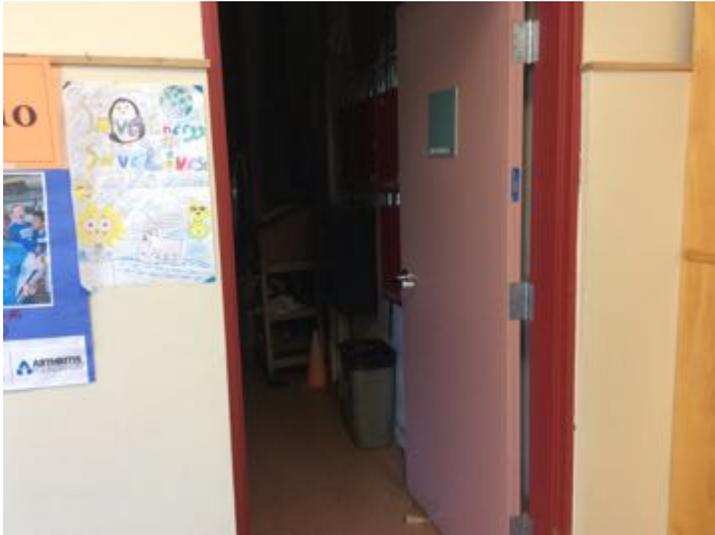
PM2 - Door to the Mechanical room should be locked during school hours.

2. Doors to the Mechanical room should be closed and locked during school hours. (PM2)
3. Some student lockers were found to be unlocked or without locks. All lockers should have school issued locks. (PM3)

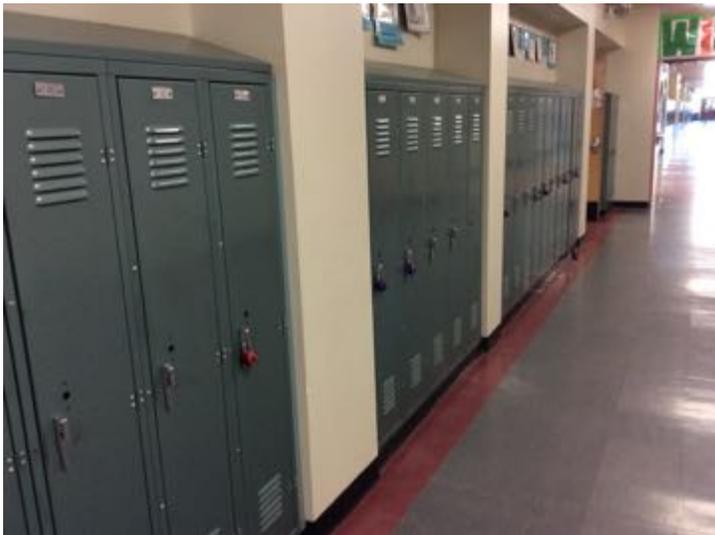
PM3 - Some student lockers were found to be unlocked or without locks. All lockers should have school issued locks.

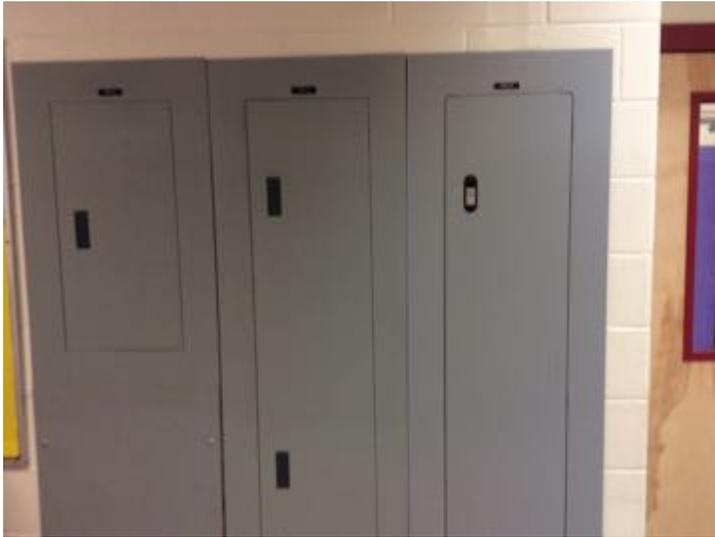
PM4 - Power breaker panel doors should be locked at all times, accessible only by school administration and custodial staff.

4. Power breaker panel doors should be locked at all times, accessible only by school administration and custodial staff. (PM4)
5. Fire extinguishers were found to be sitting in the cabinets unsecured. We recommend contacting your local fire department to confirm the current fire code regulations related to the securing and accessing fire extinguishers on school grounds. (PM5)

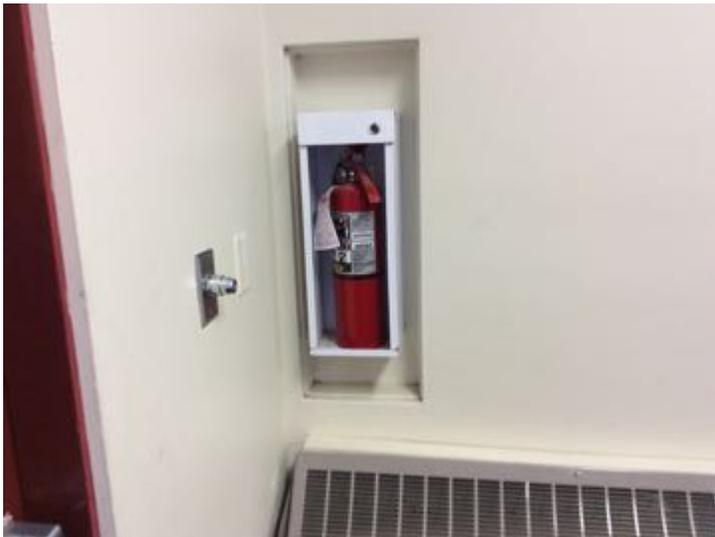
PM5 - Fire extinguishers were found to be sitting in the cabinets unsecured. We recommend contacting your local fire department to confirm the current fire code regulations related to the securing and accessing fire extinguishers on school grounds.

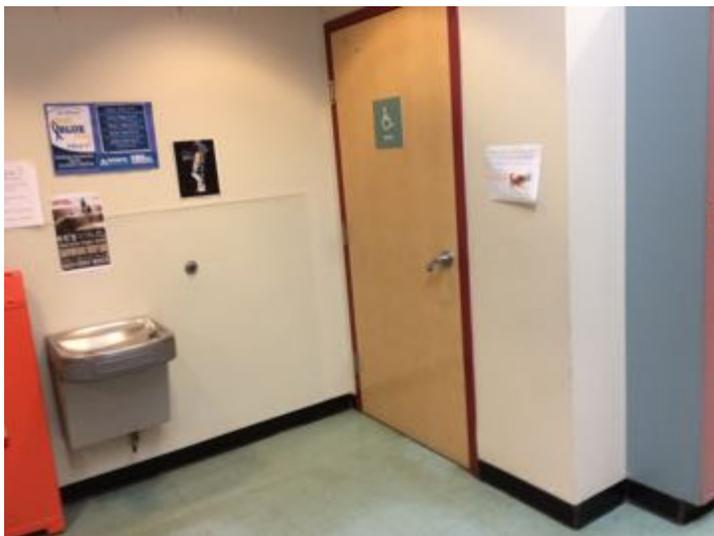
PM7 - Door handles were found to be broken on most boy's and girl's restrooms. We recommend replacing the broken handles and keeping all restroom doors open during school hours.

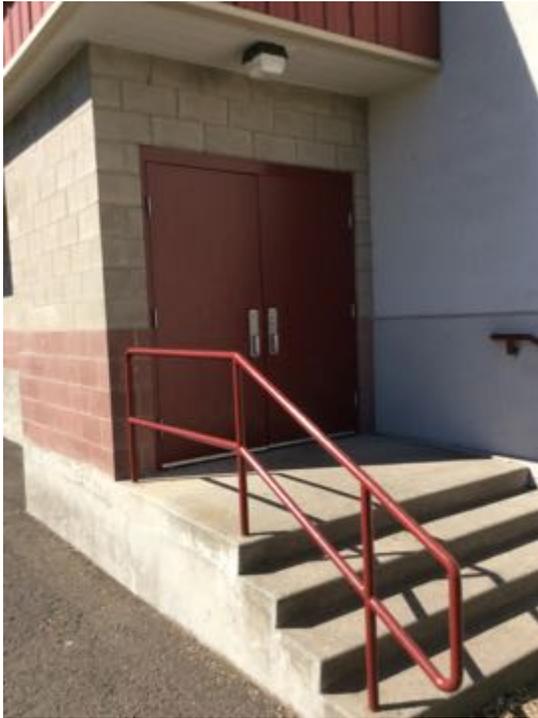
PM8 - Open exterior door leading to gym. All exterior doors should be locked during school hours.

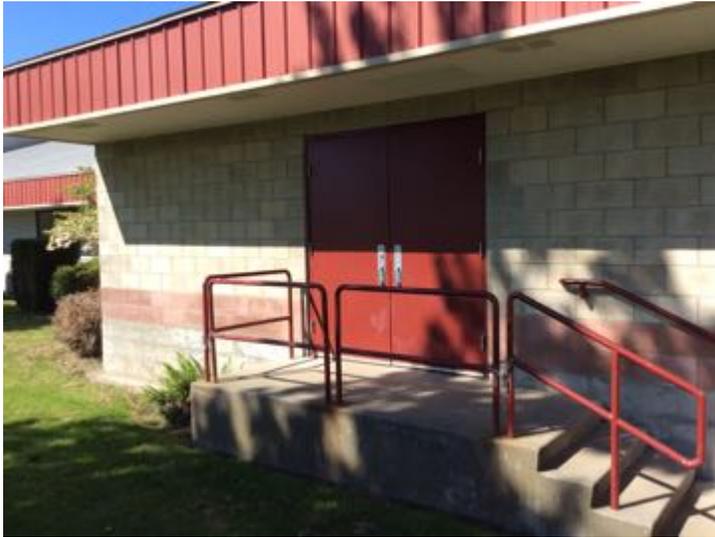
PM11 - Unlocked door found. All exterior doors should be locked during school hours.

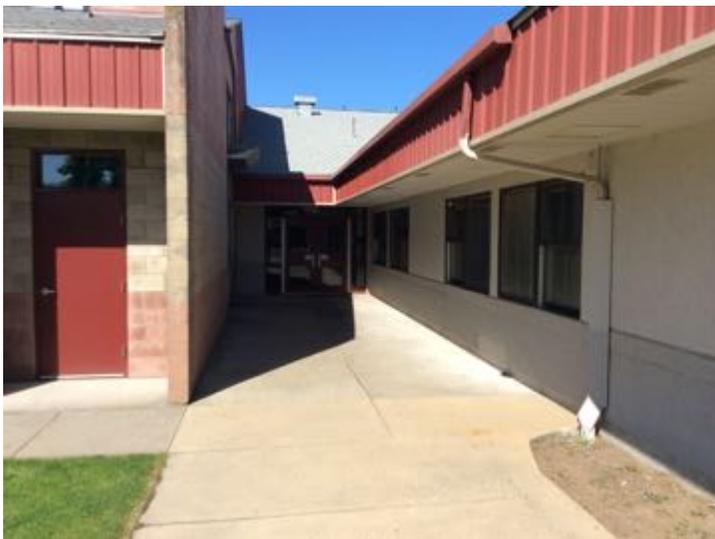
PM12 - Alcove. A security camera is needed and door found unlocked.

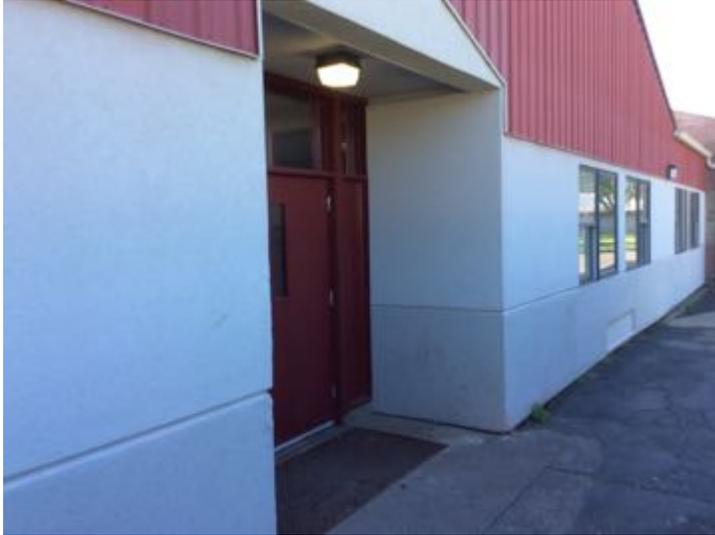
PM13 - Unlocked door on #3 side.

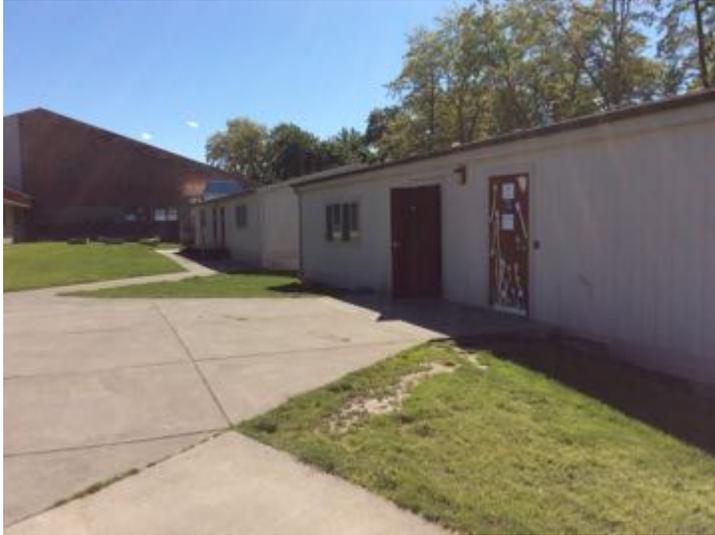
PM15 - Portables with open doors and pane glass windows. Windows should be replaced with either wire mesh or double pane windows.

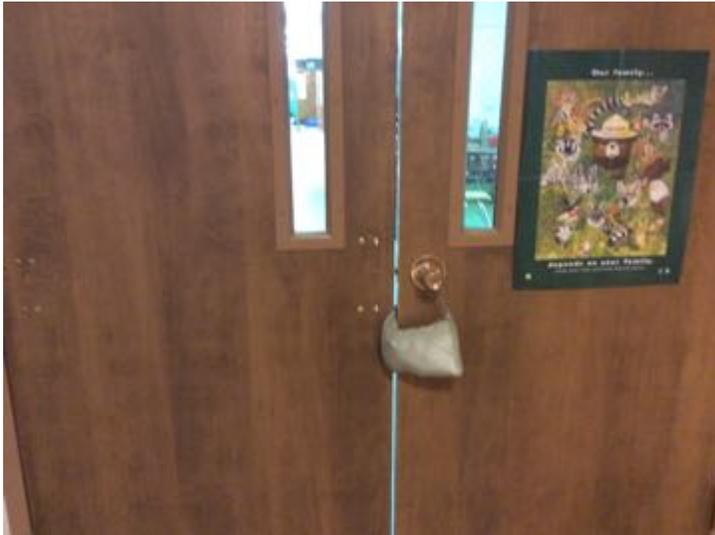
BE1 - Currently classroom doors are being held ajar with cushions like the one featured here. We recommend replacing the door handles and door locking mechanisms so that all doors remain closed and locked during school hours. Doors should be able to be locked from the interior and exterior.

1. We recommend creating a secure vestibule area at the front entrance of the school that would prohibit access to the main hallways and classrooms.
2. Currently classroom doors are being held ajar with cushions like the one featured here. We recommend replacing the door handles and door locking mechanisms so that all doors remain closed and locked during school hours. Doors should be able to be locked from the interior and exterior. (BE1)
3. Many of the classroom and hallway doors have keyhole locks in a standard doorknob that do not allow the doors to be locked from interior. All doors should have the ability to be locked from both the interior and exterior.
4. We did not find evidence of any security cameras on the interior of the school. We recommend adding security cameras to cover common areas and hallways.

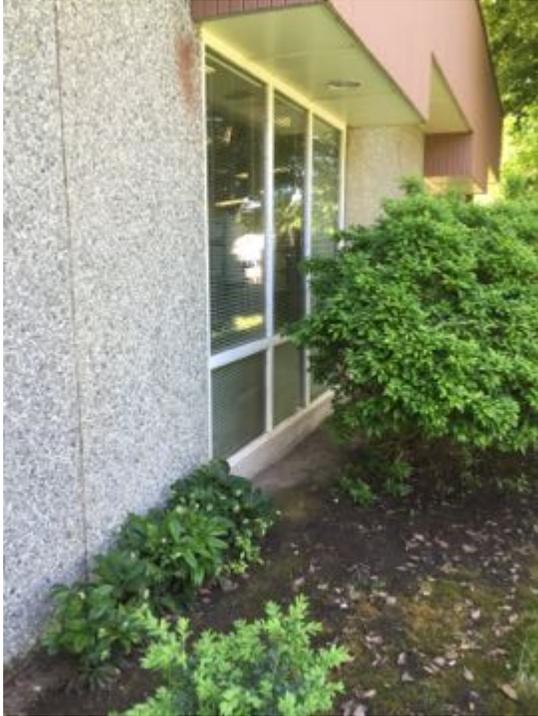
BE2 - Shrub cut back and window tint.

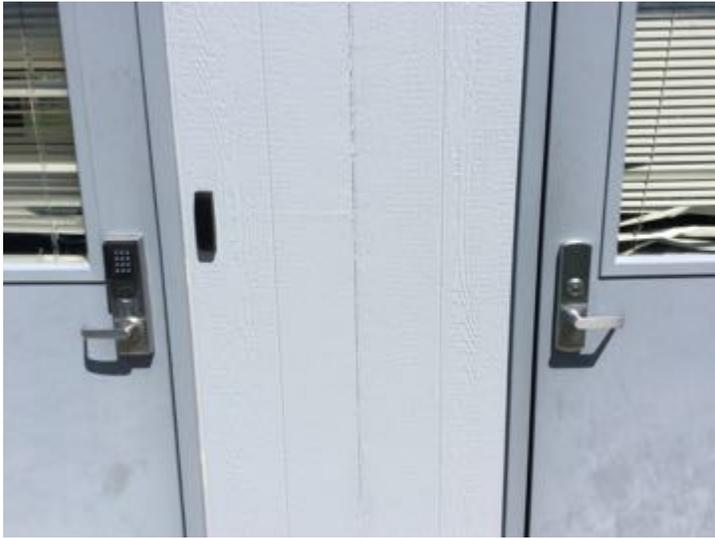
PP1 - We recommend a consistent approach to securing all classroom doors. The doors seen in the picture above have keypad/swipe access. Most doors on the school campus are accessible by traditional key. Keypad/swipe access is the more secure of the two options.

1. We recommend a consistent approach to securing all classroom doors. The doors seen in picture PP1 have keypad/swipe access. Most doors on the school campus are accessible by traditional key. Keypad/swipe access is the more secure of the two options. (PP1)
2. Although this site was constructed in the ranch style/open school layout we would recommend that the front office has a secure vestibule area that would prohibit access to staff and administration in the front office building.
3. The security camera on the gym side of the cafeteria/gym building is not currently not

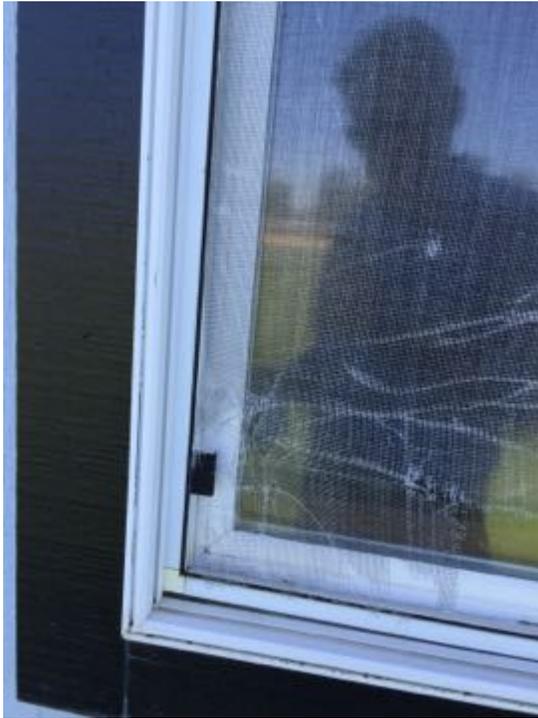
PP7 - Damaged screens on portables. Screens should be replaced and installed properly.

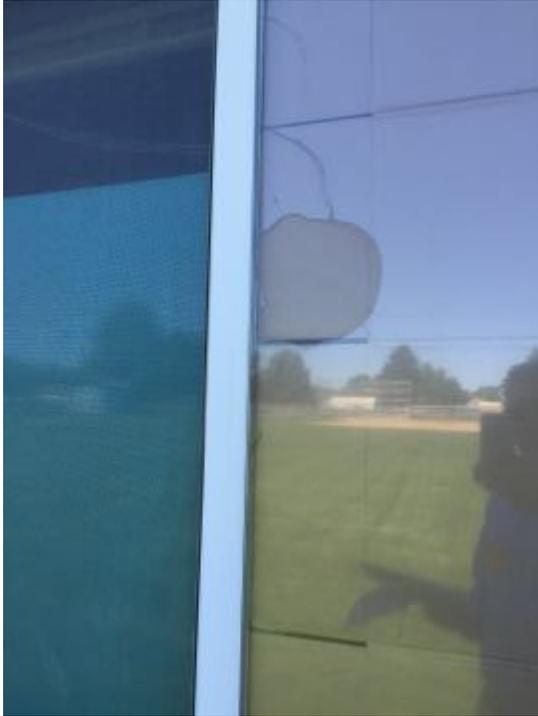
PP8 - Broken window on back of portable. This window should be replaced. Portable windows as well as all exterior windows on regular classrooms should have shatterproof window tinting.

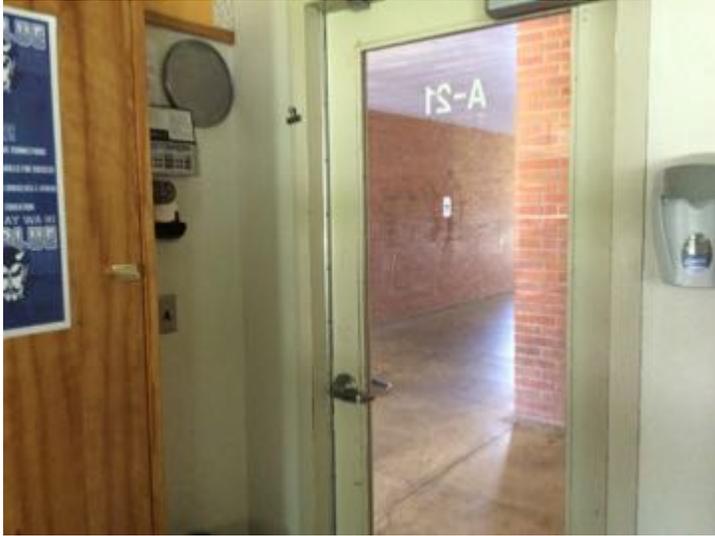
WH1- Classroom doors should be closed and locked during school hours. Doors with a large piece of glass present a security risk. We recommend doors with a smaller viewing window with wire mesh, like what is present at many of the elementary schools.

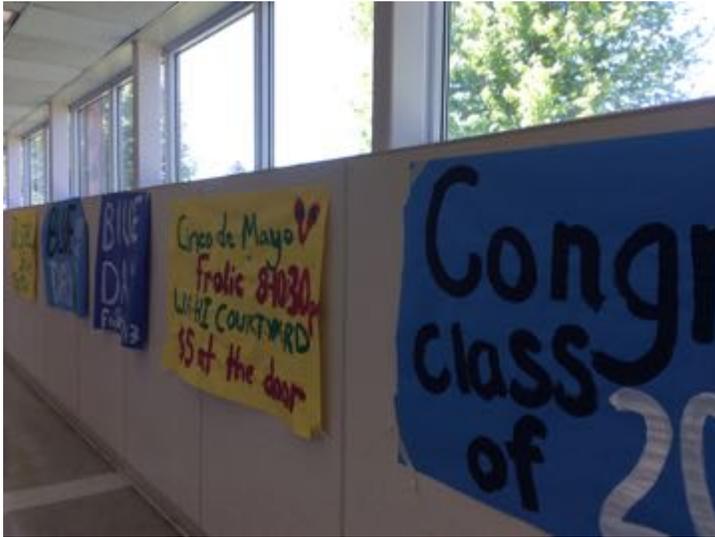
WH3 - The Vocational Technical building uses windows above the viewing level to limit visual access to the interior hallways. By limiting visual access, the building and students inside the building are at lower risk from outside intruders.

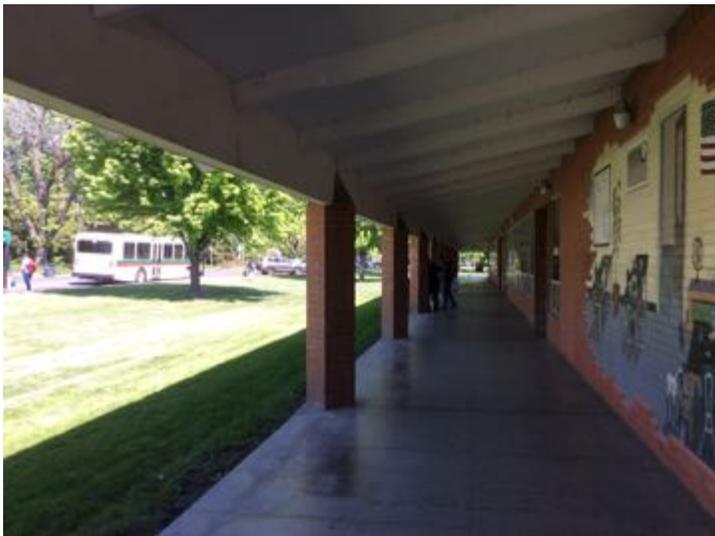
WH4 - Exterior hallways currently provide open access to classroom doors and windows. We recommend consulting an architect on the possible construction of exterior hallways that would prohibit access to the classrooms except by double door access points at the end of each hallway.

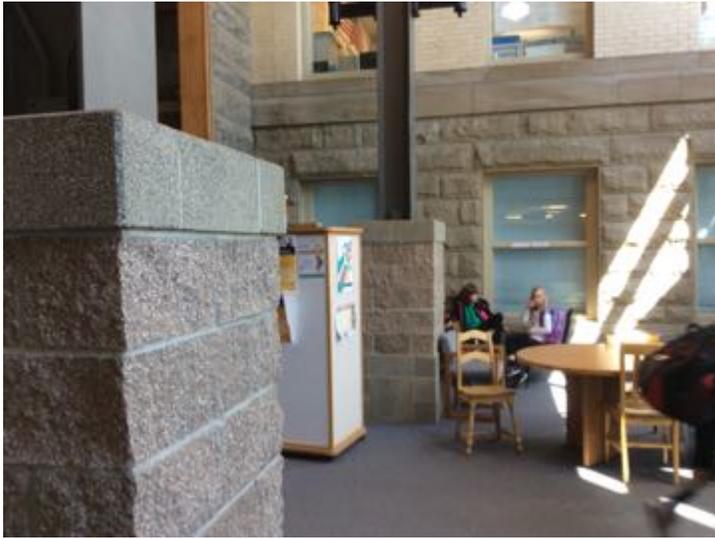
SE1 - We recommend creating a secure vestibule area here that would prohibit access to the interior of the school and classrooms.

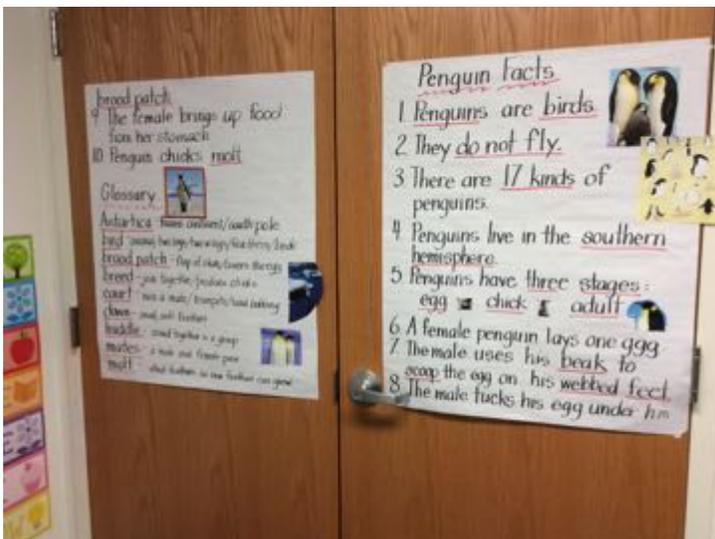
SE2 - The door handle was locked; however, we were able to pull both doors open by applying minimal force. We recommend securing double doors with door bars or a center bar.

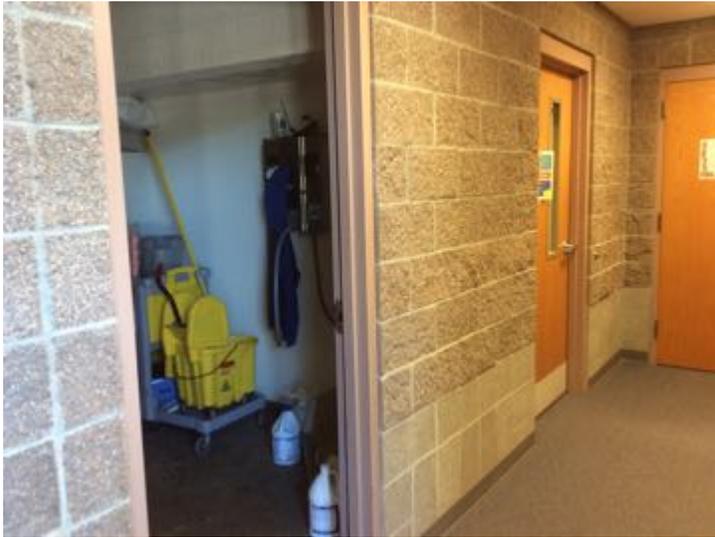
SE3 - Storage and custodial rooms should be closed and locked during school hours.

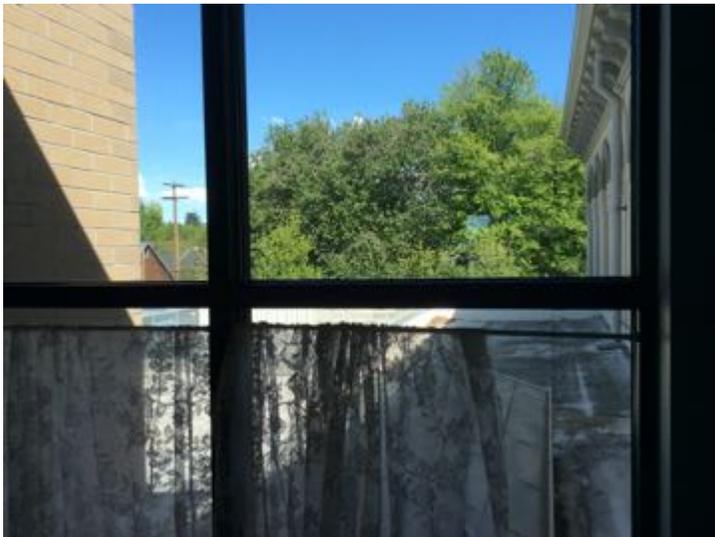
SE6 - Double pane windows like the ones seen in the picture above provide additional security for the school building. We also recommend applying shatterproof window tint to the exterior of these windows so that visual access is limited from the exterior.

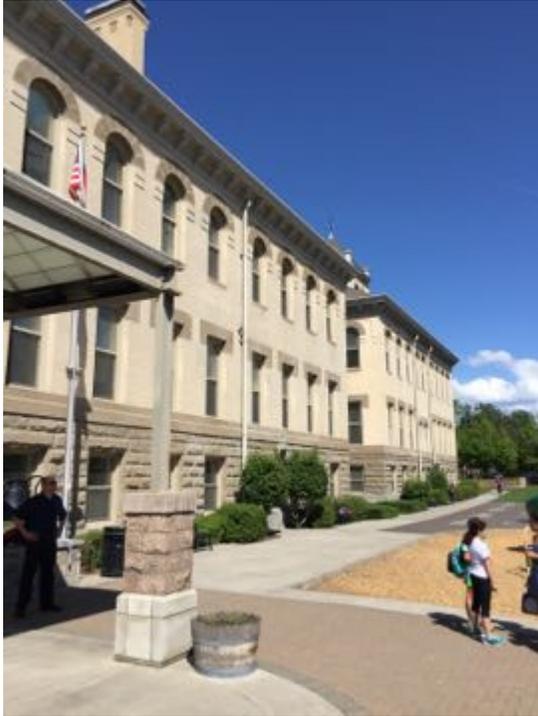
SE7 - #1 side. Shatterproof window tinting can be installed on all exterior windows. In the interim all interior blinds can be closed to limit visibility from the exterior. Shrubbery growing next to all building exterior walls should be cut down to a minimum height of 6ft and trimmed to allow for a minimum, unobstructed passage way of 3ft between the shrubbery and the exterior school walls.

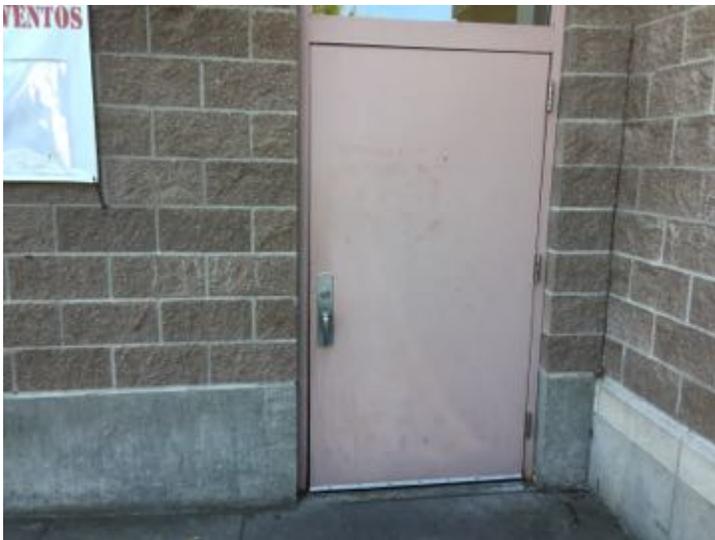
SE8 - Gym door on #3 side found unlocked. No camera view. A security camera is needed to capture this view.
