Sprigeo, Summary Report

School Safety Onsite Evaluation Summary Report

Walla Walla School District

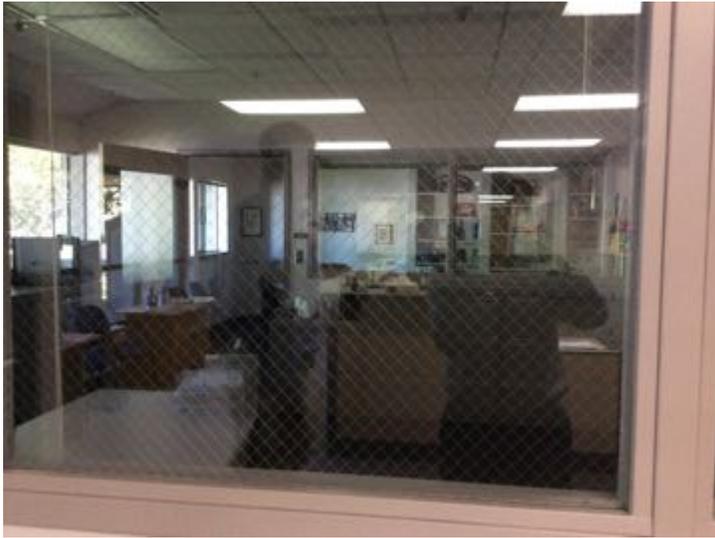
SD1 - Wire mesh windows provide an additional layer of security by forming another barrier that an intruder must overcome in order to gain entry into the room. We found wire mesh windows throughout the school district office.

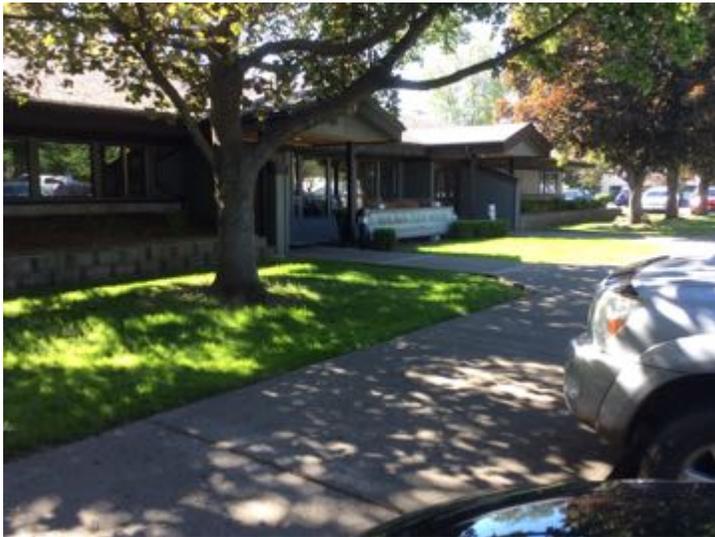
SD2 - We recommend creating a secure vestibule area immediately upon entering the administration building as well as limiting access to a single entry point.

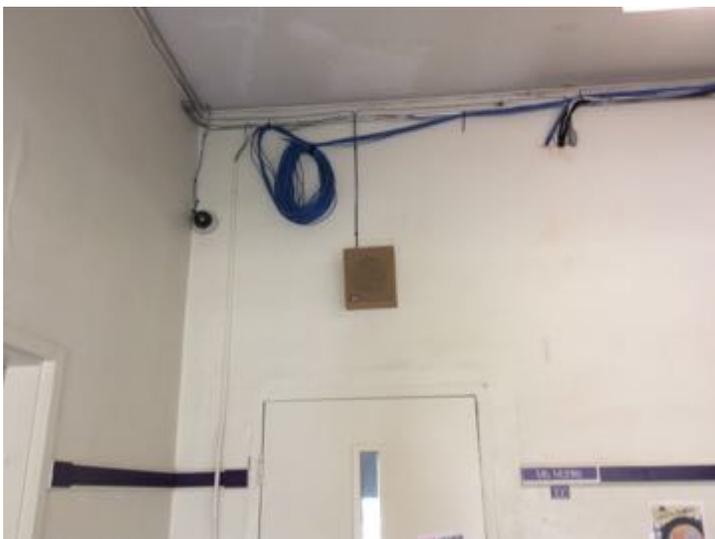
LH2 - Wires leading to the security camera should be enclosed in conduit to prevent access.

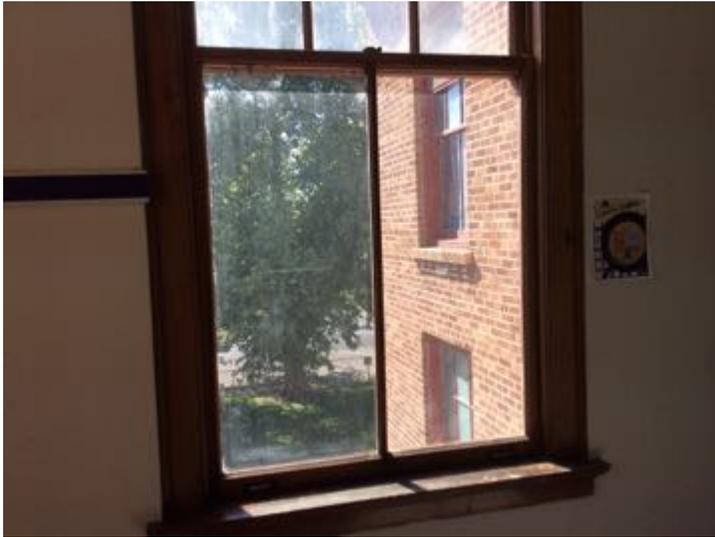
LH3 - Replace the wood frame windows with either the wire frame glass or the double pane windows found in many of the district's schools.

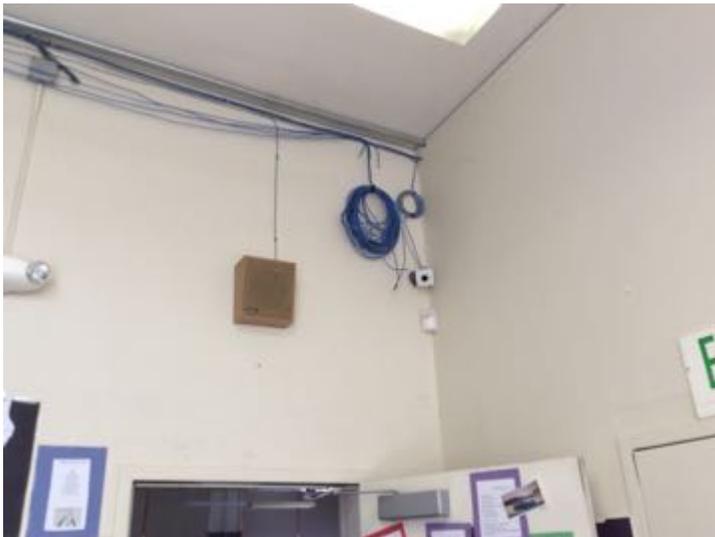
LH4 - Wires leading to the security camera should be enclosed in conduit to prevent access.

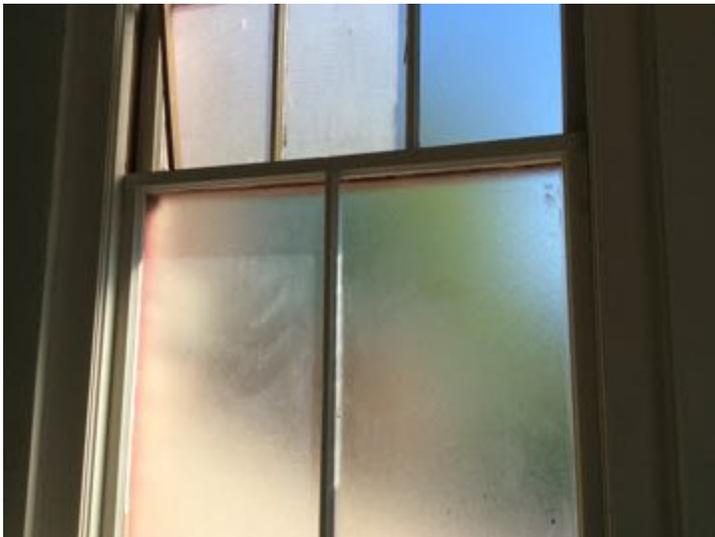
LH6 - Windows are currently held closed by a piece of wood that is positioned at the top of window. We recommend replacing these windows with either wire frame glass or the double pane windows found in many of the district's schools.

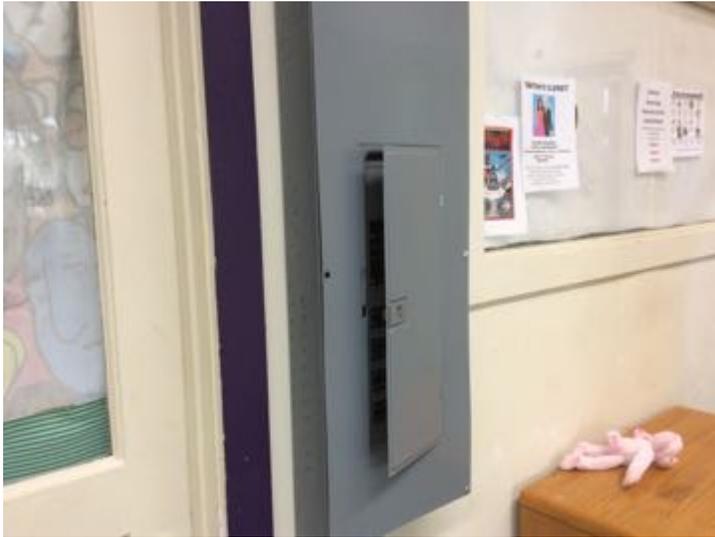
LH7 - Breaker panel doors by Room 103 should be locked and accessible only by school administration or custodial staff. Confirm that additional breaker panel compartments at the school are secured.

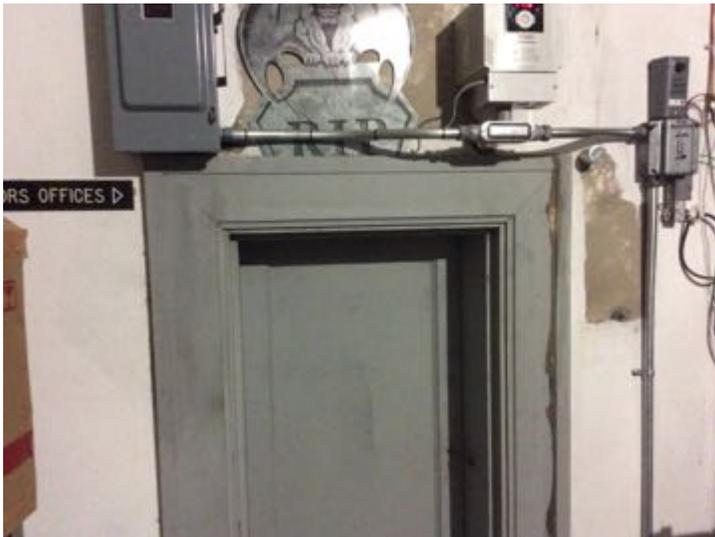
LH8 - Small latched door to room inside of the boiler room. We recommend that this door be removed and access to the room beyond the door should be cut off unless this room serves a purpose that the school or district can clarify.

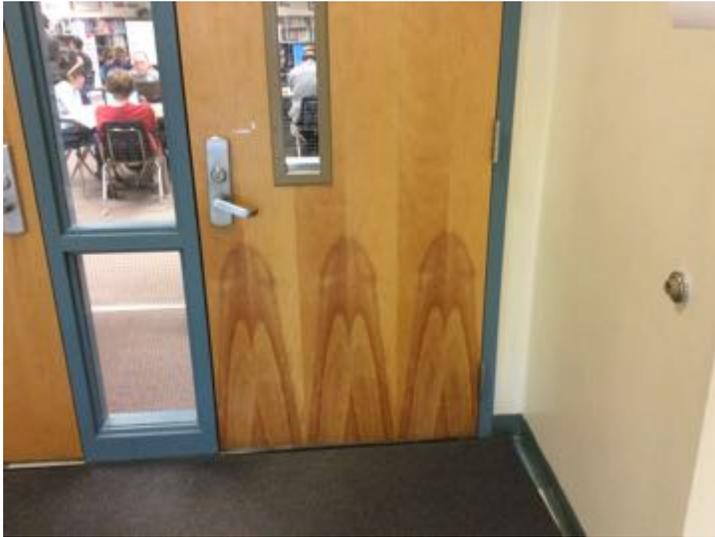
GM2 - The door handle is broken on exterior of this entrance to the library and should be repaired or replaced.

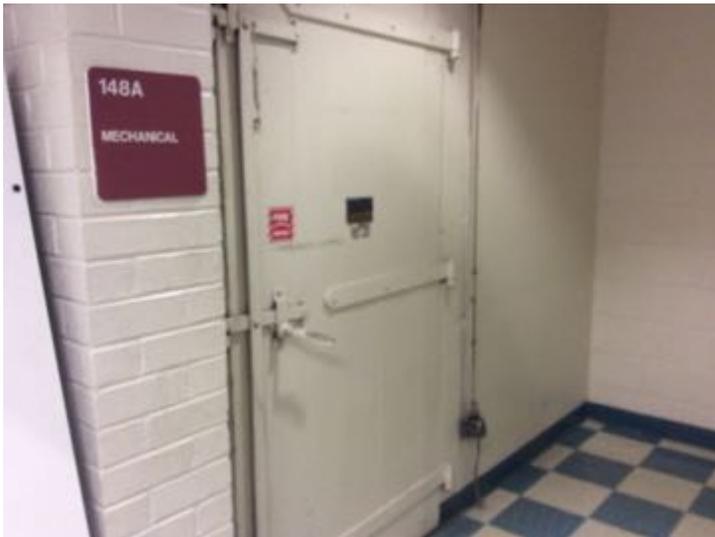
GM3 - Mechanical room door should be locked during school hours.

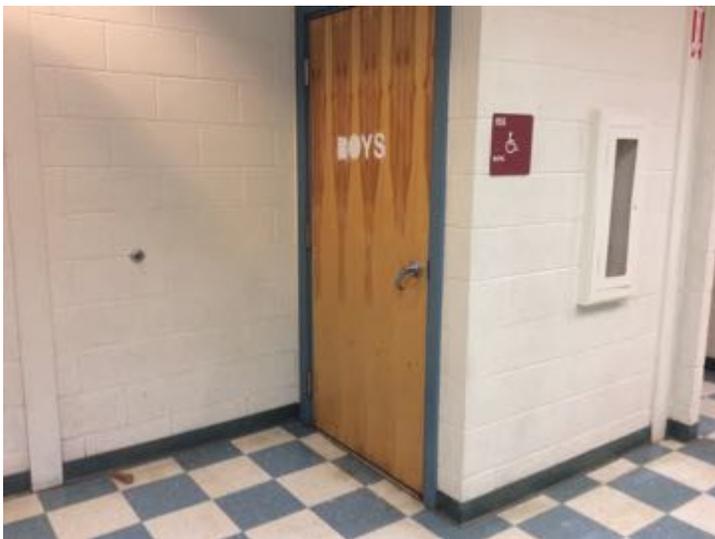
GM7 - Exterior door handles on both the girl's and boy's restrooms are broken. All student restroom doors should be open during school hours.

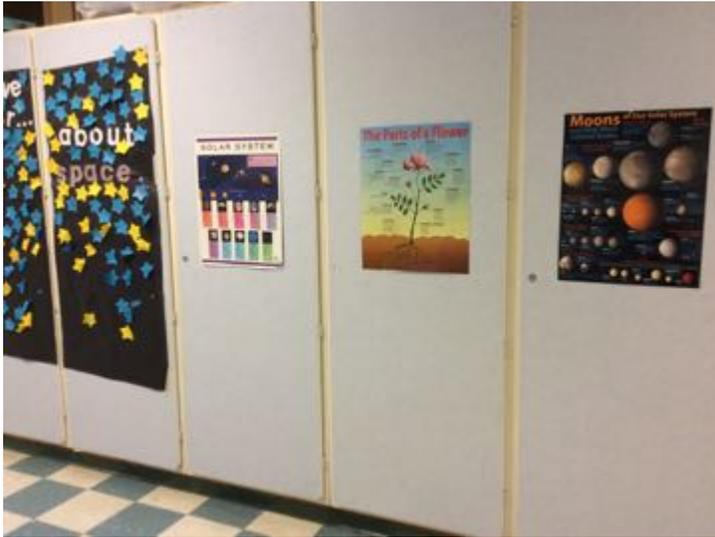
GM8 - Supply cabinets near Room 157 should be locked during school hours.

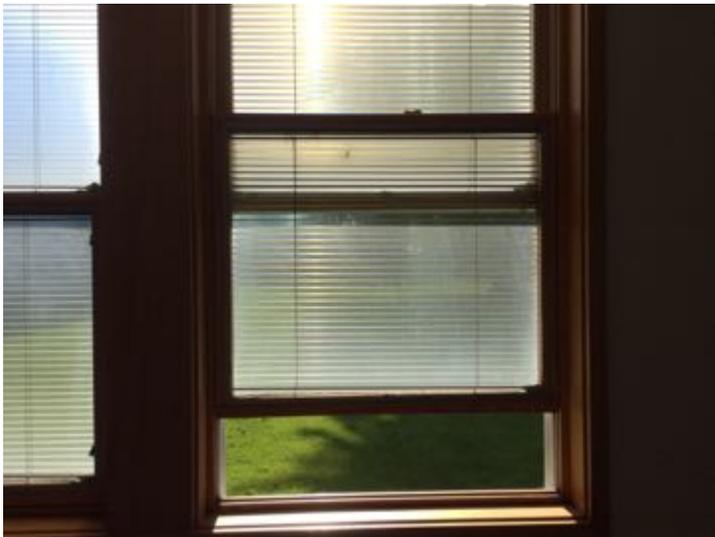
GM9 - Windows near Room 161 were found unlocked. All windows leading to the exterior area of the school should be locked during school hours.

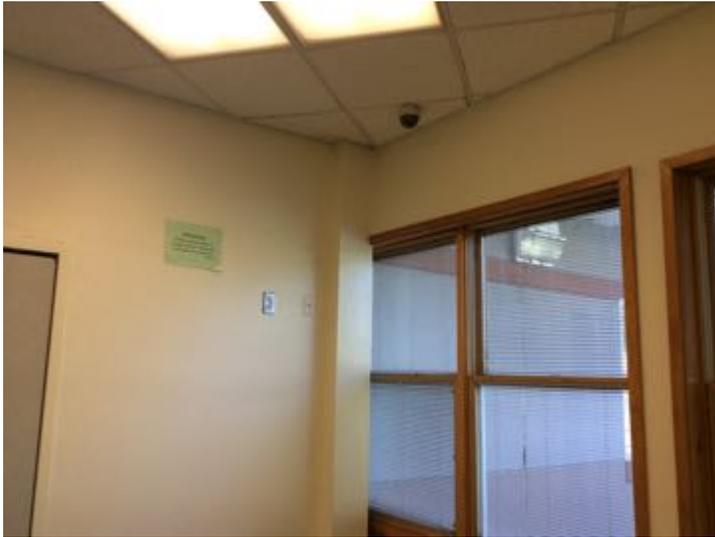
GM12 - Wood framed windows in the cafeteria should be replaced with either the wire mesh windows or double pane windows found at the other school sites.

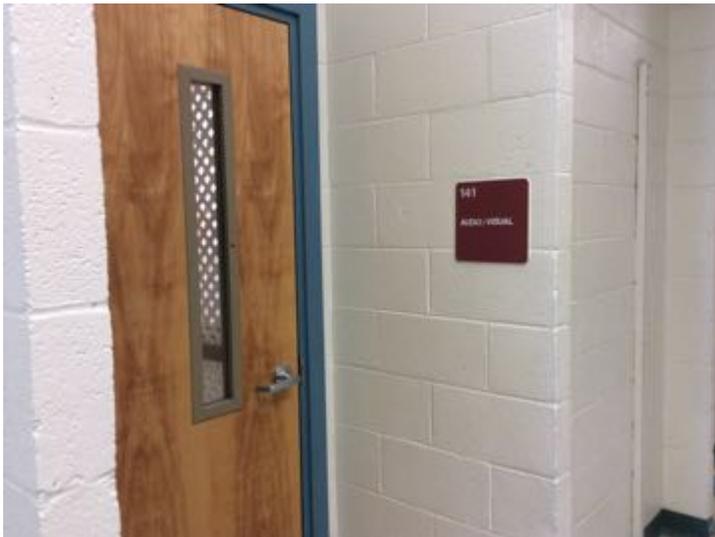
GM13 - The door to the AV Room 141 should be locked during school hours.

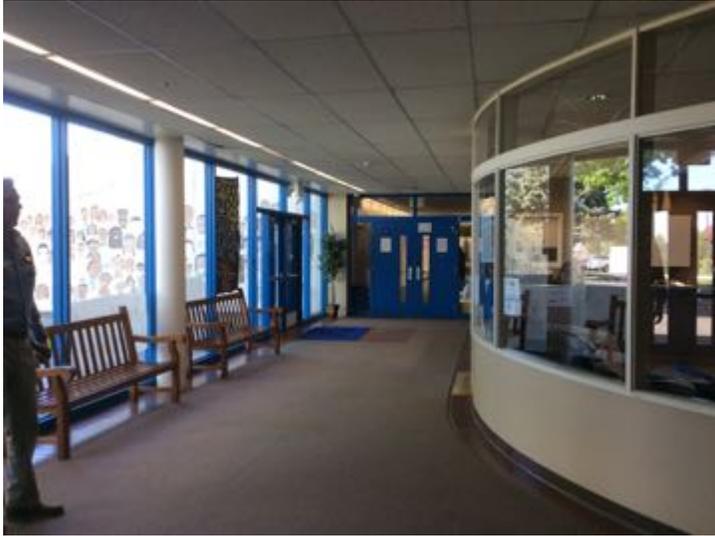
BR1 - We recommend creating a secure vestibule area here that would prohibit access to the front office staff. The hallway doors have an electronic access mechanism in place that prohibits access to the classroom areas until the front office staff have activated the door lock.

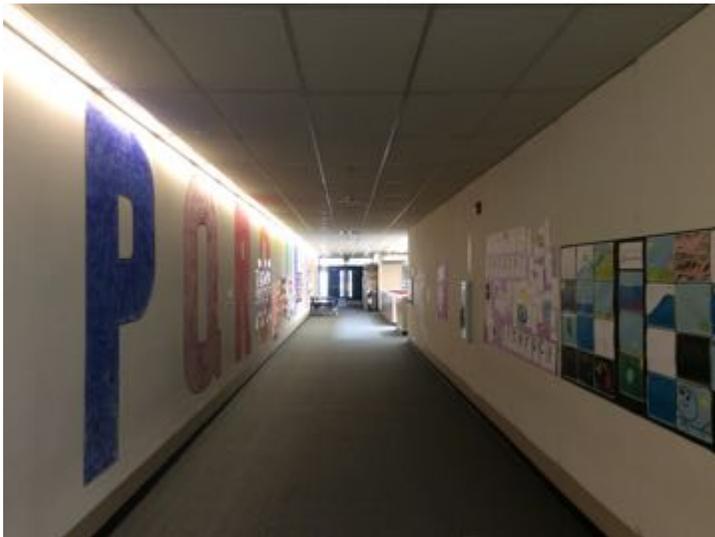
BR4 - A security camera is needed to see hallway on upper level.

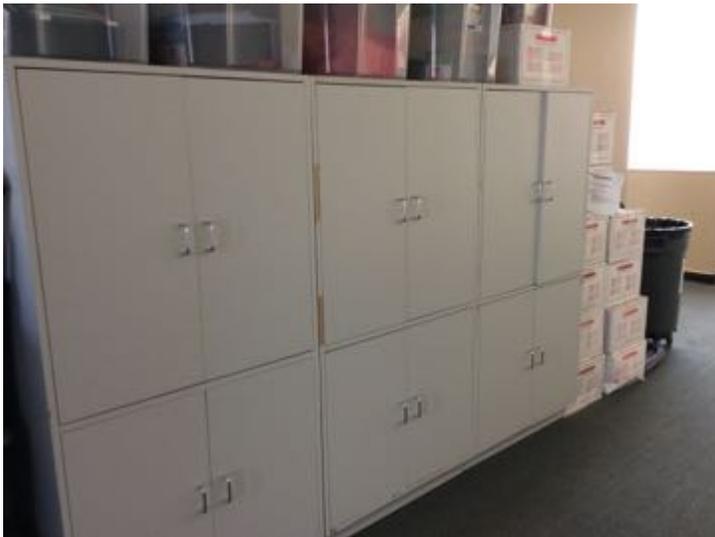
BR6 - Supply cupboard doors needed to be locked during school hours.

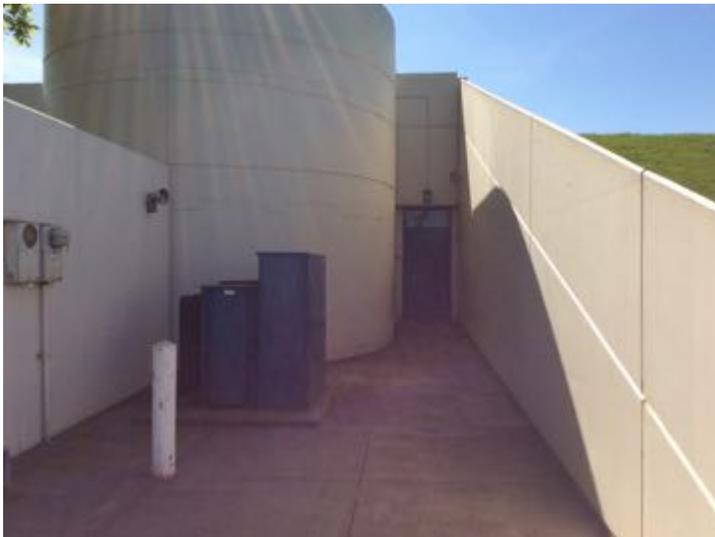
BR10 - Alcove on #1 side near 1, 2 corner. Door found unlocked. All exterior doors should be closed and locked during school hours.
