Walla Walla Public Schools
October, 2016

# Building Conditions

## OSPI Rating System

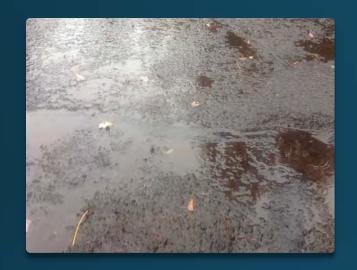
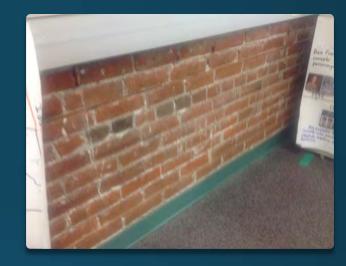
#### Green Park Elementary

- Roofing at end of life (losing shingles), frequent leaks
- Carpet needs replacing (especially stairs)
- Need to seal interior brick to stabilize crumbling
- Roof drainage issues at planters causing leaks into building
- Windows inoperable due to defects
- Water intrusion and settlement at SW corner of gym
- Exterior brick needs cleaning and sealing
- Original boilers (20+ years)
- Asphalt in parking lot failing, needs replacement

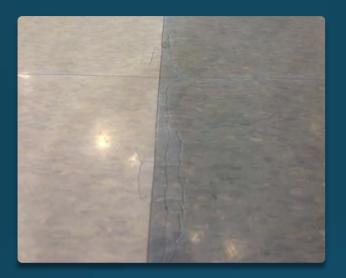
#### Sharpstein Elementary

- Minor amount of efflorescence on masonry
- Commons VCT floor tile due for replacement
- Carpets beginning to wear
- Exterior caulking and paint needed
- Some roof leaks
- Lighting original to 2000
- Some single pane windows

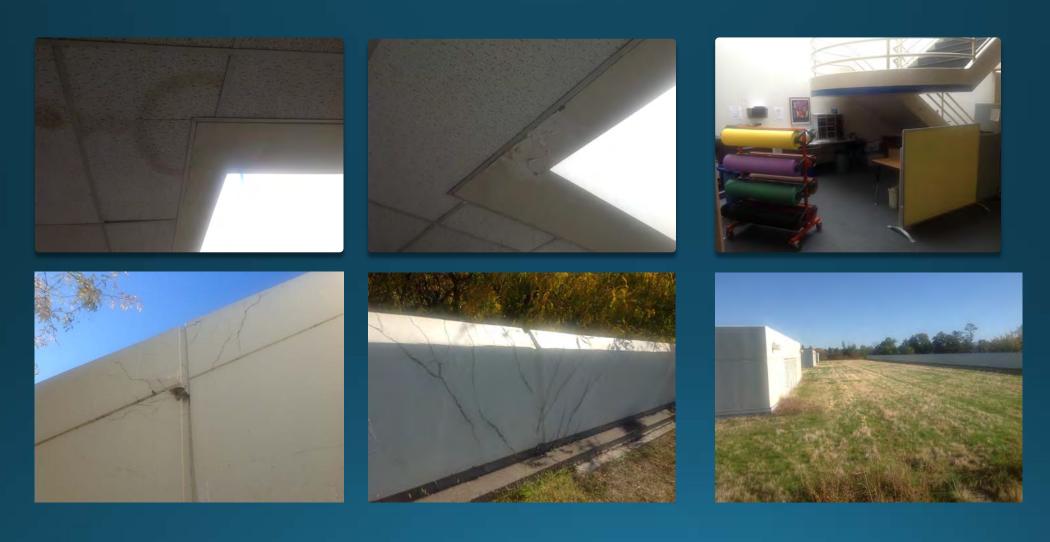
#### Blue Ridge Elementary

- Foundation cracking
- Roofing is original (end of life span?)
- Leaks and water intrusion (constant battle)
- Restrooms due for restoration
- Single pane windows
- Exterior painting and caulking needed
- Library carpet needs replaced (other carpets recently done)
- Significant cracking of concrete parking lot

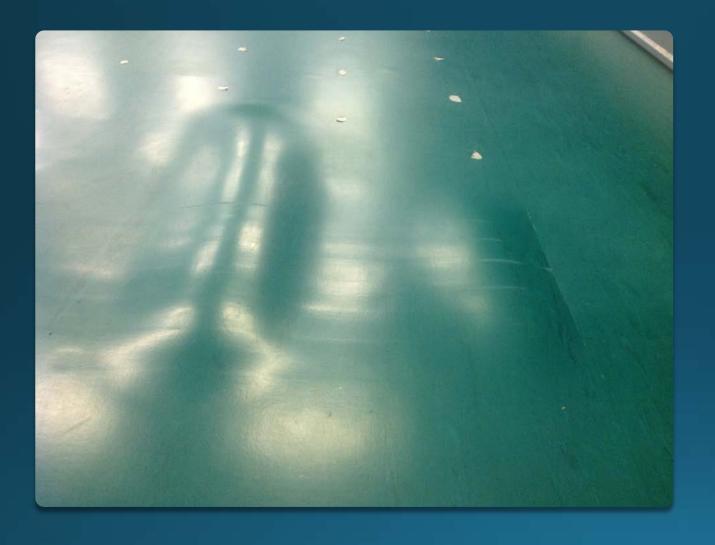
#### Edison Elementary

- Gym floor failing (widespread adhesion problems and bubbles)
- HVAC and controls work well

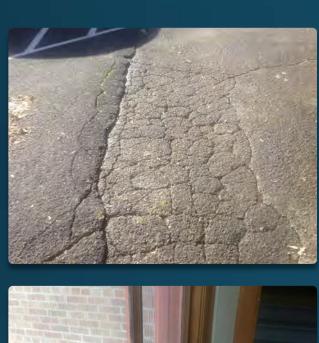
#### Lincoln Alternative High School

- Windows need replacement
- Old steam boiler has surpassed its useful life expectancy
- Asphalt slopes to building causing drainage problems
- Inadequate electrical capacity (always blowing breakers)
- Exposed wiring throughout
- HVAC systems beyond service life
- Plumbing systems beyond service life
- Aging restroom finishes and fixtures
- Detection and alarm inadequate

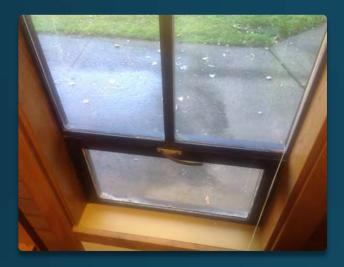
### Prospect Point Elementary

- Exterior walls not insulated
- Restrooms can get cold and freeze pipes
- Moss on roofs, frequent roof leaks
- Single pane windows
- Need more roof gutters and improved drainage
- Zoning and air-flow issues due to added walls
- Flooring due for replacement
- Interior walls need repair and paint
- Parking lot needs crack sealing and seal coat

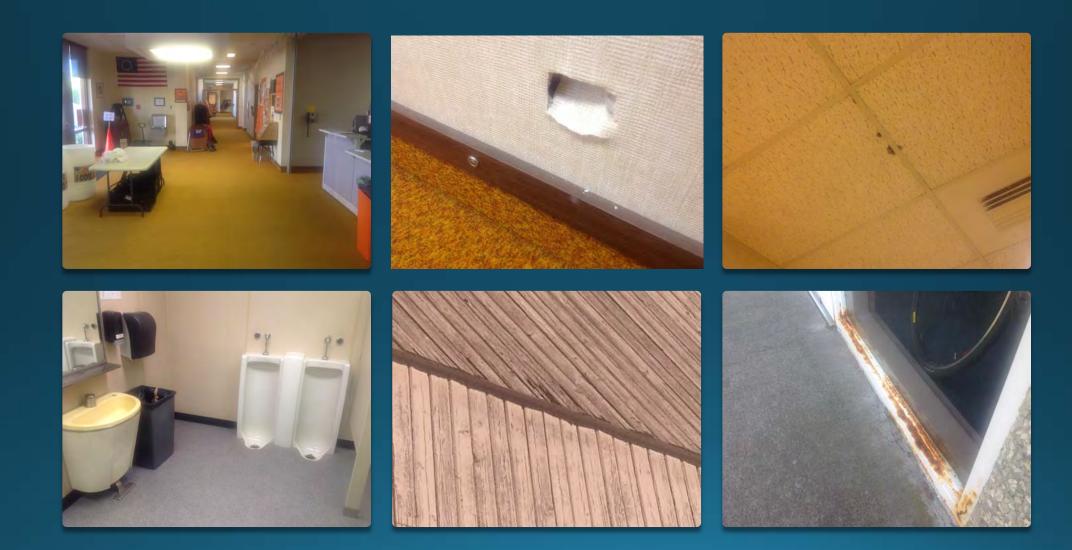
### Berney Elementary

- Wood siding is aged and deteriorated
- Roof due for replacement (periodic leaks, fasteners wearing through)
- Due for lighting upgrade
- Restrooms need renovation (2 done already, 4 to go)
- Carpets need replacement (original)
- VCT in commons over crawl space failing
- Ceilings stained and dull
- HVAC system aged and needs upgrading
- Cooling tower due for replacement (leaks often)
- New boilers in 2014
- Some sidewalks settling and damaged/weathered
- Music room ventilation inadequate
- Parking lots need overlay/replacement

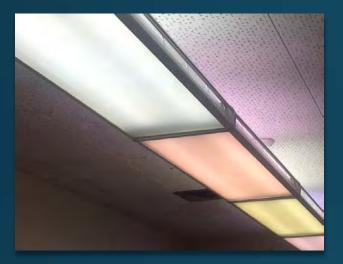
### Walla Walla High School

- HVAC systems are aged and need major upgrade or replacement
- Plumbing systems are largely original and beyond service life, failing
- Lighting is inconsistent and discolored where not upgraded, mostly original to 1990
- No air-conditioning (few exceptions. Temporary window units to be installed this year. A short term fix.)
- Lockers are worn out and do not work
- Principal reports not enough cameras and many are inoperable
- Weight room mechanical not to code
- Door hardware failing in places
- Ceilings dirty and stained
- Communications exhibits inadequate coverage
- Surveillance and detection inadequate coverage
- Roofing mostly good but some nearing life expectancy
- Crawl spaces under science building always wet and "terrarium like" (results in rusty pipes and structures)
- Stormwater runoff causes problems throughout campus
- Restrooms not ADA and needing update
