Sprigeo, Summary Report

School Safety Onsite Evaluation Summary Report

Walla Walla School District

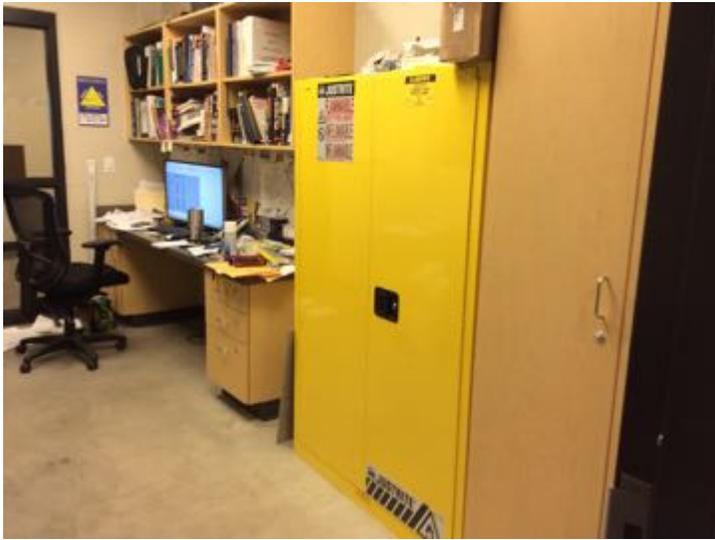
ST1 - All supplies lockers should be locked during school hours.

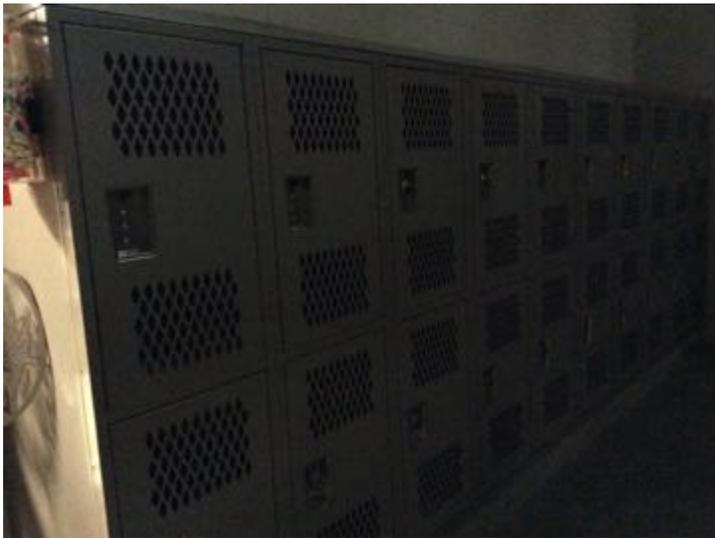
ST2 - All lockers should have school issued locks

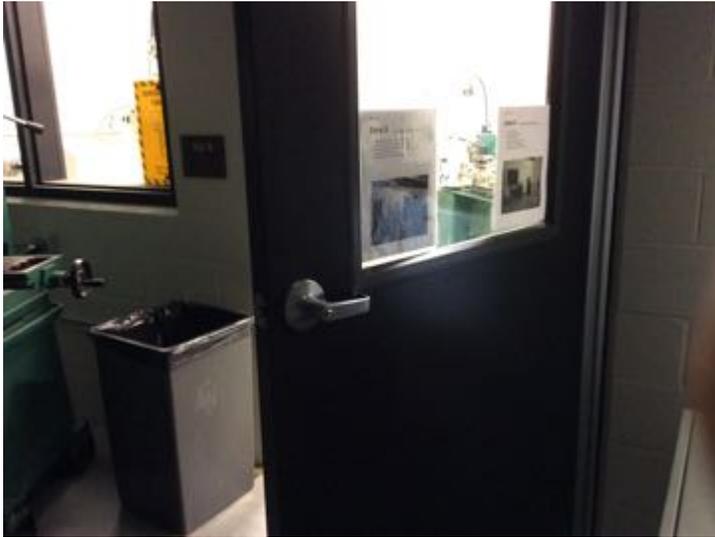
ST3 - doors to equipment areas should be locked during non-school hours

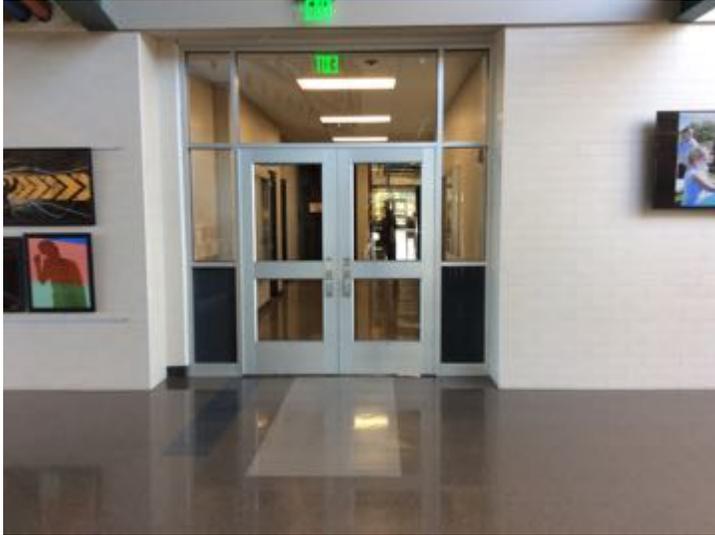
ST5 - Double doors to classroom areas should be locked during school hours.

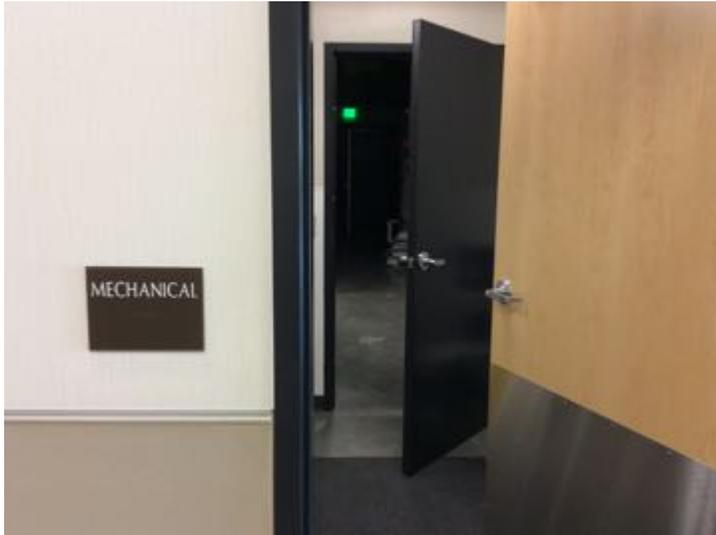
ST7 - Doors to the Mechanical room should be locked during school hours.

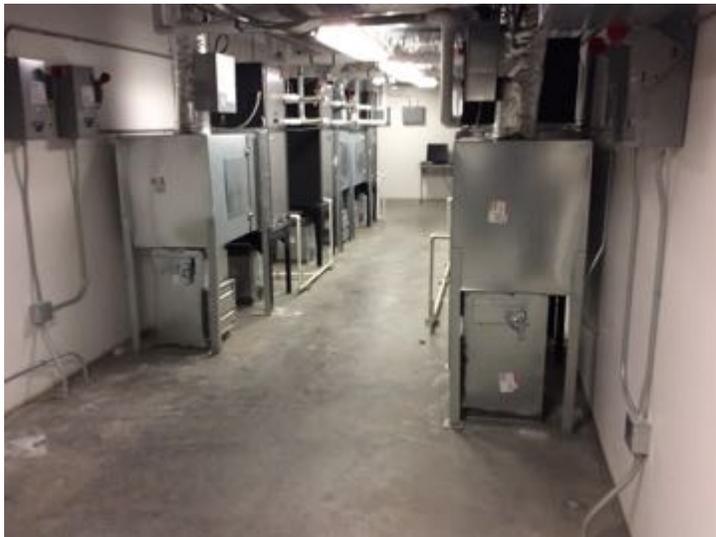
ST8 - Security cameras needed in the upstairs area of the Mechanical room.

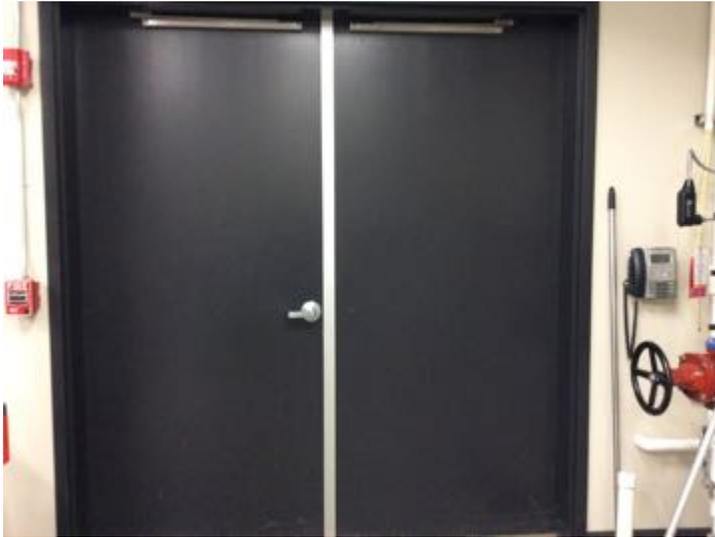
ST9 - Reinforce these double doors with a bar locking mechanism.

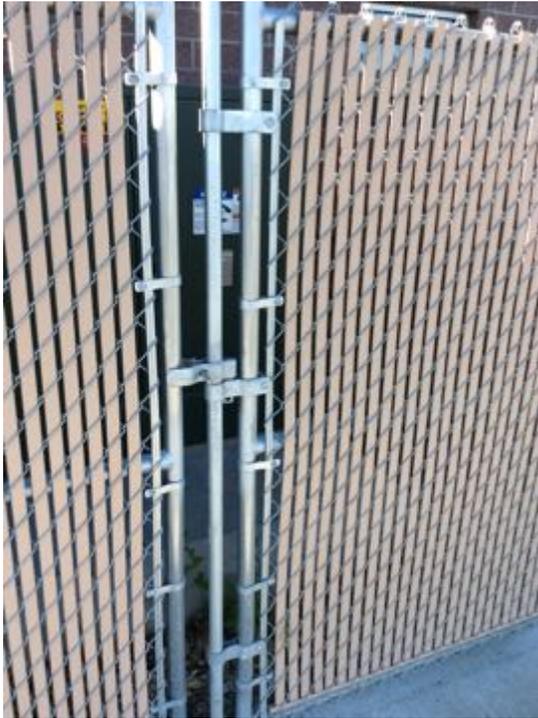
ST12 - Unsecured access to electric panel. A gate lock is needed like what is displayed in the next picture ST13.

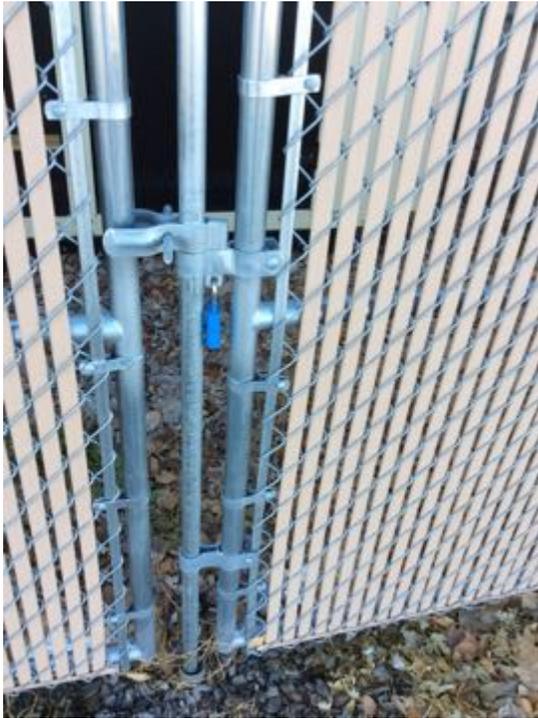
ST13 - Locked gate at the far end of #3 side. Properly secured compared to photo ST12.

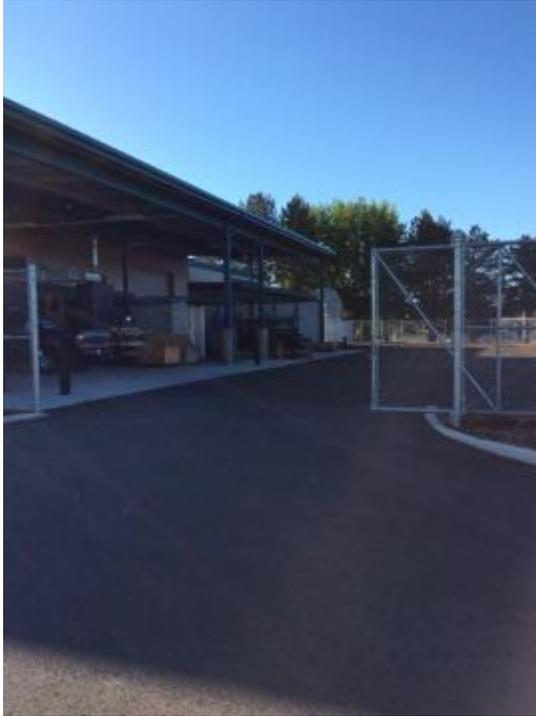
ST14 - Open fence access to #4 side. Area is surrounded by 12' high chain link fence. This area should be closed with a locked gate during school hours.

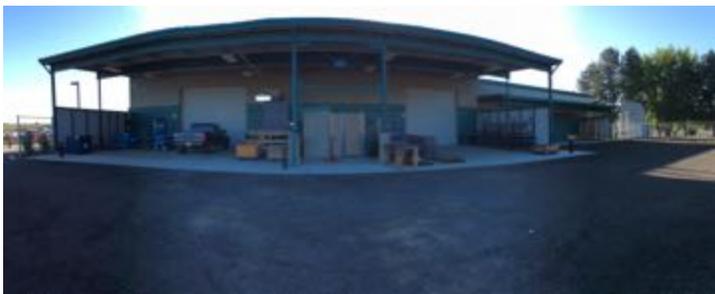
ST16 - Panoramic image of #4 side. Two security cameras are needed to capture the view in this area.

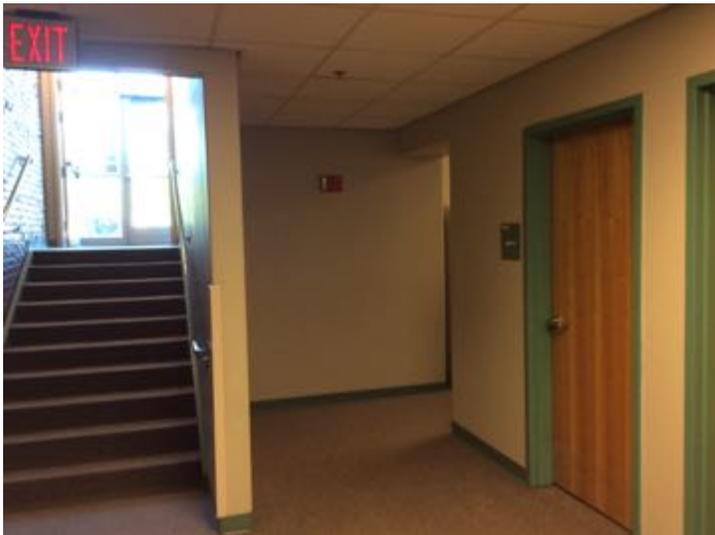
GP3 - A security camera is needed to see this view of the corner.

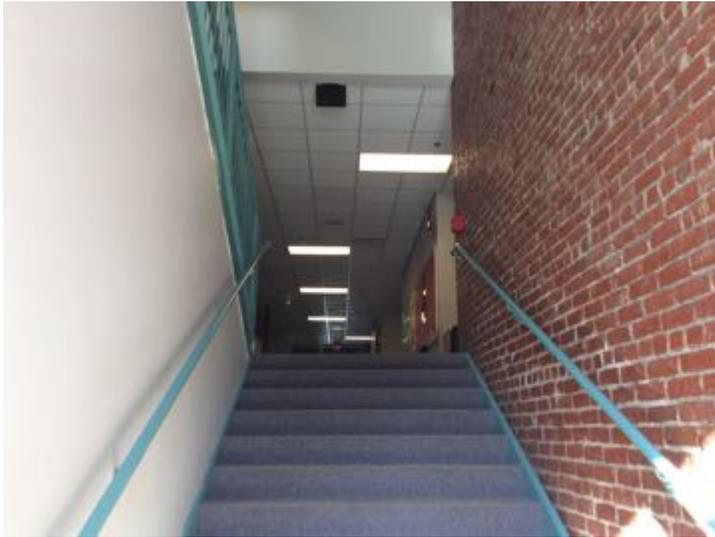
GP4 - A security camera is needed to see stairwell views.

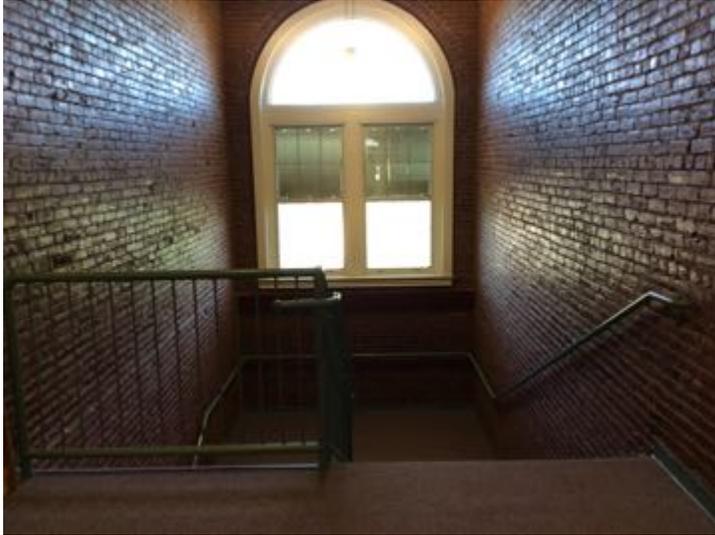
GP8 - A security camera is needed to see this view of the stairwell.

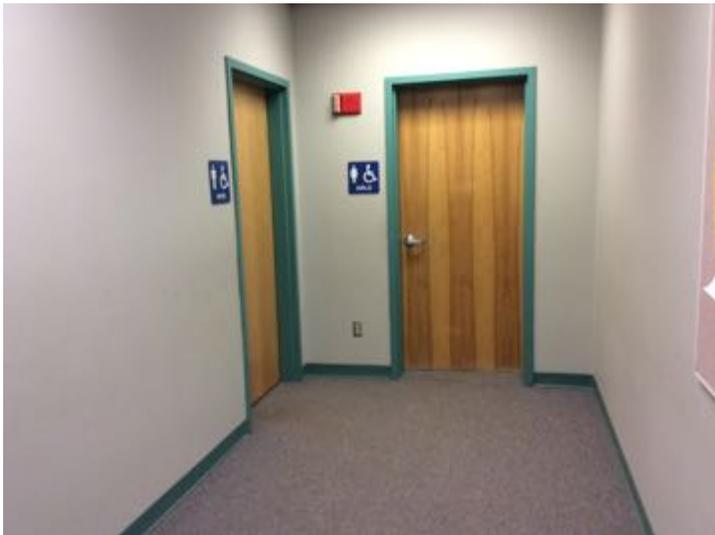
GP9 - All bathroom doors should be open during school hours.

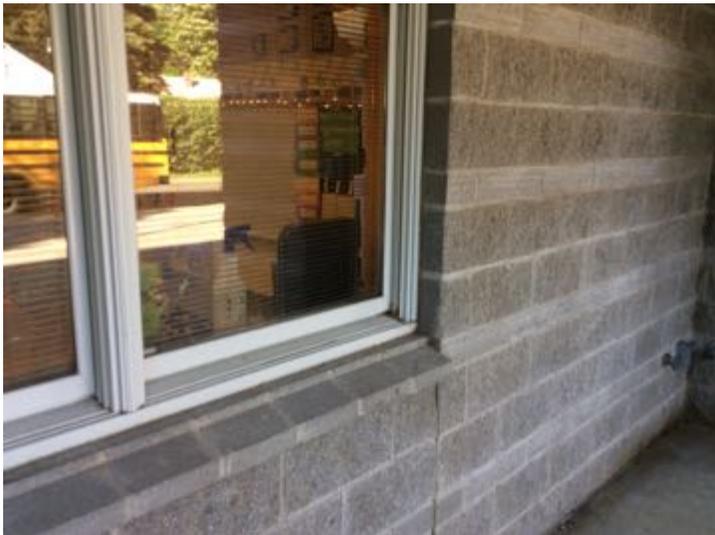
GP13 - All windows need shatterproof window tinting.

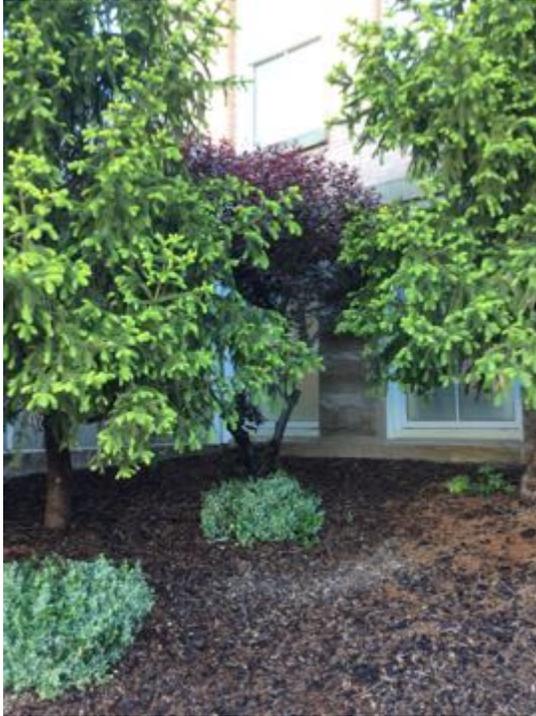
GP14 - Dead space on #2 side in need of hedge cut back.

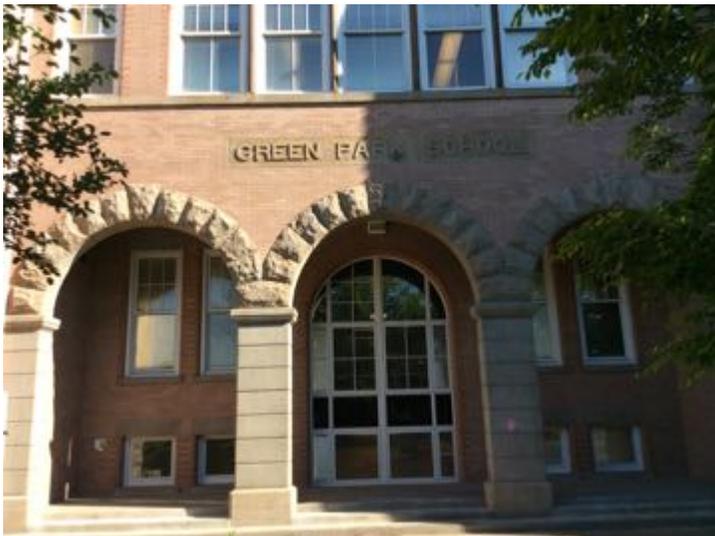
GP15 - #3 side. No cameras covering dead space. A security camera is needed to see this view.

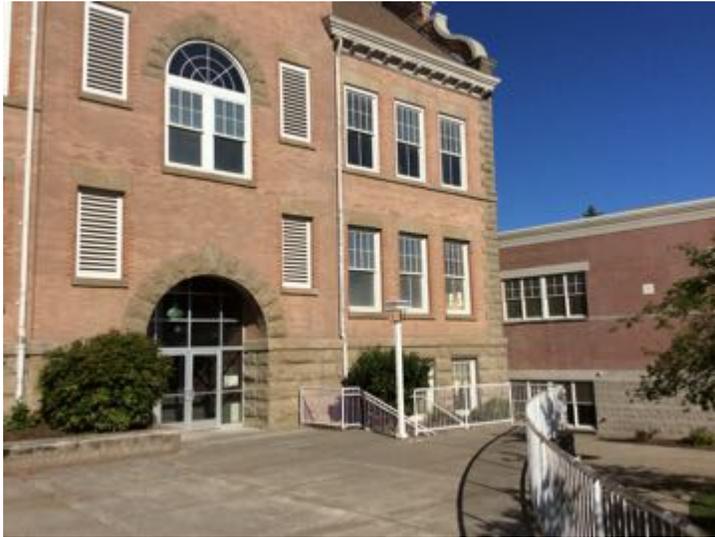
GP16- Back corner of playground off of #3 side. Shrubbery should be cut back in this area.

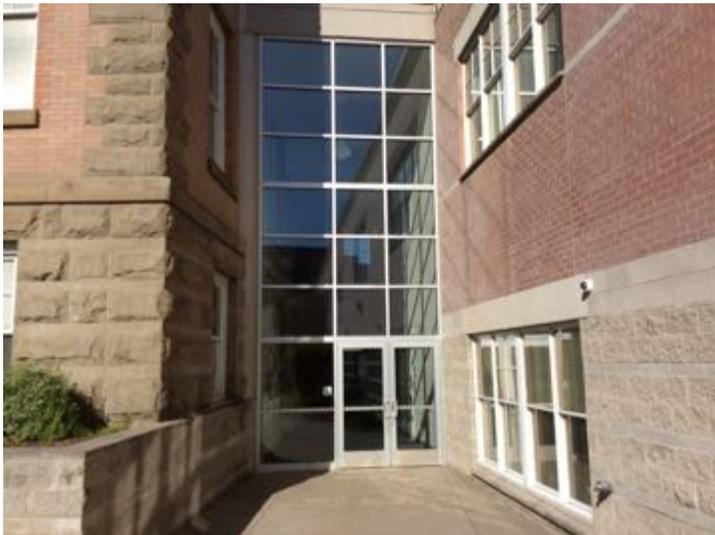
GP17 - Alcove. Note, camera lens on right side of photo. This one lens camera view is of playground. A multi-lens camera should be used to cover both playground and alcove.

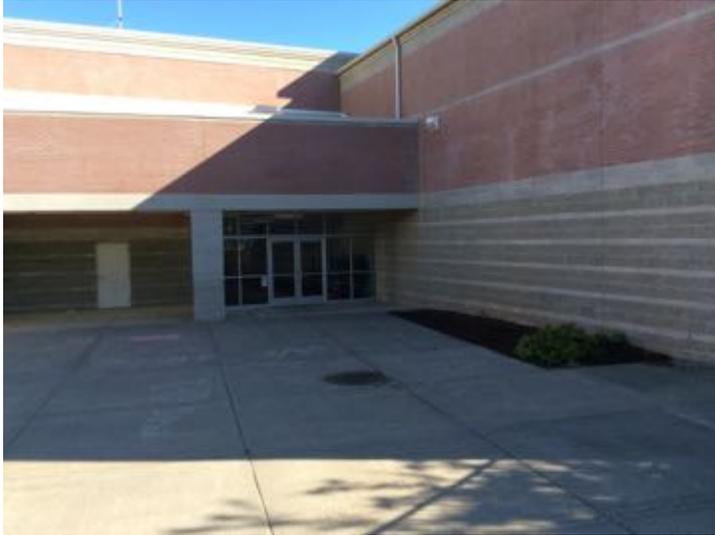
GP18 - Backside of gym area. A security camera is needed to see this view.

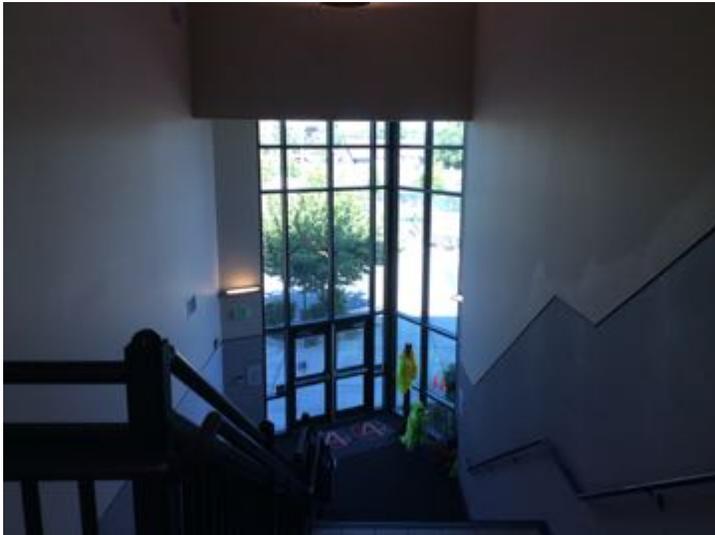
EE9 - A security camera is needed to see this view of stairwell.

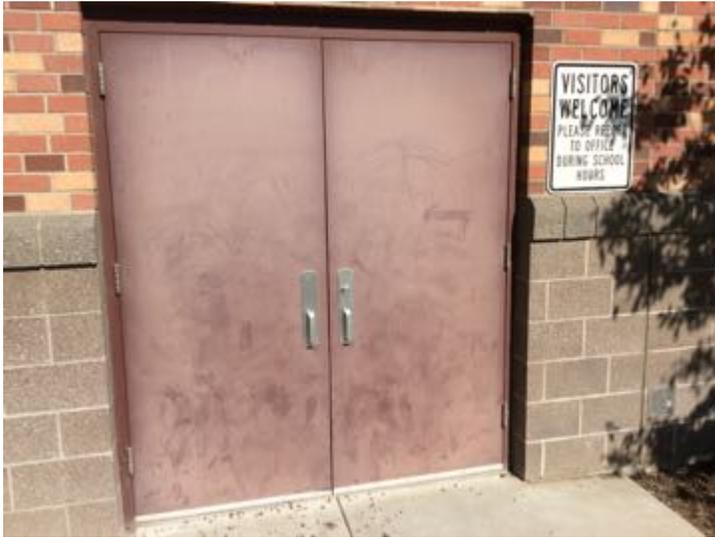
EE10 - Unsecured door leading directly into cafeteria. All exterior doors should be locked during school hours.

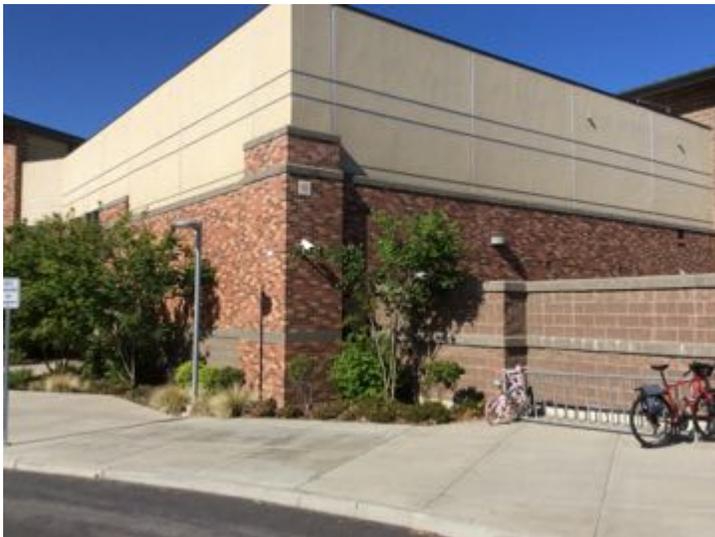
EE11 - 1,2 corner. A security camera is present here but the view is being blocked by the shrubbery. Cut back shrubbery to a minimum height of 6ft and trimmed to allow for a minimum, unobstructed passage way of 3ft between the shrubbery and the exterior school walls.

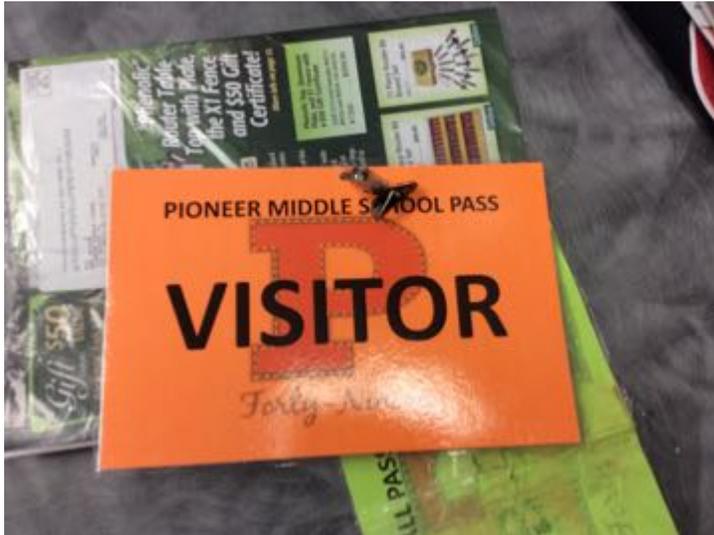
PM6 - We were not asked to show our visitor badge during the course of the evaluation. We recommend a consistent procedure for staff to use when encountering a person who is not wearing a visitor badge so that all visitors are met with a consistent approach by staff.

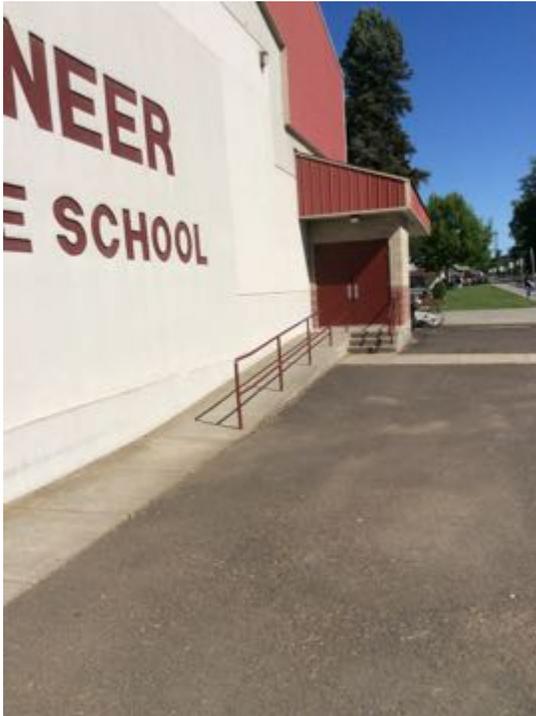
PM9 - Another open door to gym. All exterior doors should be locked during school hours.

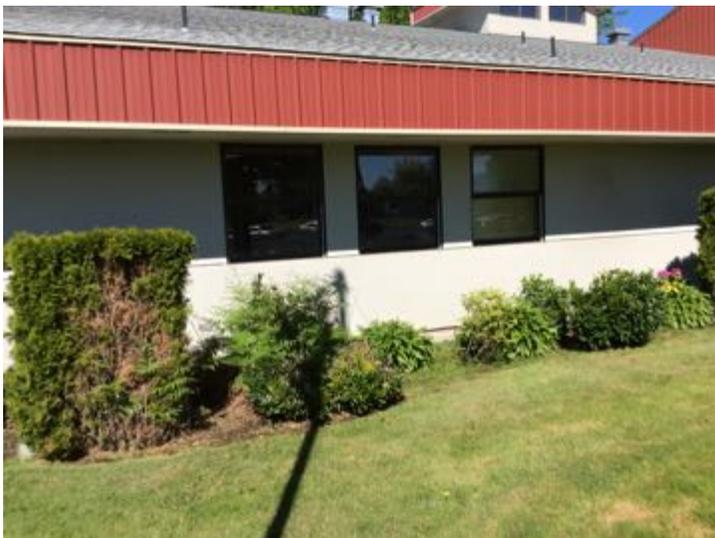
PM10 - Shatterproof window tinting needed on all exterior windows.

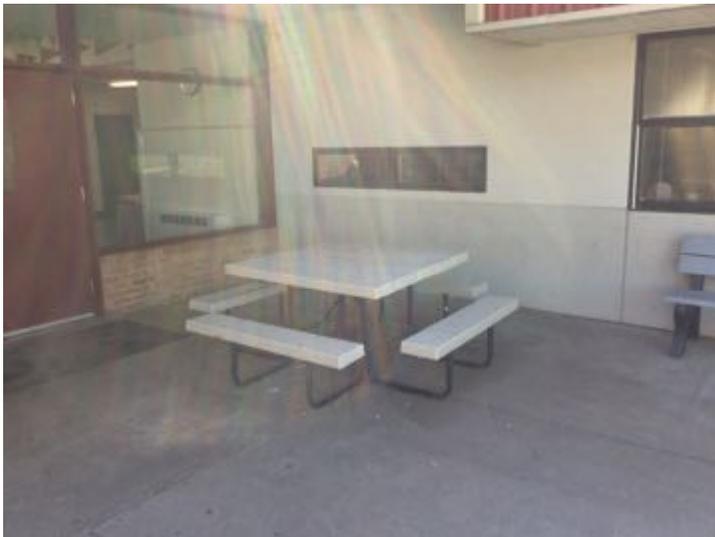
PM14 - Unlocked door.

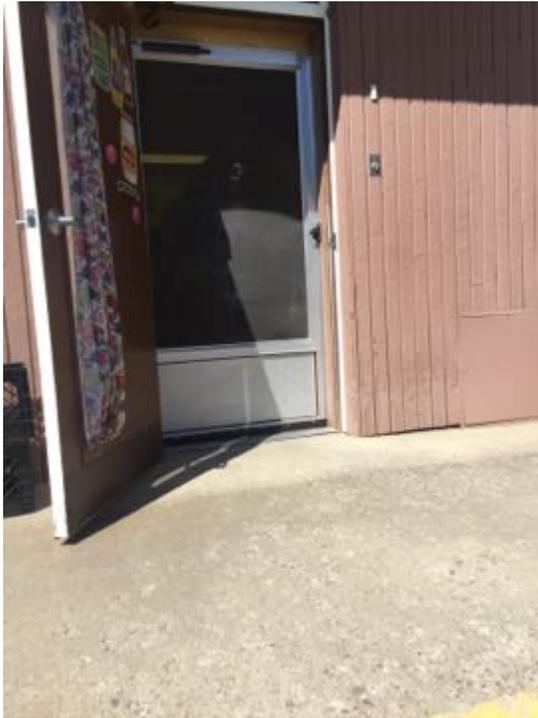
BE3 - Open kitchen door and unlatched screen. All exterior doors should be closed and locked during school hours.

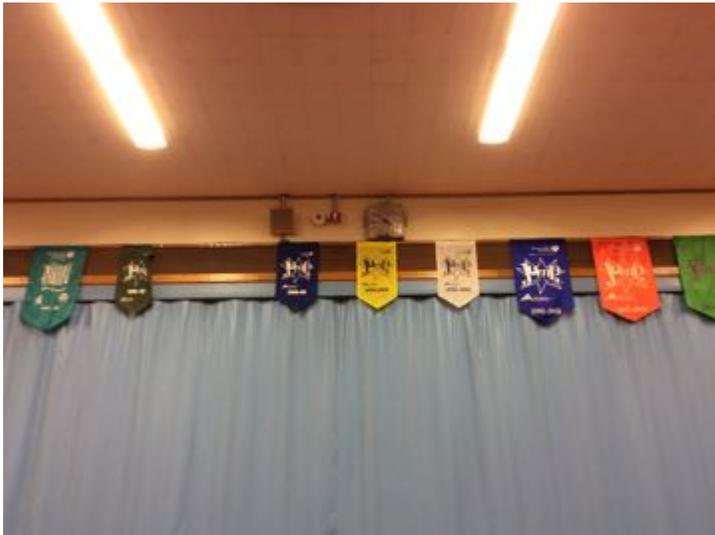
PP2 - The security camera on the gym side of the cafeteria/gym building is not currently not functioning.

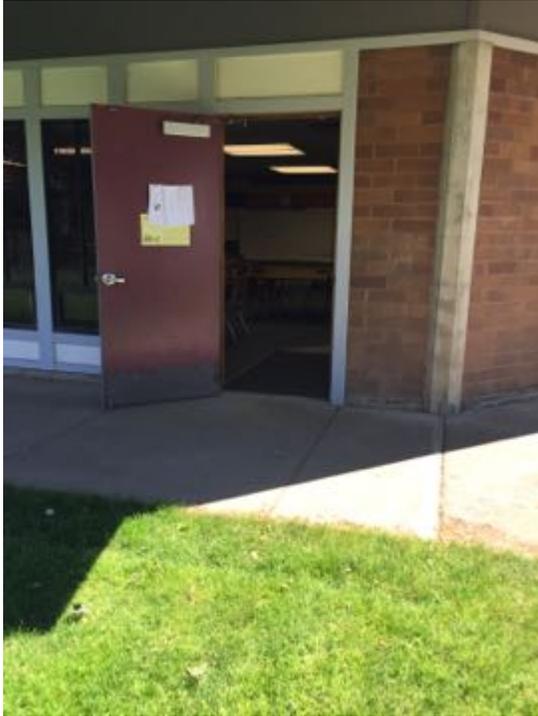
PP3 - Unlocked, open door. Building B. All exterior doors should be closed and locked during school hours.

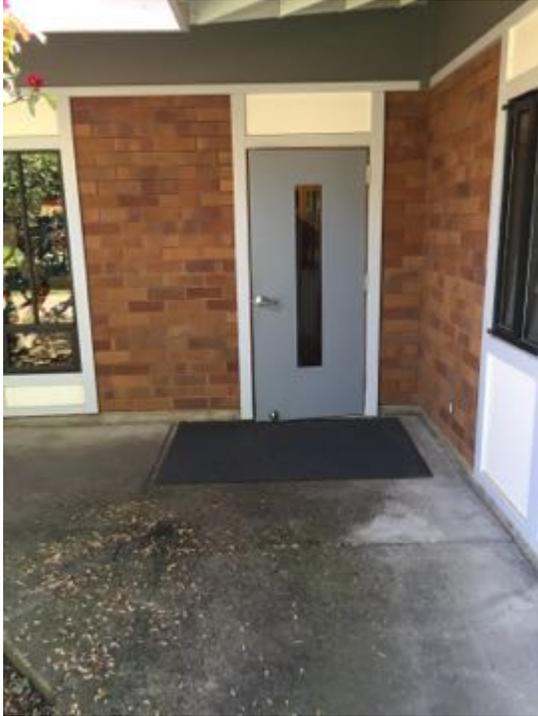
PP4 - Door locked, but ajar. All exterior doors should be closed during school hours.

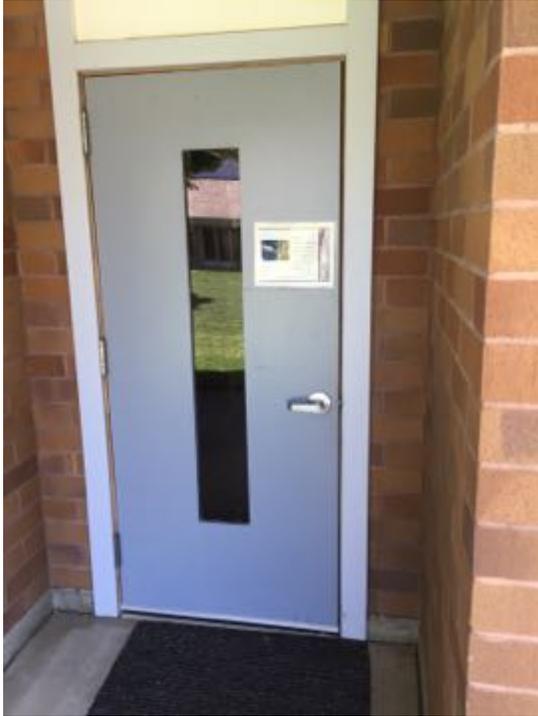
PP5 - Same door as above. Locked, but ajar.

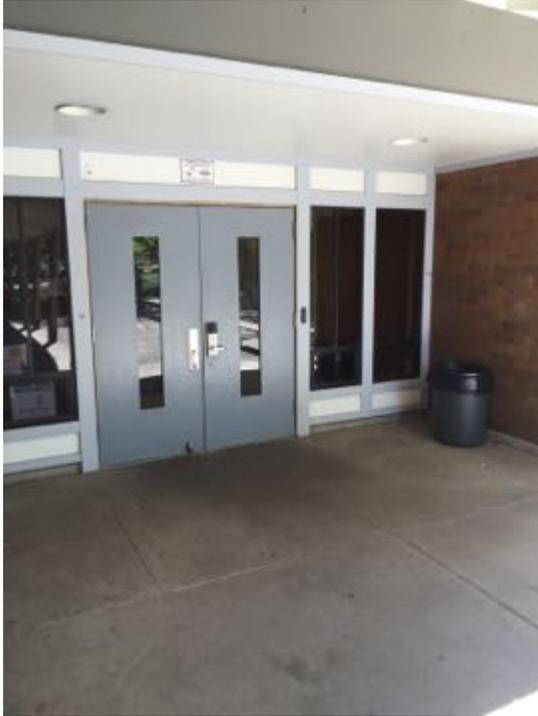
PP6 - Double doors unlocked, students going in and out. Building D

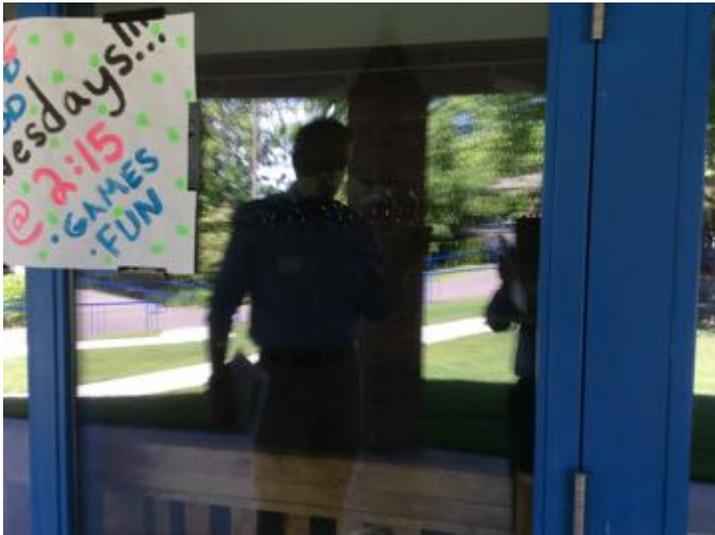
WH2- Tinted glass limits visual access to the interior of classrooms and is highly recommended on doors and windows where students are present. This photo was taken at the Auditorium.

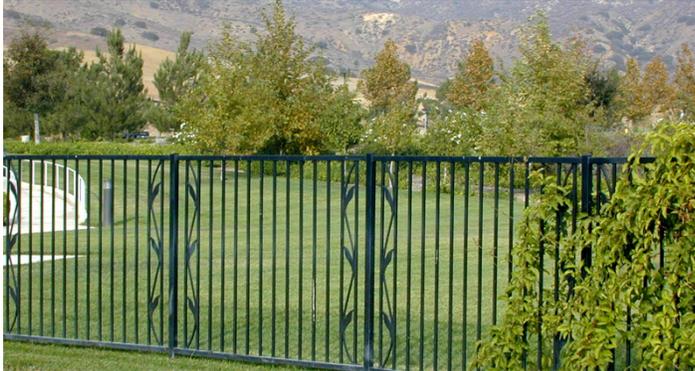
WH5 - Example 1 of ornamental fencing that could be used to secure the perimeter entrances to the school

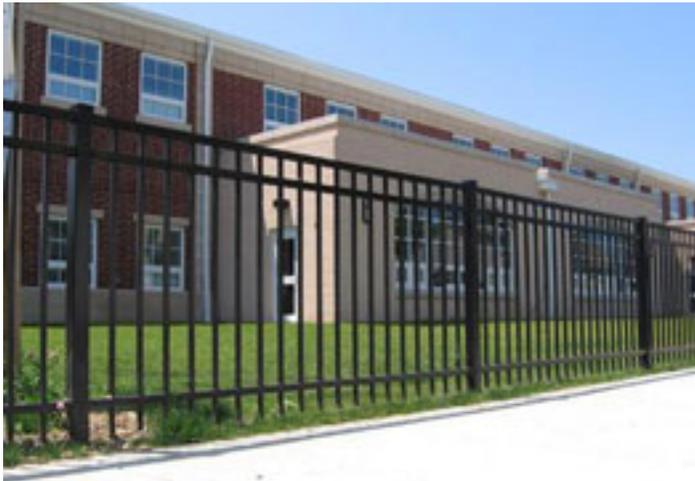
WH6 - Example 2 of ornamental fencing that could be used to secure the perimeter entrances to the school

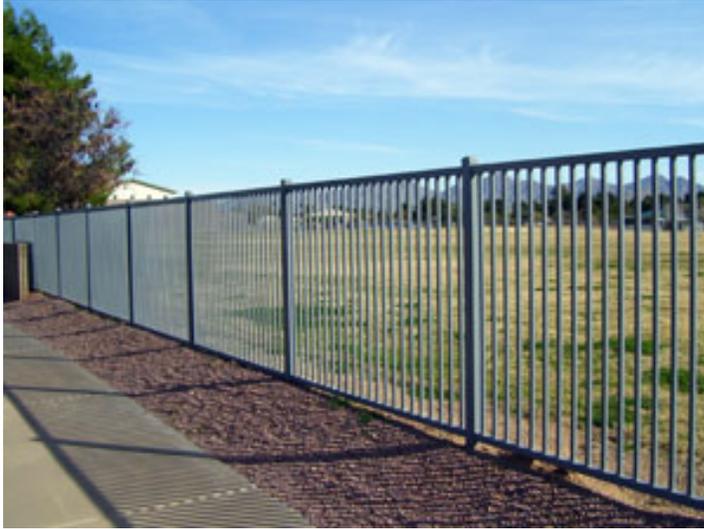
WH7- Example 3 of ornamental fencing that could be used to secure the perimeter entrances to the school

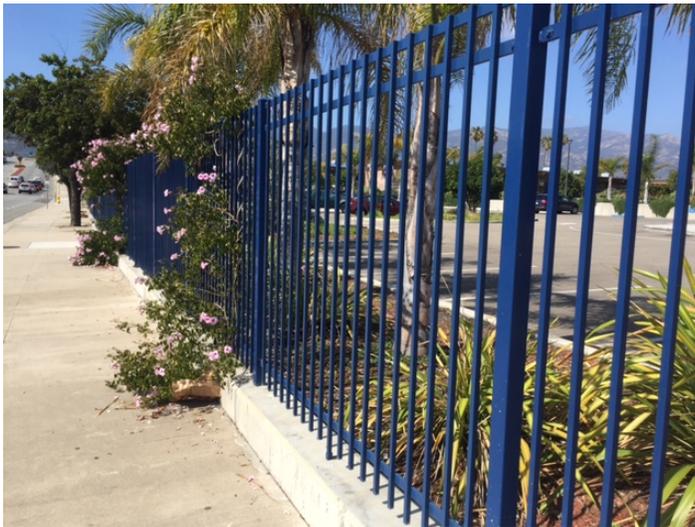
WH8- Example 4 of ornamental fencing that could be used to secure the perimeter entrances to the school

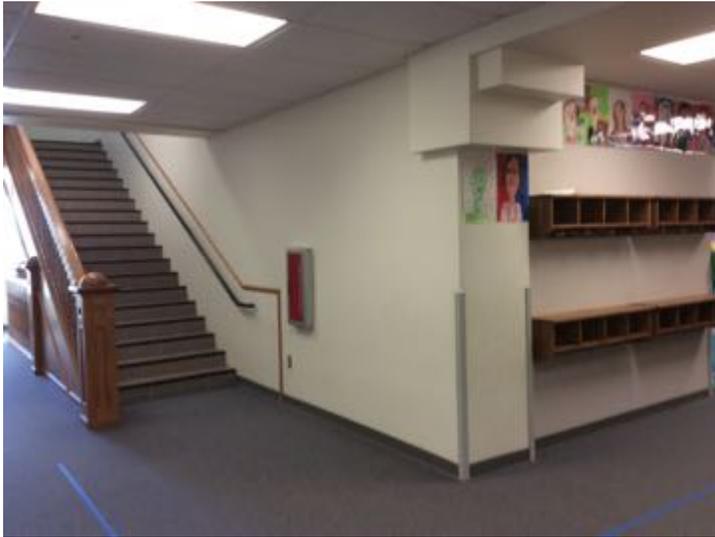
SE5 - A security camera is needed to see this view of the common area.

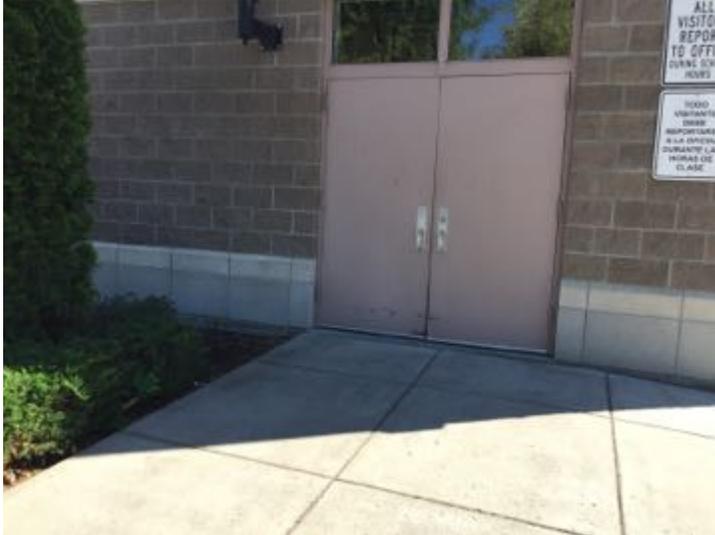
SE9 - Door on #3 side near #4 corner, found unlocked.

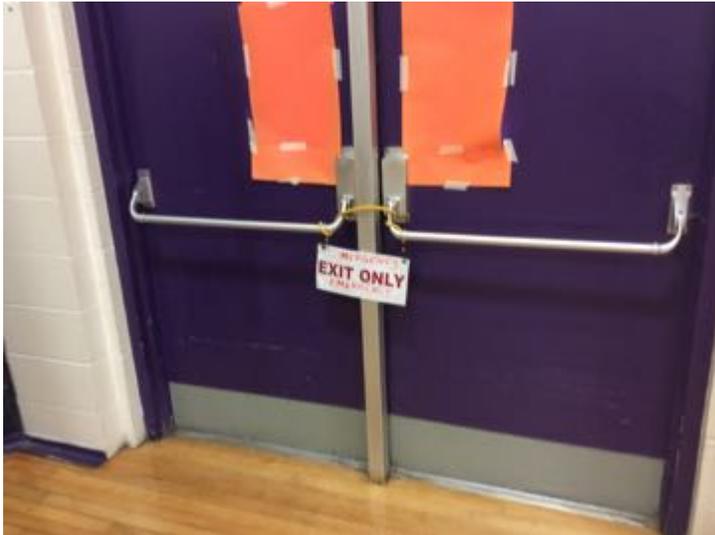
LH1 - Doors are currently being secured with a bungee cord. We recommend that the bar locking mechanism is repaired or replaced so that the doors are secured at all times.

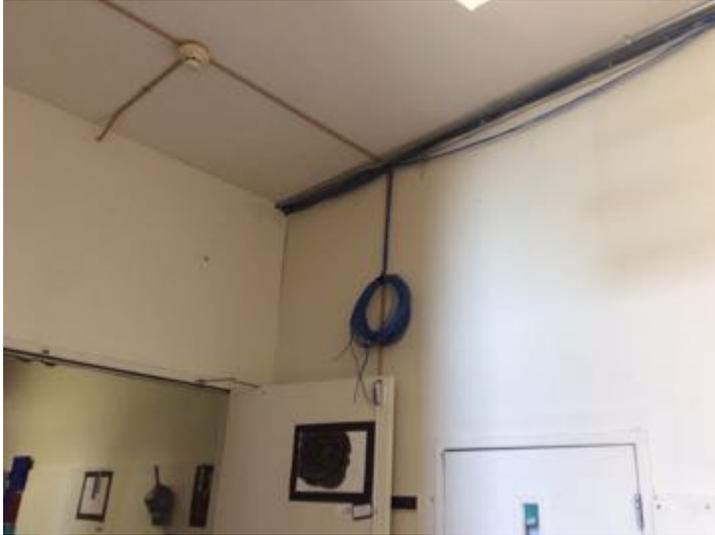
LH5 - Excess wire should be removed or enclosed in conduit to prevent access.

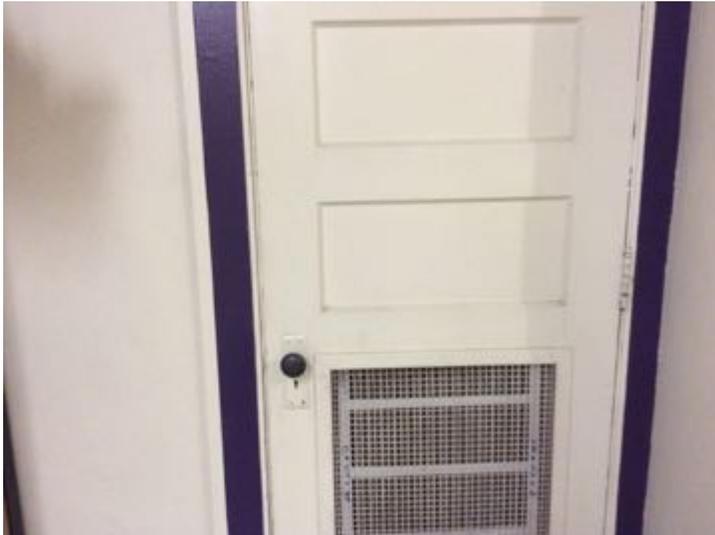
LH9 - Access doors to the boiler room should be locked from the exterior during school hours.

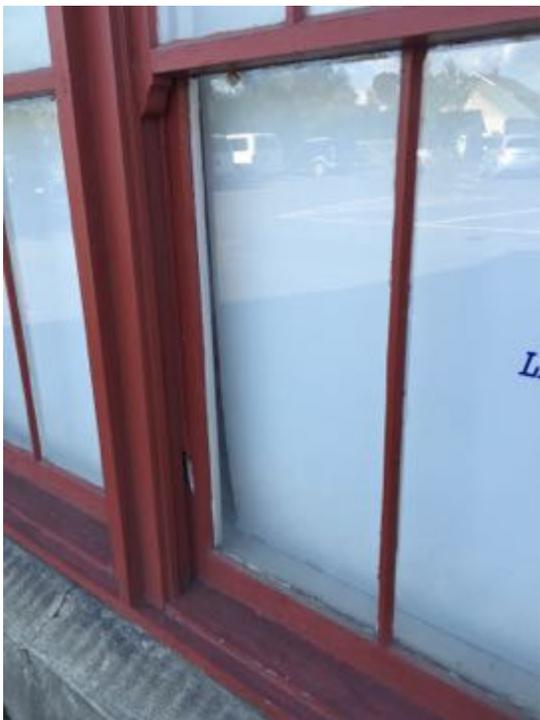
LH10 - Windows need to be upgraded to double pane and have shatterproof window tinting.

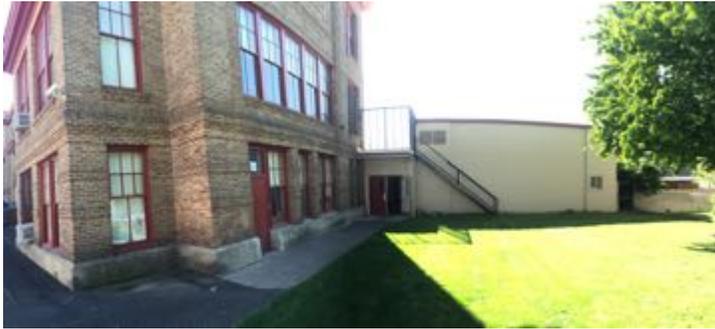
LH11 - Open door to gym. All exterior doors should be closed and locked during school hours.

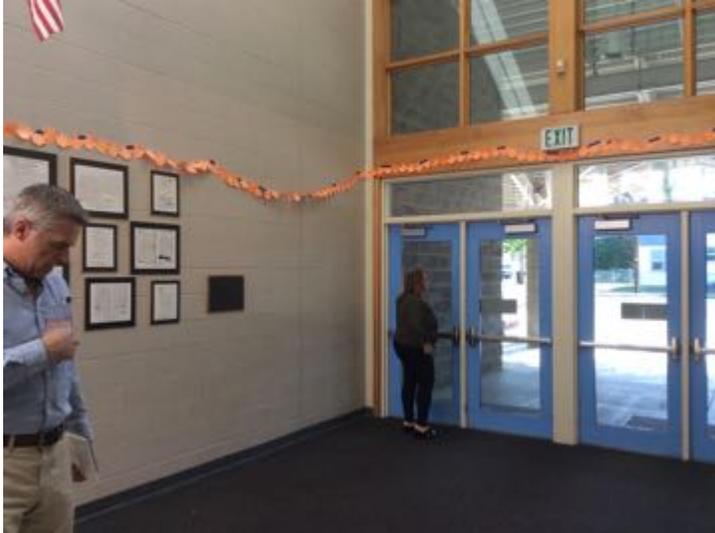
GM1 - We recommend creating a secure vestibule area at the front entrance of the school to prohibit access to the interior hallways and classrooms.

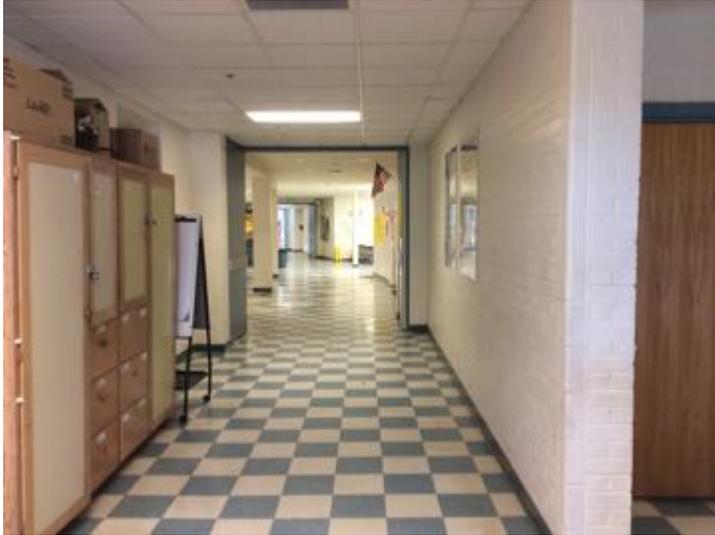
GM4 - A security camera is needed to see this view of the hallway.

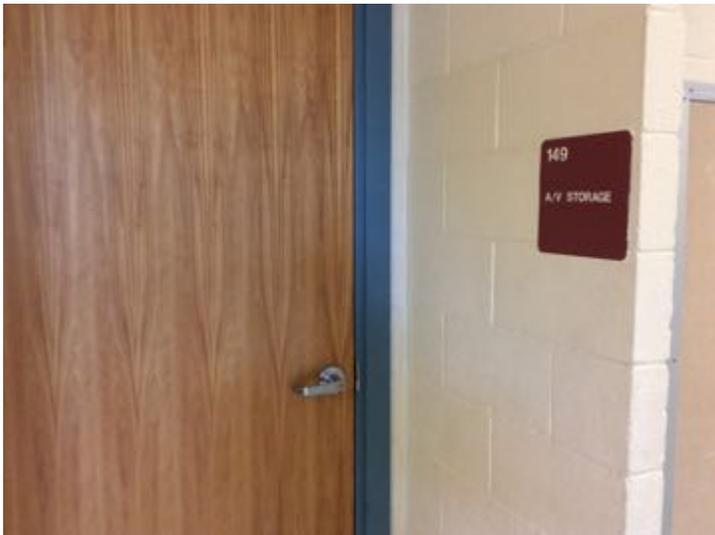
GM5 - AV storage room door should be locked during school hours.

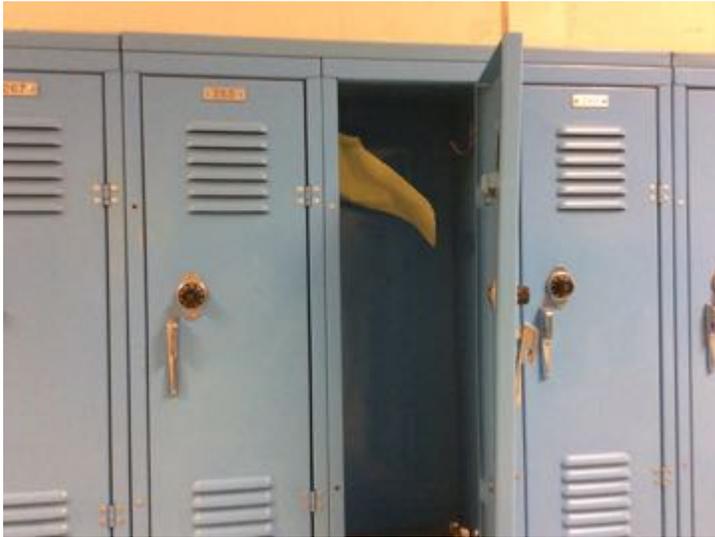
GM6 - All school locker doors should be shut and locked with a school issued lock.

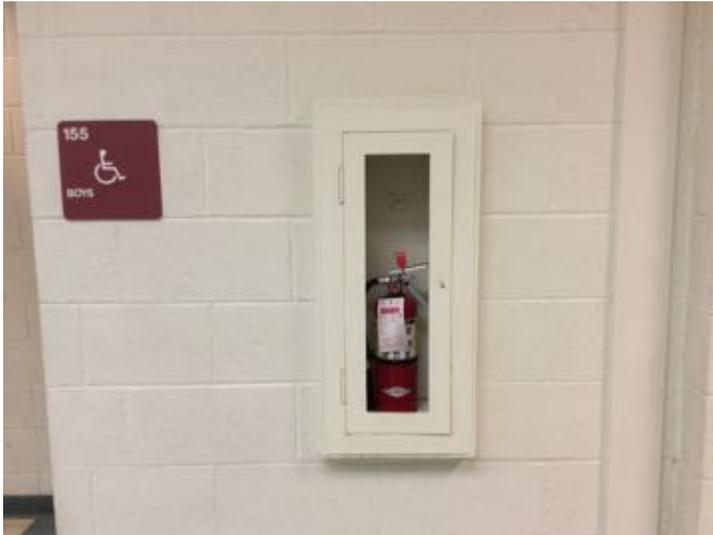
GM10 - Fire extinguisher near Room 155 was found to be unsecured. We recommend consulting your local fire department regarding fire code regulations for securing and accessing fire extinguishers on school grounds.

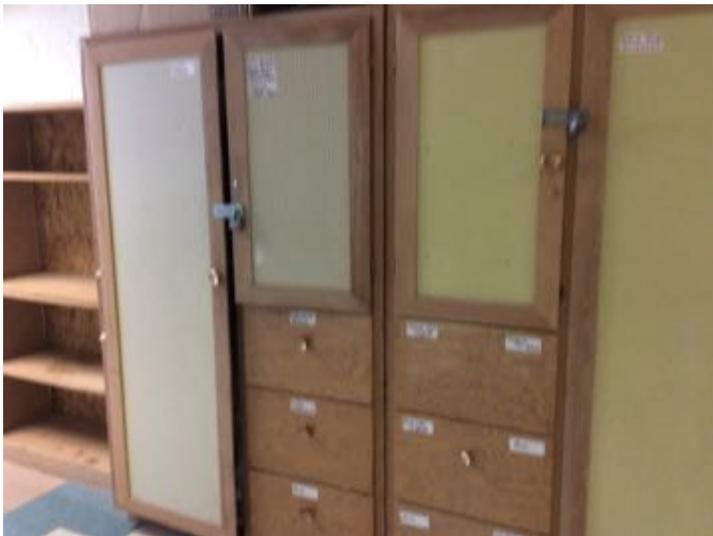
GM11 - Supply doors near Room 148A need to either be locked or the supply cabinets can be replaced with a style similar to what is present by Room 157, which can be locked from the front.

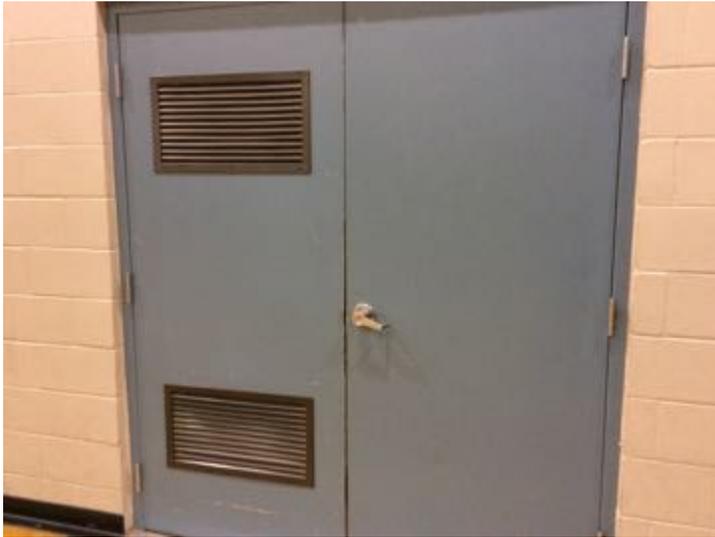
GM14 - Equipment room doors on the inside of the gym should be locked during school hours.

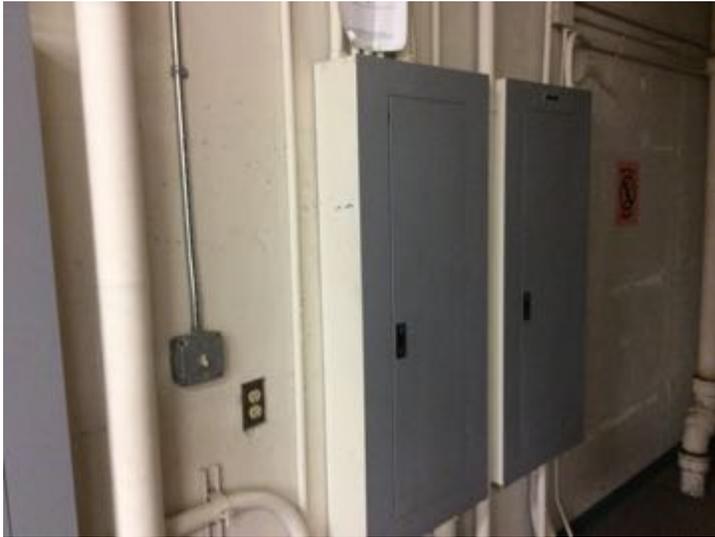
GM16 - Breaker panel doors on the stage should be locked and only accessible by school administration and custodial staff.

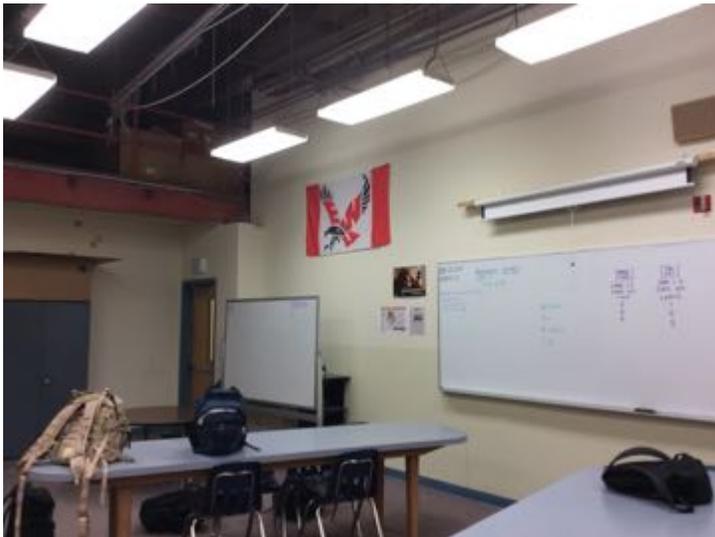
GM17 - A security camera is needed to see the backstage area.

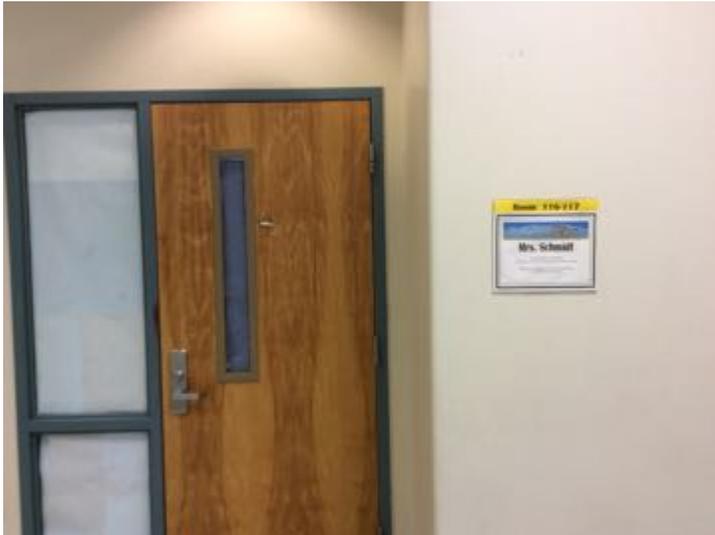
GM18 - Good example of a small window area in the classroom door. Also of note are the window coverings for the 2 side windows that limit visual access to the interior of the classroom. Doors with this window layout should also use windows covering to limit visual access to the classroom interiors.

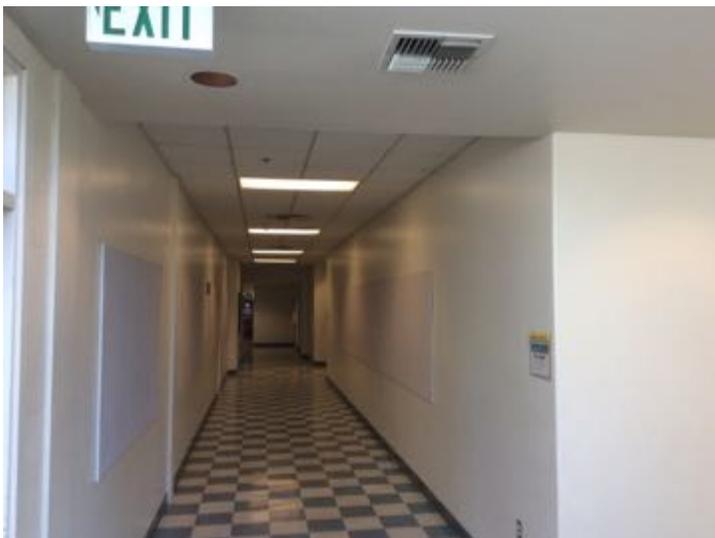
GM19 - A security camera is needed to see this view of the hallway.
