Sprigeo, Summary Report

School Safety Onsite Evaluation Summary Report

Walla Walla School District

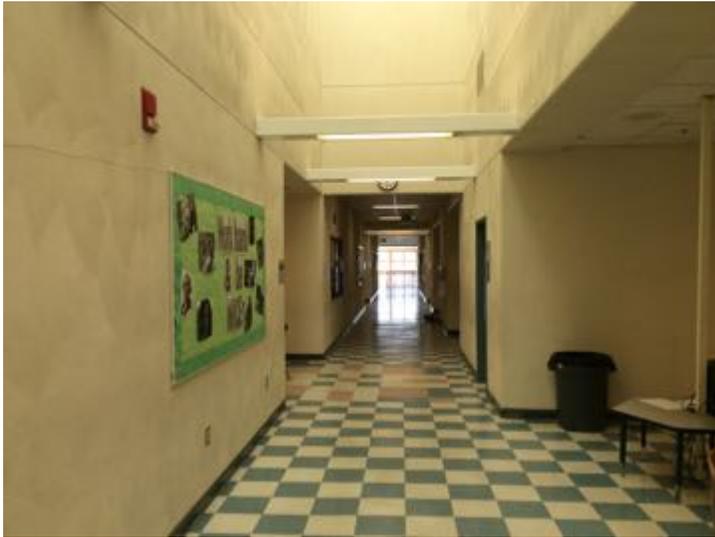
GM20 - A security camera is needed to see this view of the hallway.

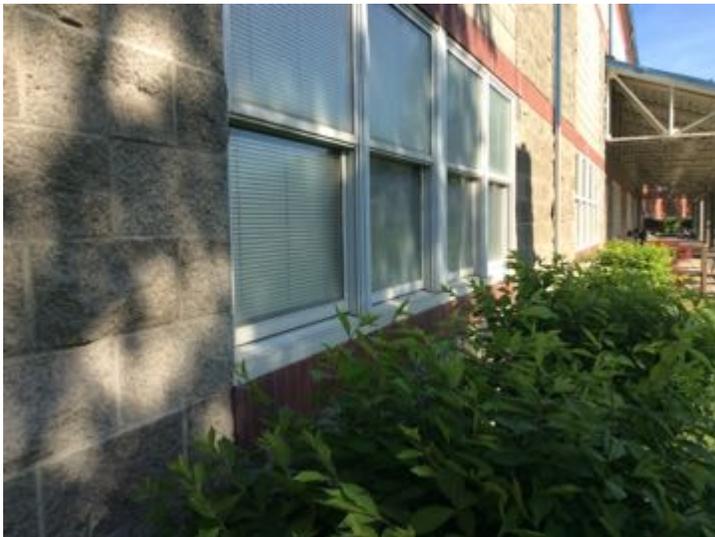
GM21 - #1 side. All exterior windows should have shatterproof window tinting installed. A security camera is needed to capture this view of the exterior.

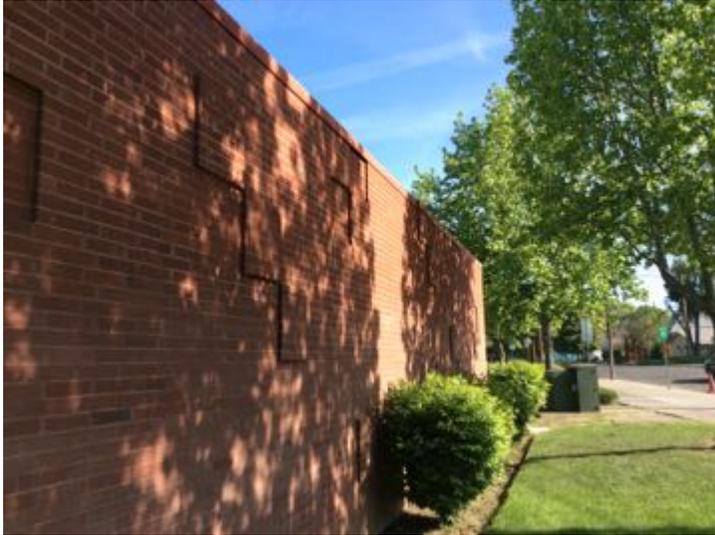
GM22 - A security camera is needed to capture this exterior view.

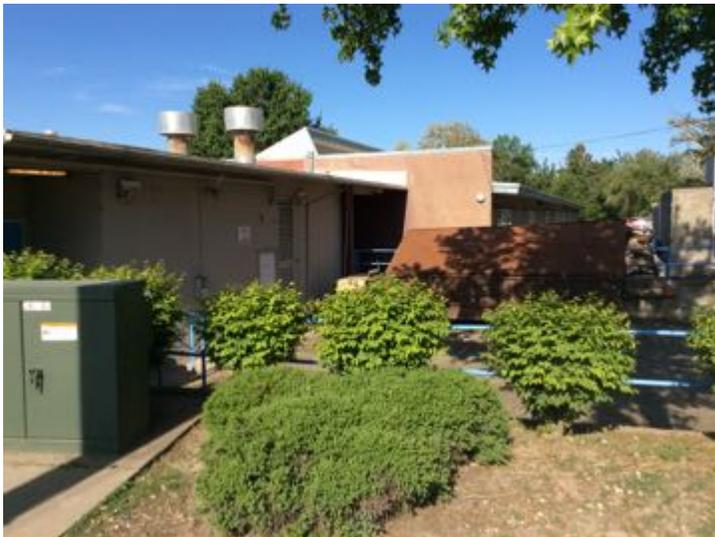
GM23 - Numerous dead spots on #2 side, delivery access area. Two security cameras are needed to capture this view.

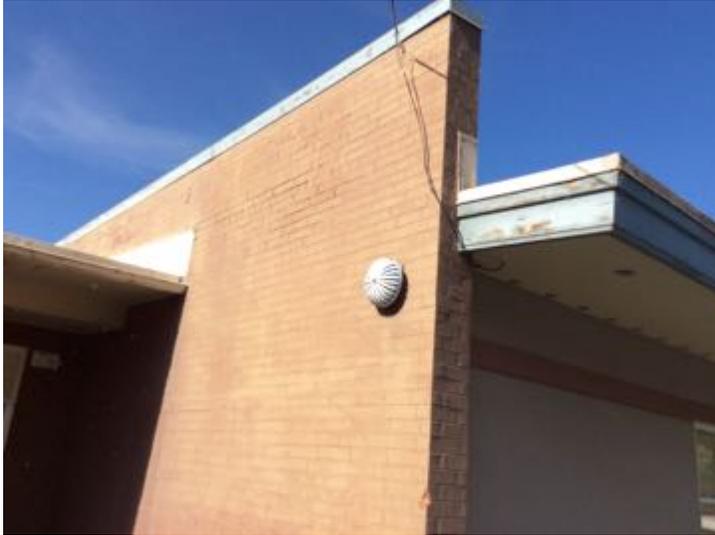
GM24 - Area where showing a potential location for a surveillance camera to cover dead spaces adjacent to delivery area.

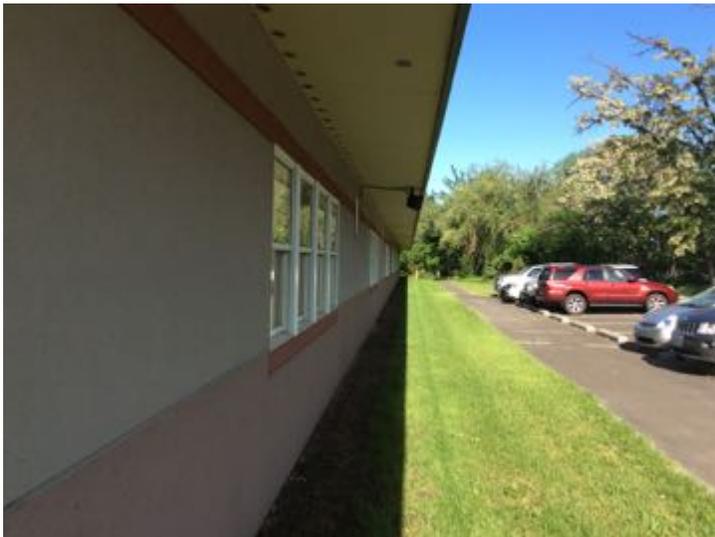
GM25 - #2 side. Keep all window blinds closed on exterior windows until window tinting can be installed. (This is the #2 side of the West Wing.)

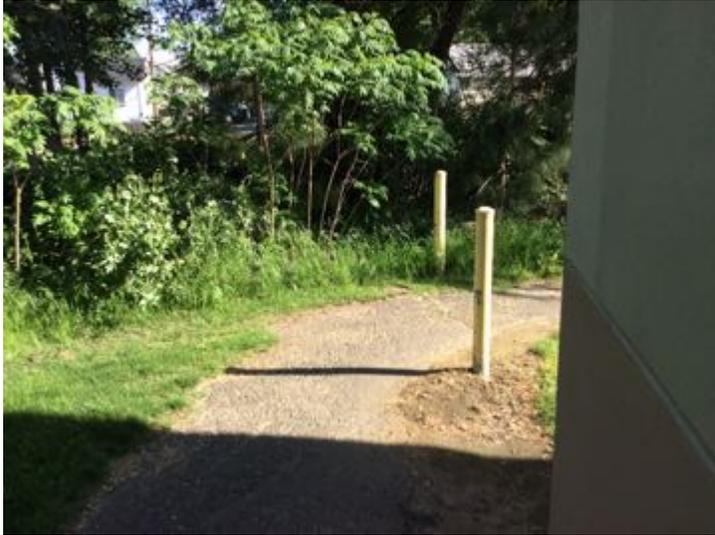
GM26 - At the 2, 3 corner of building. PR - chain link fence, with locked gate, from corner of building to creek edge. At this juncture, another fence (3') should be running alongside creek perimeter.

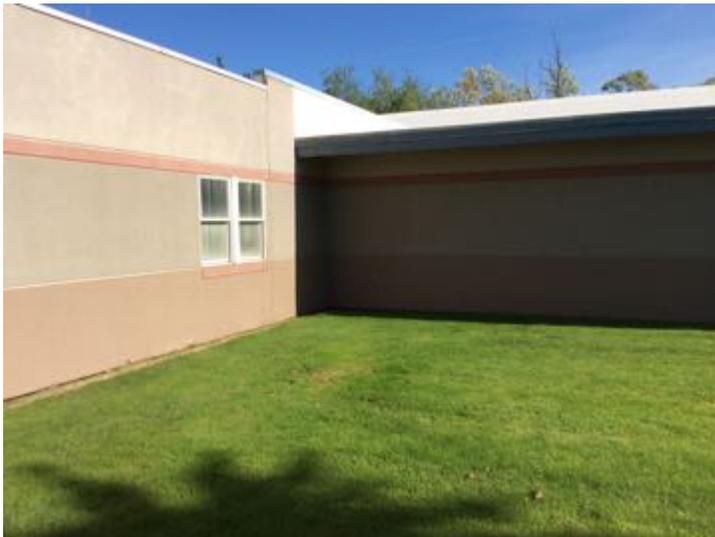
GM27 - West Wing corner of courtyard. A multi-lens camera should be installed here, showing courtyard to East Wing.

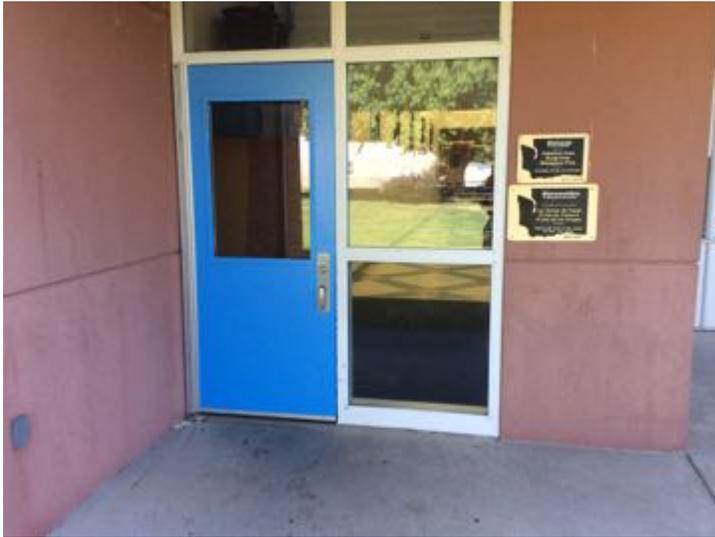
GM28 - Doors and windows in back courtyard area can also be treated with tinting.

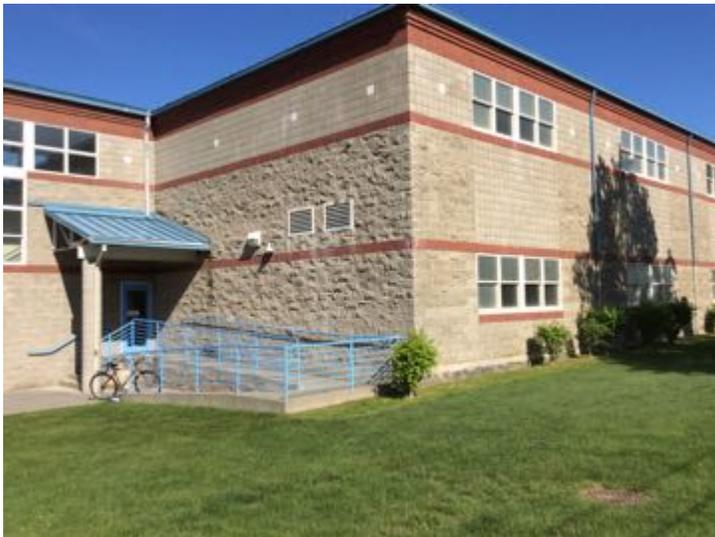
GM29 - Perimeter: #1 side of main building surrounded by neighborhood. East Wing/ gym building surrounded by fields, the area across from Fair Grounds. Fields have 5' high fence surrounding up till creek bed area. Chain link should extend around this dead space because of close proximity to school and numerous dead spaces creek provides.

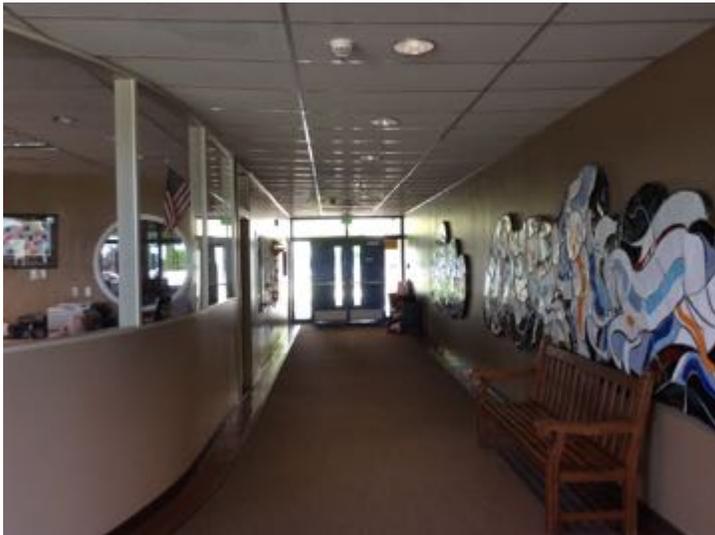
BR2 - A security camera is needed to see this view of the hallway.

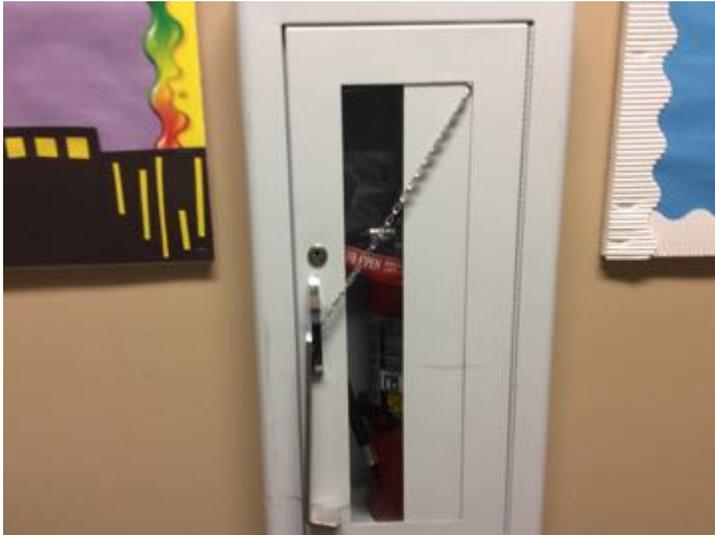
BR3 - We recommend consulting your local fire department regarding fire code regulations for securing and accessing fire extinguishers on school grounds.

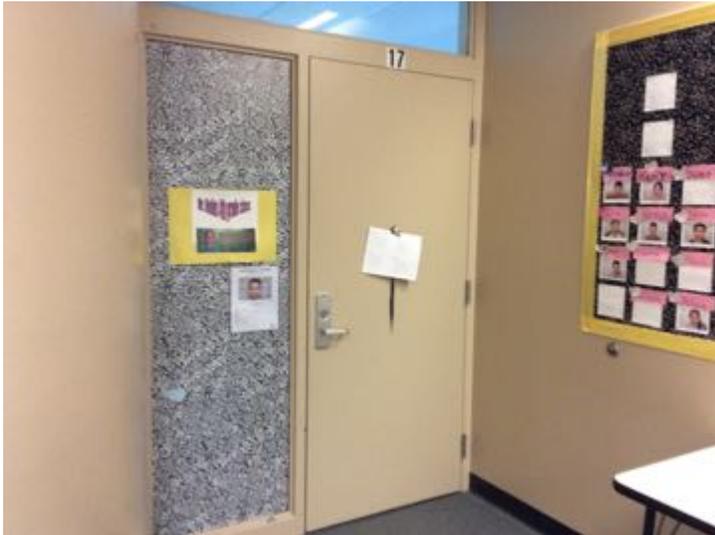
BR5 - The door locking mechanism on Room 17 should be checked to confirm that it is functioning properly and not in need of replacement.

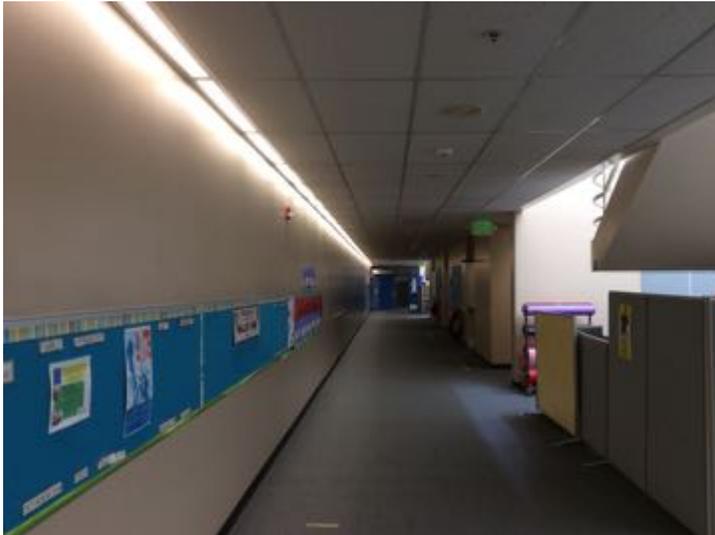
BR7 - A security camera is needed to see opposite end of the lower level main hallway.

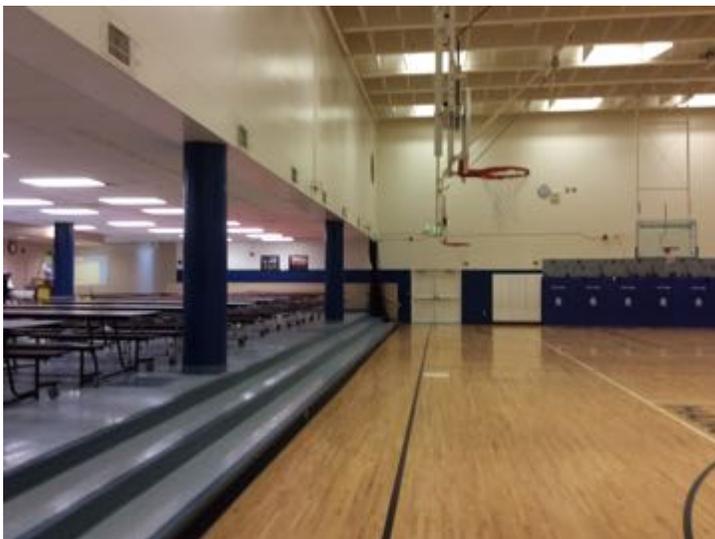
BR8 - Security cameras are needed on the far ends of the gym to capture the view of both the gym and cafeteria.

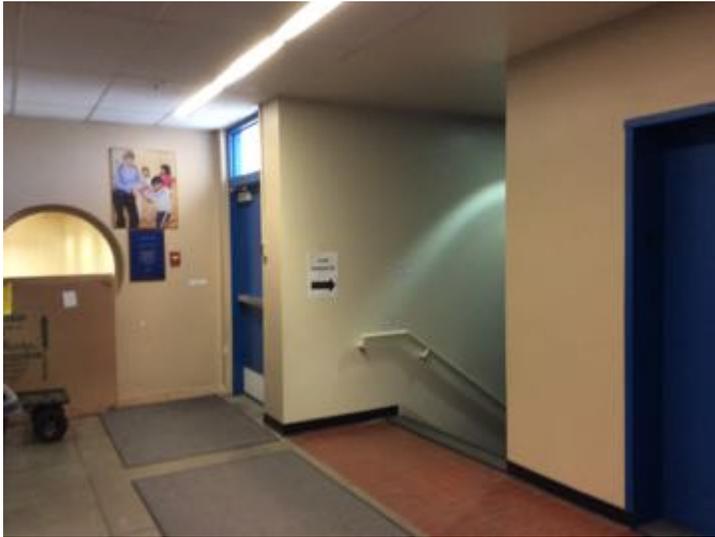
BR9 - A security camera is needed to see the upper level area next to the elevator.

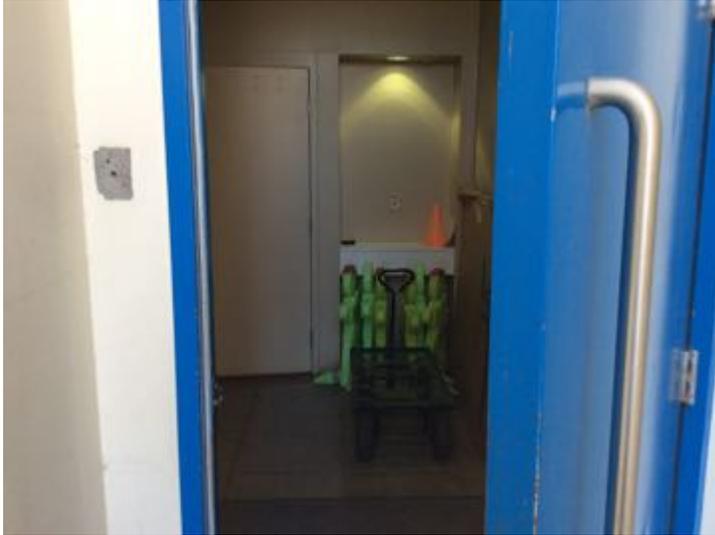
BR10 - Alcove on #1 side near 1, 2 corner. Door found unlocked. All exterior doors should be closed and locked during school hours.
